**UPDATED PRELIMINARY GEOTECHNICAL INVESTIGATION
AND UPDATED FAULT RUPTURE HAZARD EVALUATION
TENTATIVE TRACT 34760, CORONA
RIVERSIDE COUNTY, CALIFORNIA 92882**

W.O. 5166-A-SC OCTOBER 9, 2006

Subject: Updated Preliminary Geotechnical Investigation and Fault Rupture Hazard Evaluation, Tentative Tract 34760, Corona, Riverside County, California

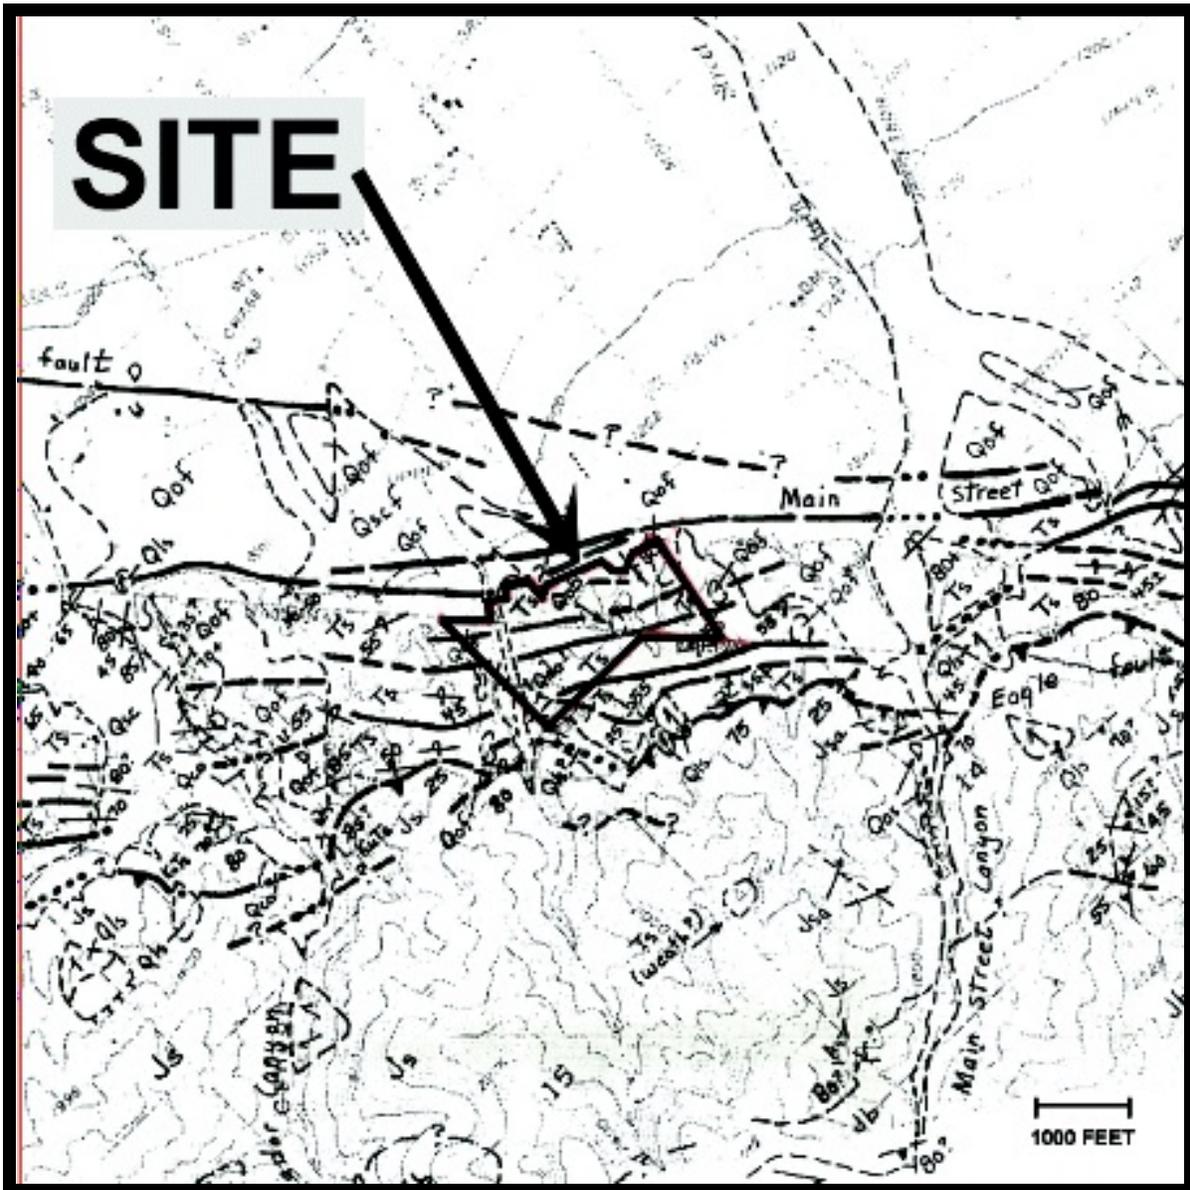
Colluvium was encountered overlying the Silverado Formation in FT-2. The colluvium consisted of fine- to medium-grained silty sand with trace gravel. A buried pedogenic Bt soil horizon exhibiting a blocky, columnar structure with weakly-developed pedes was observed within a portion of the colluvium. This buried Bt soil horizon is similar in
