***UPDATED GEOLOGIC FAULT HAZARD EVALUATION FOR THE PROPOSED 17-ACRE MULTI-USE
"SKYLINE VILLAGE" DEVELOPMENT, LOCATED AT WEST CHASE DRIVE AND FOOTHILL
PARKWAY IN THE CITY OF CORONA, RIVERSIDE COUNTY, CALIFORNIA; APNS: 275-050-014-6
AND 275-080-041-3***

*Dated: July 16, 2020
Project No. G19-1802-10*

Project No. G19-1802-10

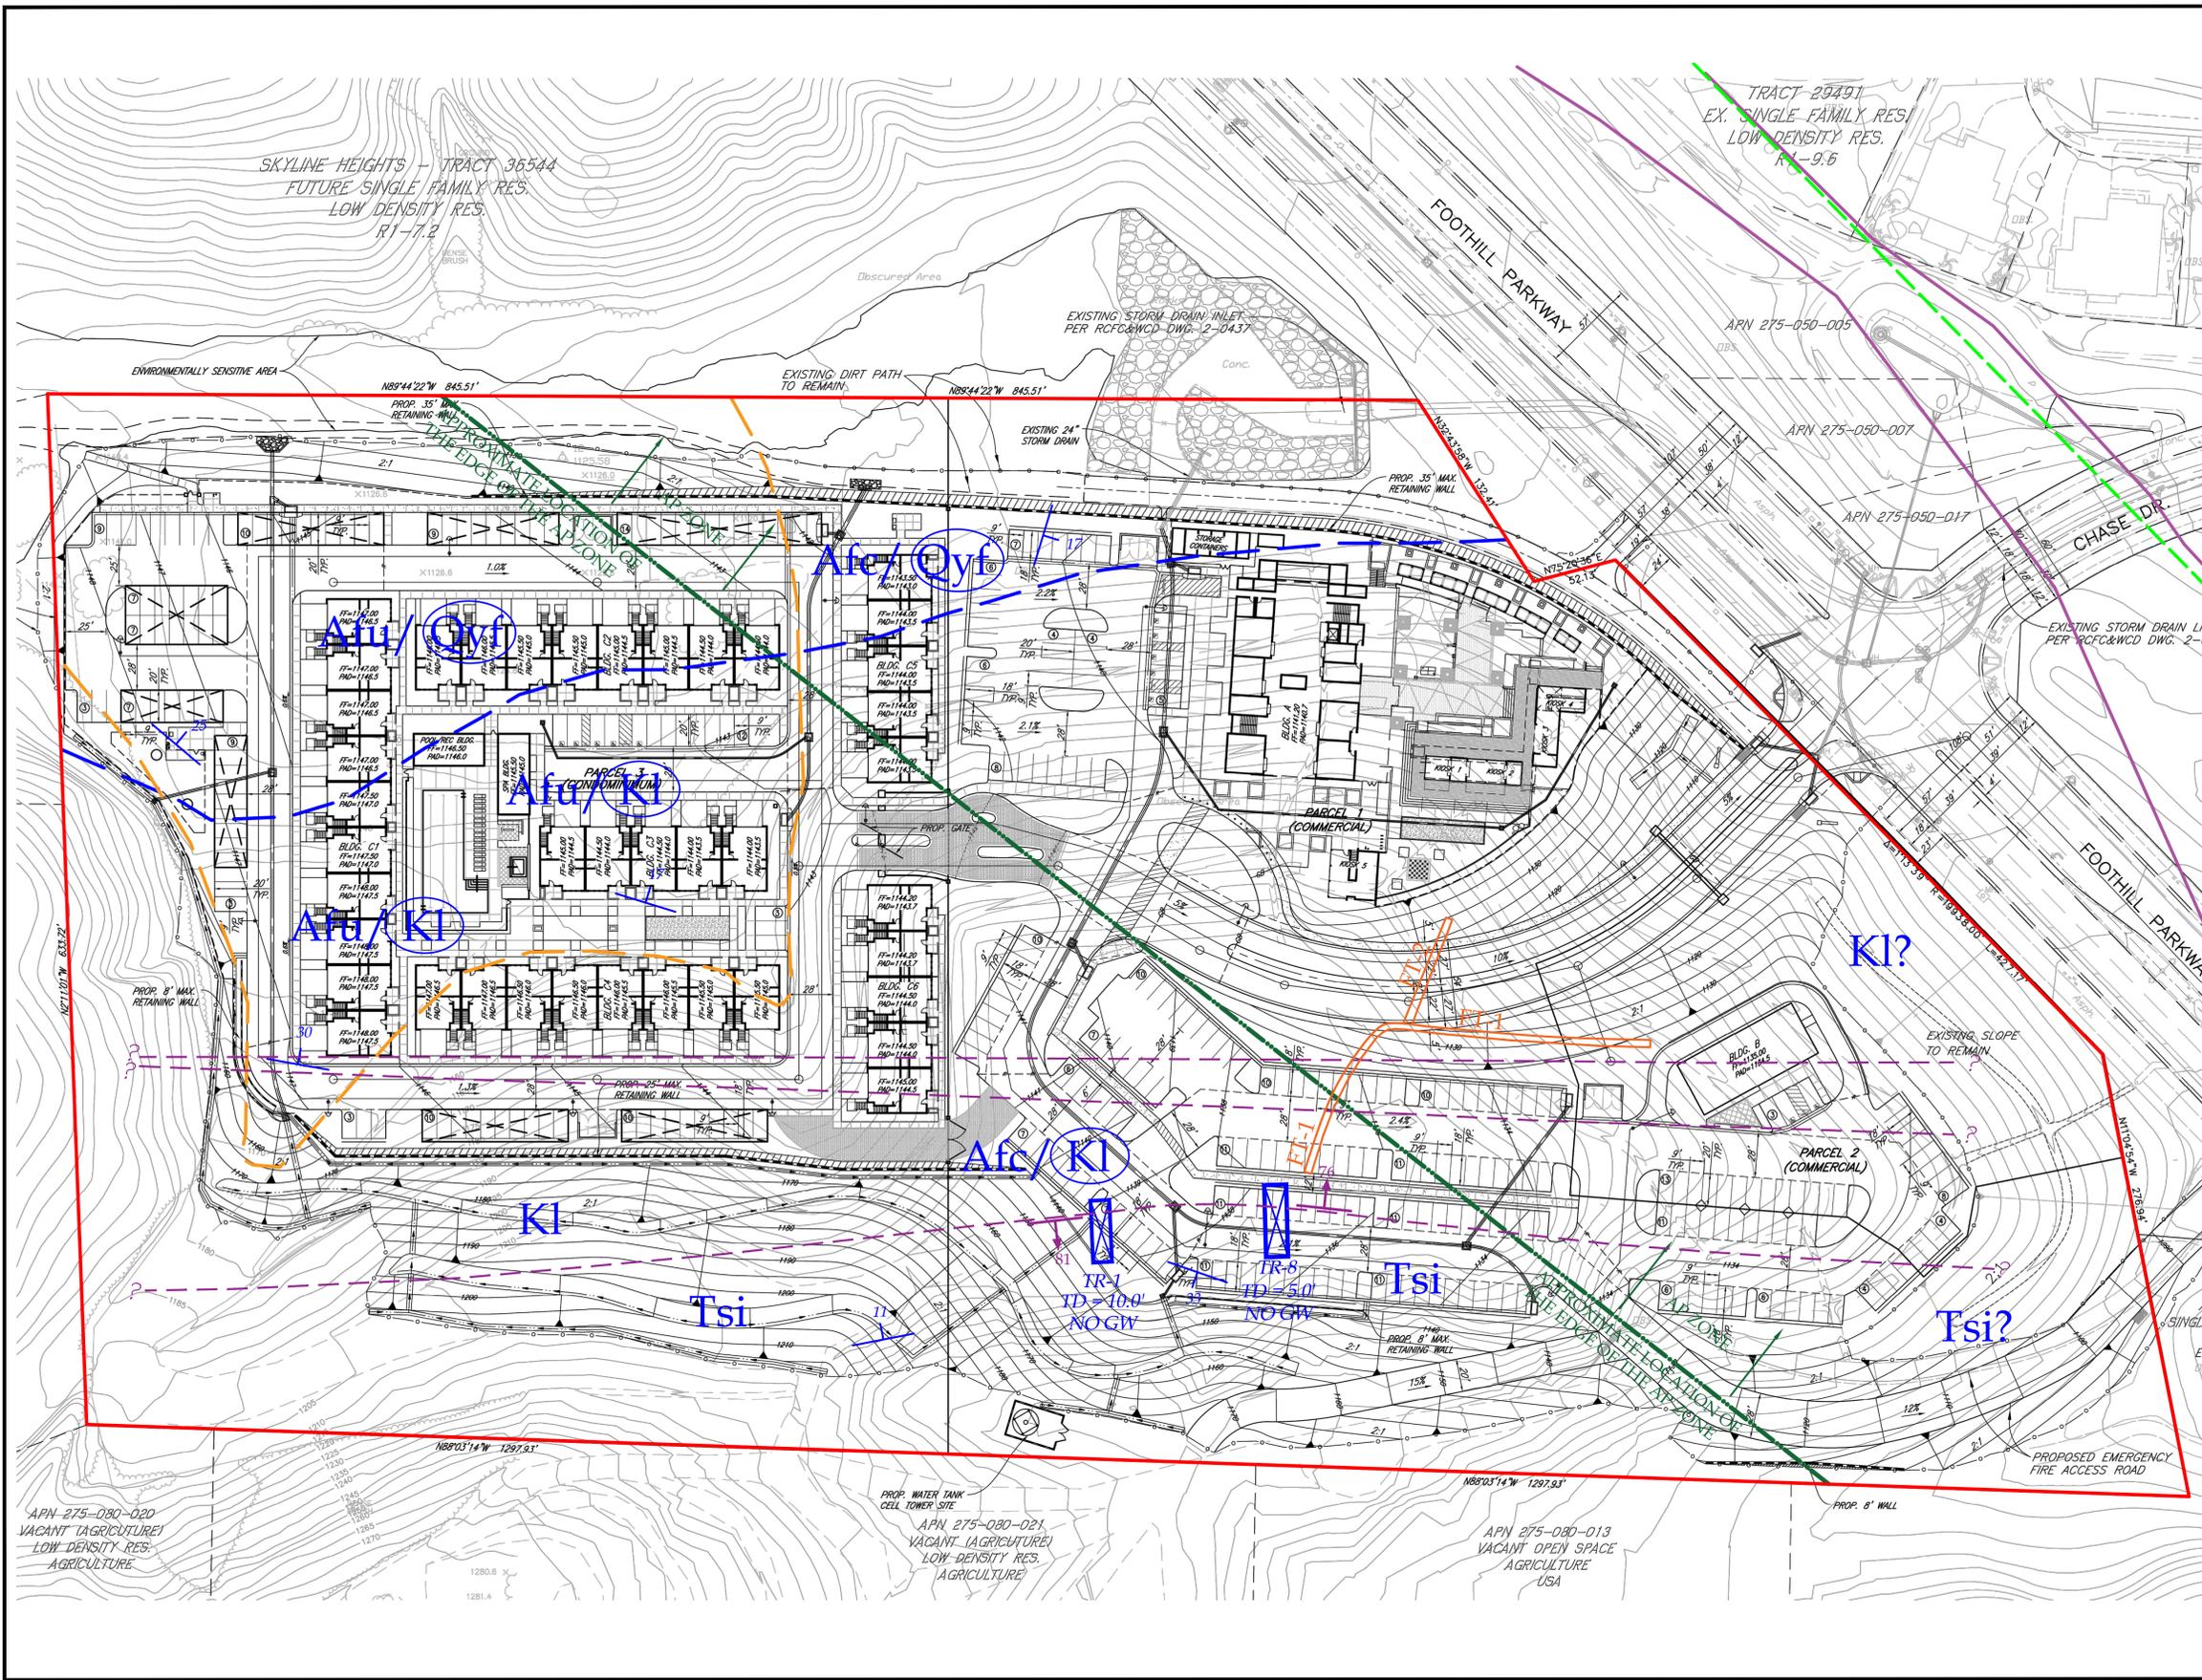
Based on our review of available geological and geotechnical literature, field mapping, and past subsurface investigation of the site, it is our understanding that the site is primarily underlain by undocumented artificial fill, compacted artificial fill, young alluvial fan deposits, Silverado Formation bedrock, and Ladd Formation bedrock. The subsurface geological units are described in greater detail below and presented on the Fault Trench Logs (Plate 2) where encountered. The observed geologic units are depicted on the Geologic/Fault Location Map (Plate 1).

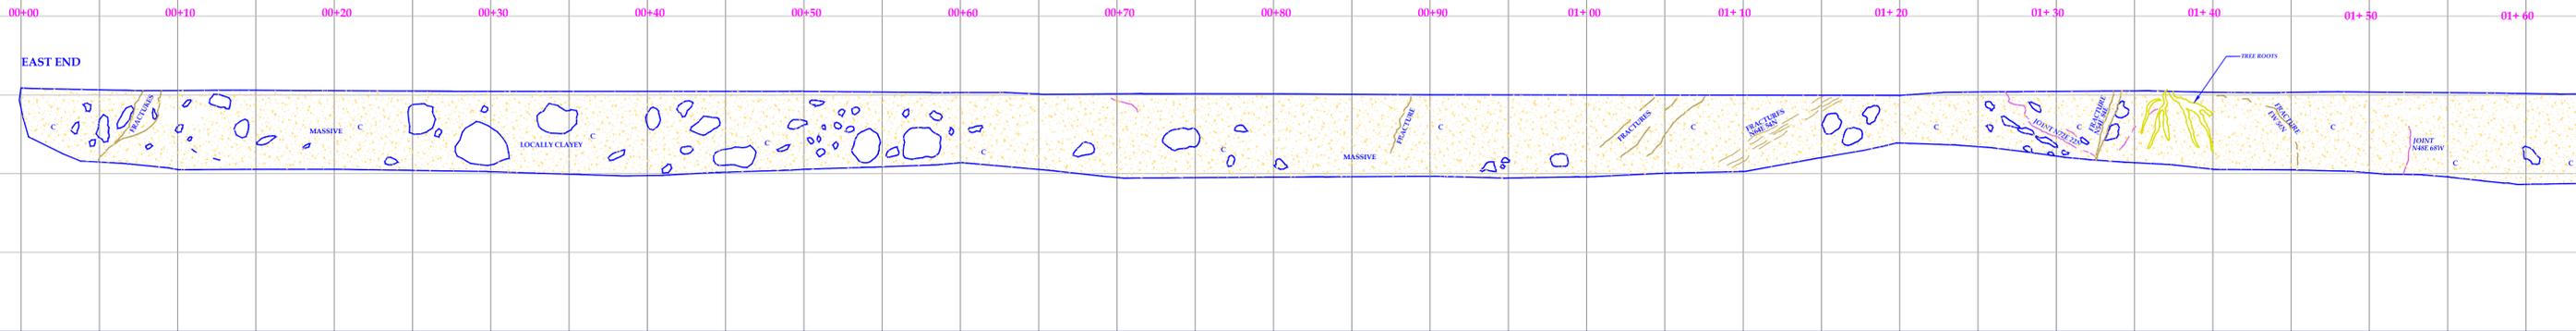
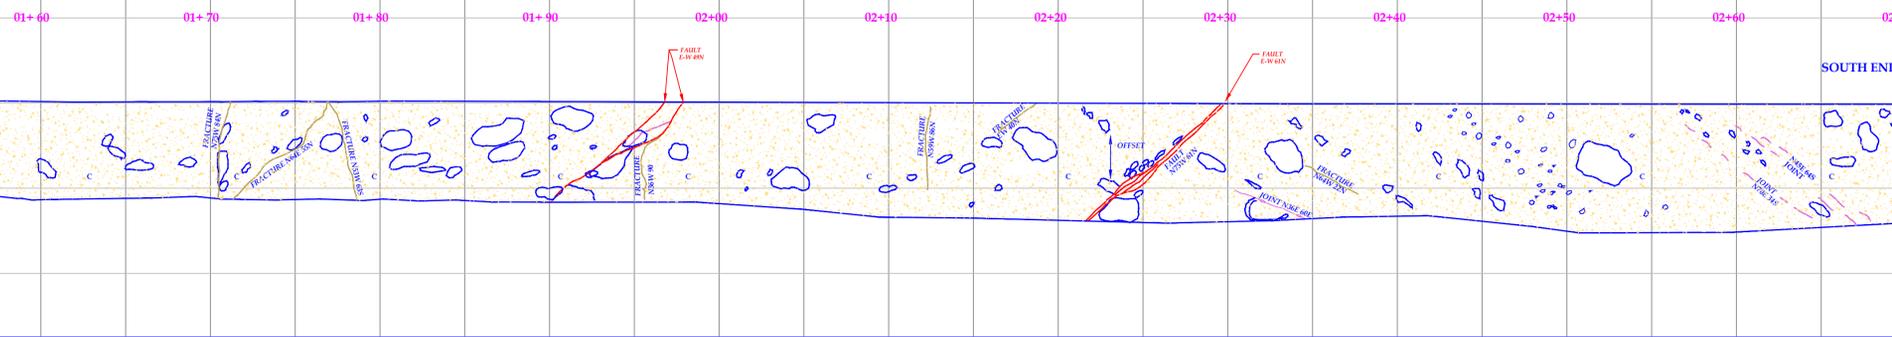
FT- 1

Fault Trench FT-1 was previously excavated across a portion of the Alquist-Priolo Earthquake Fault Zone roughly perpendicular to the mapped trend of the Elsinore fault zone. This trench was approximately 270 feet in length and to a maximum depth of approximately 7 feet below existing ground surface (see Plate 2). Most of the trench generally exposed Ladd Formation bedrock. Two faults were mapped within the bedrock (see Plate 2). According to LGC Inland (2004), faulting was evident by a thin, green and white clay gouge zone within the bedrock. The observed faulting coincided with the approximate location of the USGS Tin Mine fault trace. Holocene aged overlying soil was not observed within this trench to further evaluate the recency of activity of this fault.

Faulting associated with the approximate trace of the Tin Mine fault was observed within Cretaceous aged Ladd Formation bedrock by LGC Inland (2004) in Trench FT-1. Faulting was also observed in TR-1 and TR-8, forming the contact between the Silverado and Ladd Formations. No evidence of active faulting was observed in artificial fill soils overlying localized fault traces. Review of aerial imagery does not show geomorphic fault features associated with either splay of the Tin Mine fault transecting the site. With the absence of Holocene aged topsoil, it cannot be concluded that the fault is inactive or potentially active. However, with no lineaments observed that could indicate potential activity, LGC concludes that the Tin Mine fault is not active. Based on our evaluation and previous trenching, no structural setback zones have been recommended for this fault.

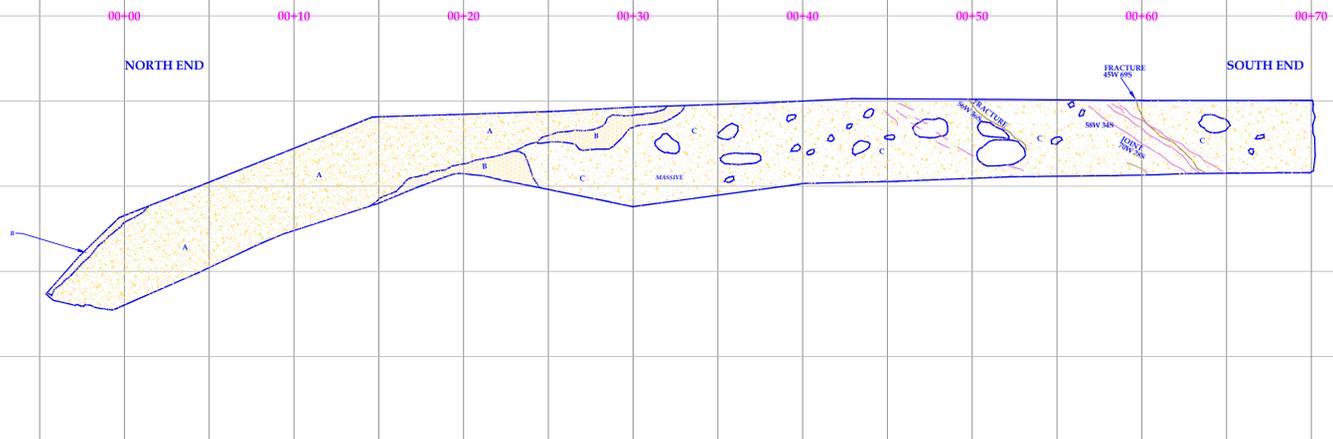
FT- 2

Fault Trench FT-2 was excavated north of FT-1. This trench was approximately 70 feet in length, a maximum of approximately 7 feet deep, and generally exposed undocumented artificial fill directly overlying top soil and Ladd Formation bedrock on the northern end of the trench and generally exposed Ladd Formation bedrock on the southern end of the trench. No faults were observed in FT-2 (see Plate 2).

Detailed geologic mapping should be performed during rough grading operations onsite to accurately locate any fault traces with respect to the proposed development. Emphasis must be placed on properly mapping and locating the Tin Mine fault splay in addition to evaluating areas north and east of the end of fault trench FT-2 for possible faulting in this area.
