# DESIGN GUIDELINES FOR HISTORIC BUILDINGS

**City of Corona Planning Department  
February 2003**

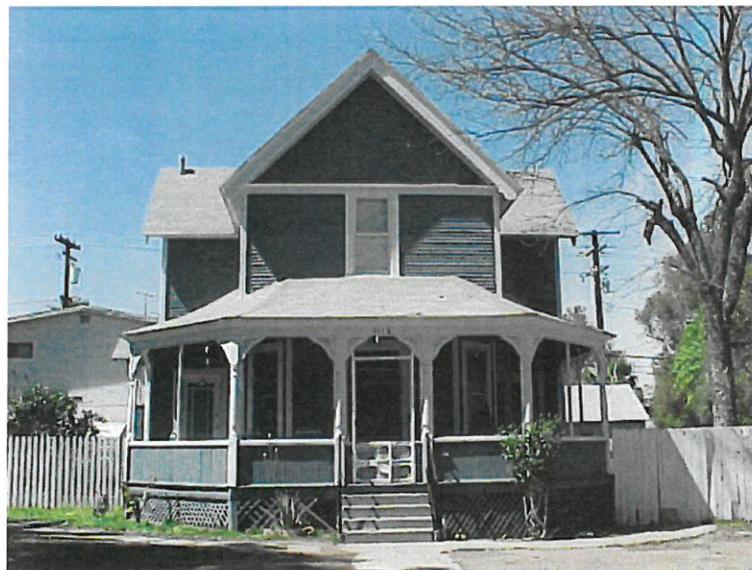
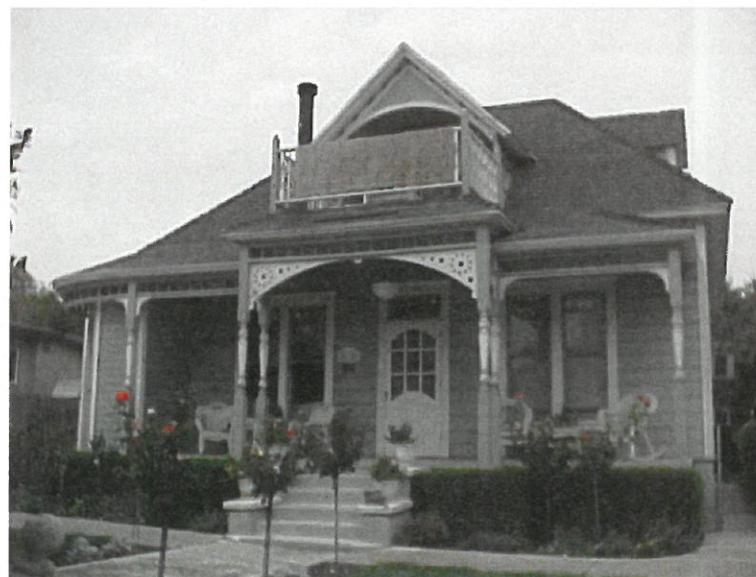
*Examples of Queen Anne style homes in Corona*

Queen Anne houses avoided flat wall surfaces by including bays, towers, overhangs, wall projections, and by using several wall materials of differing textures. The latter was most commonly achieved with patterned wood shingles shaped into varying designs or shingle over clapboard in two story houses. Extensive one-story porches were

common, accentuating the asymmetry of the façade. Second story porches and recessed porches were sometimes present.

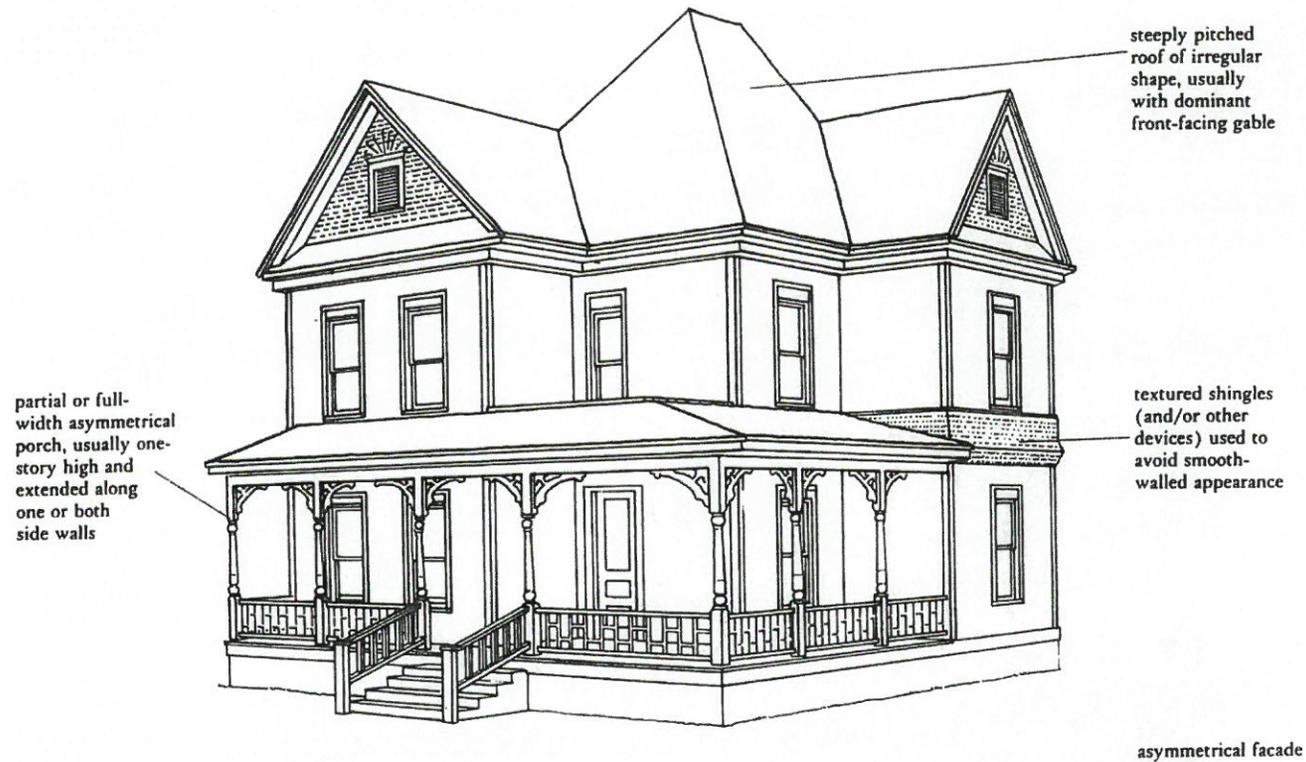
## QUEEN ANNE VICTORIAN

### IDENTIFYING FEATURES

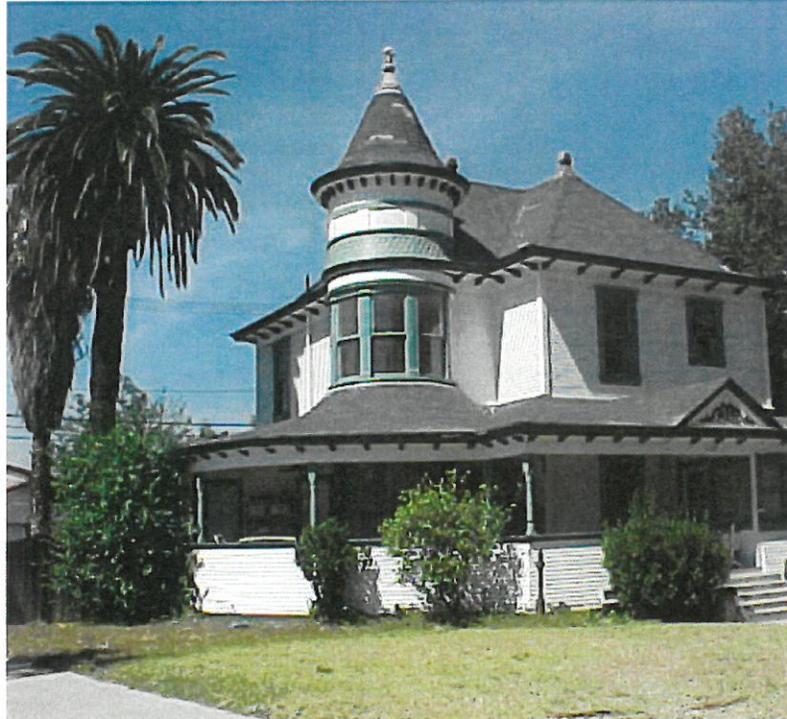
### A CORONA EXAMPLE

*This home, built in 1899, exhibits features of a Queen Anne style house beginning with its hipped-roof shape with tower. The porch covers the full width of the front entrance, extending to the south side and accentuating the rounded asymmetry of the façade. The porch supports and exposed rafters exhibit spindlework turning, the roof crests are topped with finials, the front porch gable displays decorative detailing, the wall cladding is primarily clapboard with varying shingle patterns on the tower, and the rectangular shaped windows are simple and double-hung.*

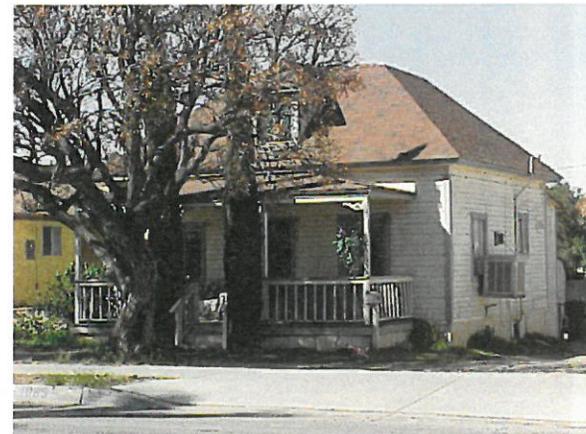
*Hipped-roof cottage with dormer.*

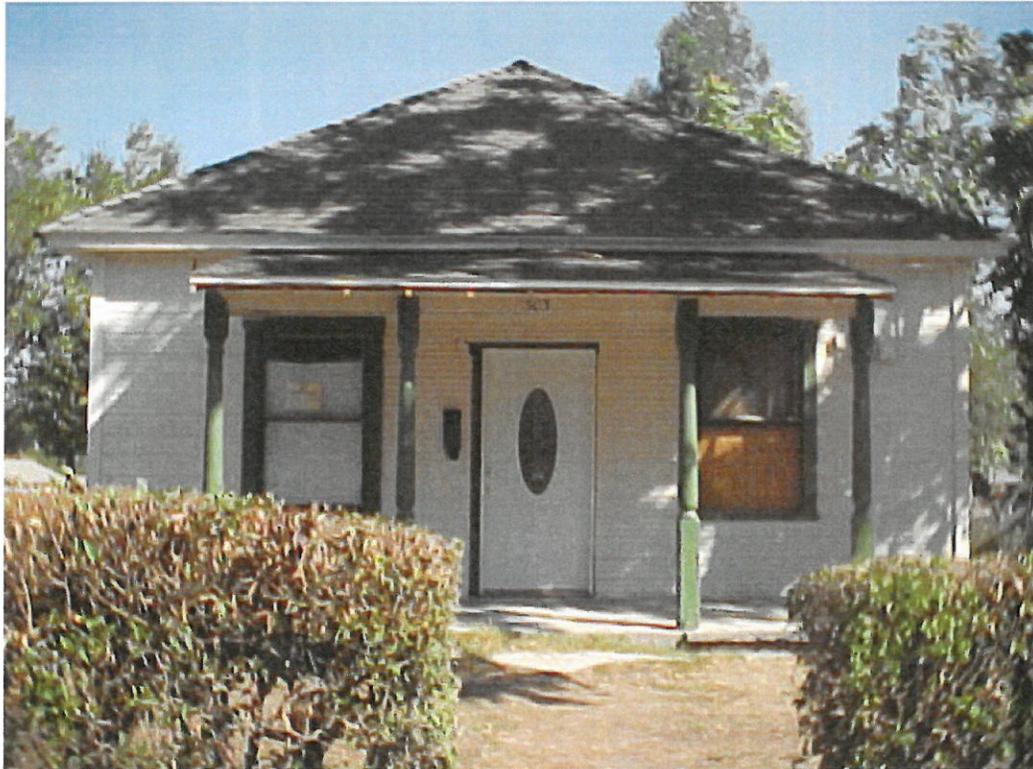
### A CORONA EXAMPLE

*This house displays several identifying features of Victorian hipped roof cottages. It is a single story, square-shaped building with a front porch extending almost the entire width of the house. The porch roof supports are turned in the Queen Anne style, but there is little other ornamentation. The windows are simple, rectangular shaped with only a single pane of glass in each sash. The estimated date of construction is 1902.*

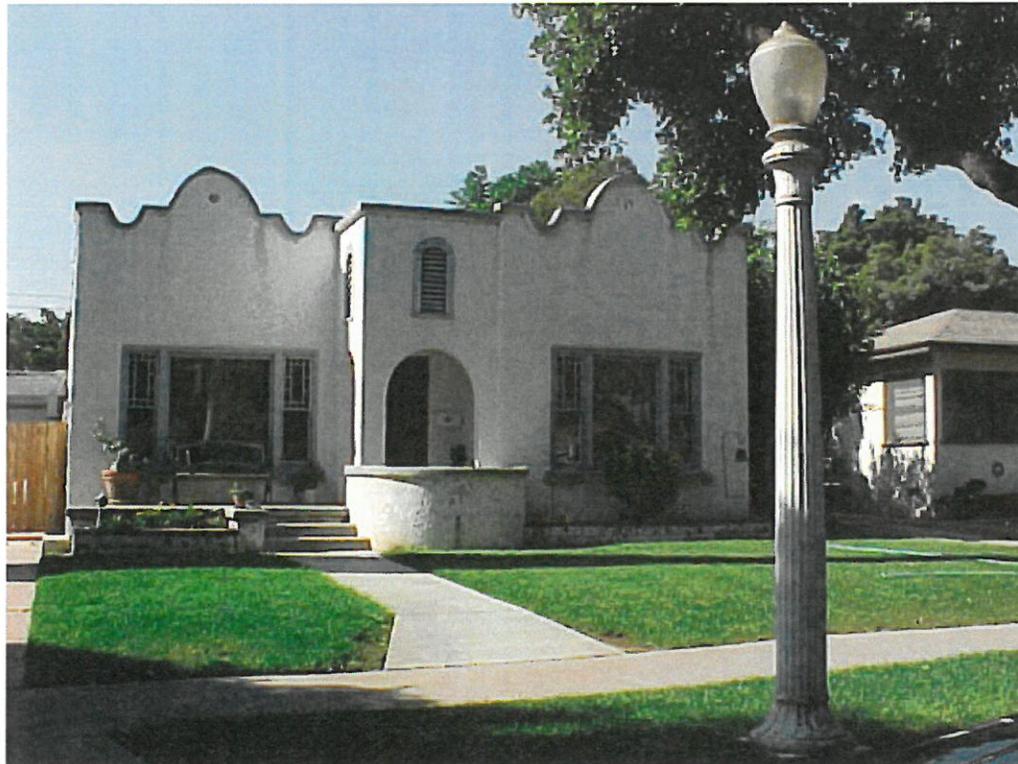
*MISSION REVIVAL*  
CORONA EXAMPLE

*This flat-roofed home displays the parapet reproductions of the original California missions. The small circle window in each parapet is a simplification of the quatrefoil windows common in Mission Revival architecture. The arched entry porch and tripartite windows with multiple panes (lights) are also identifying features.*

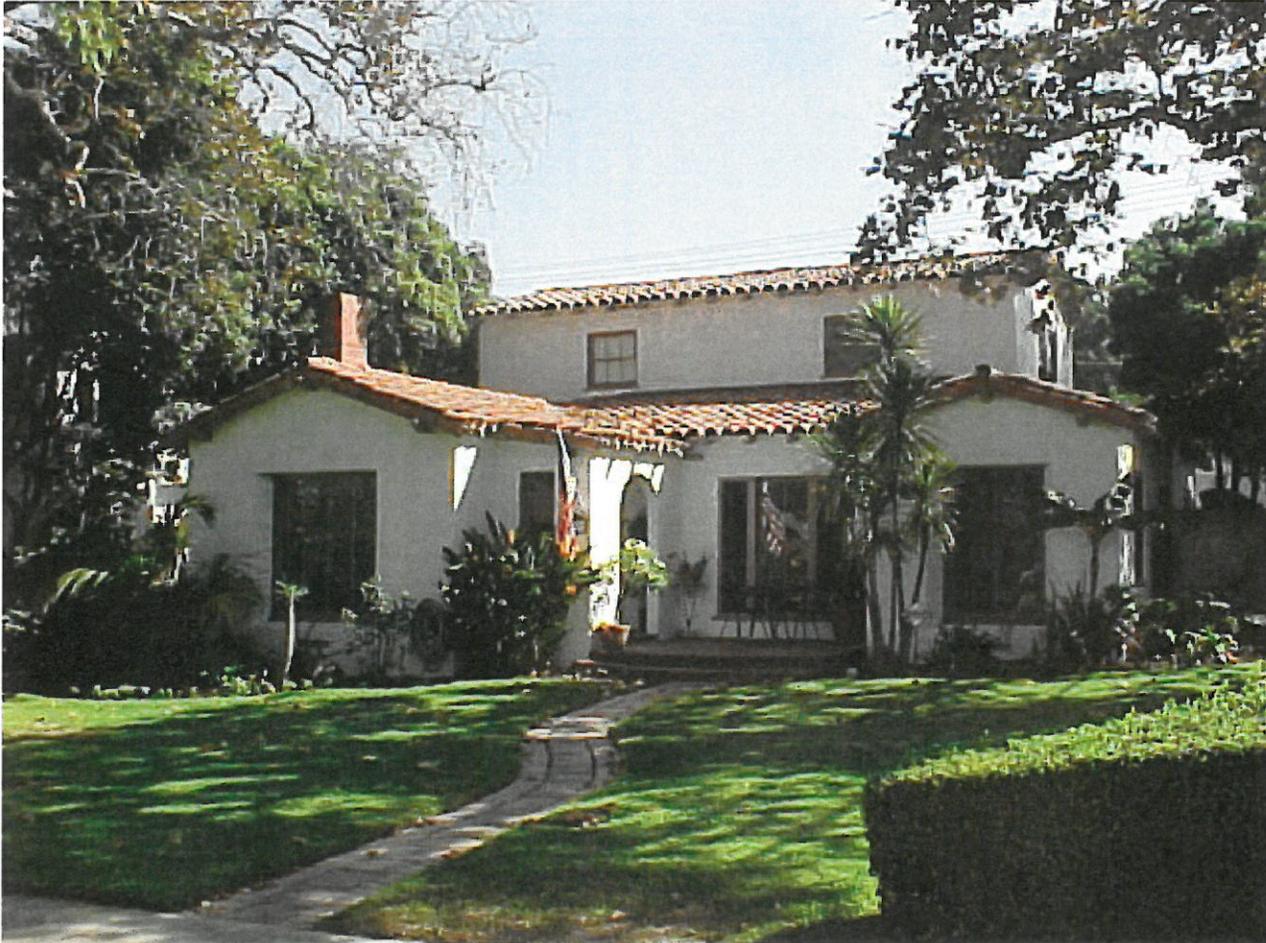
*SPANISH REVIVAL*  
CORONA EXAMPLE

*This home displays the identifying features of a Spanish Revival home: low-pitched roof with little or no overhang, red tile roof covering, arched entry, asymmetrical façade, and stucco wall surface*

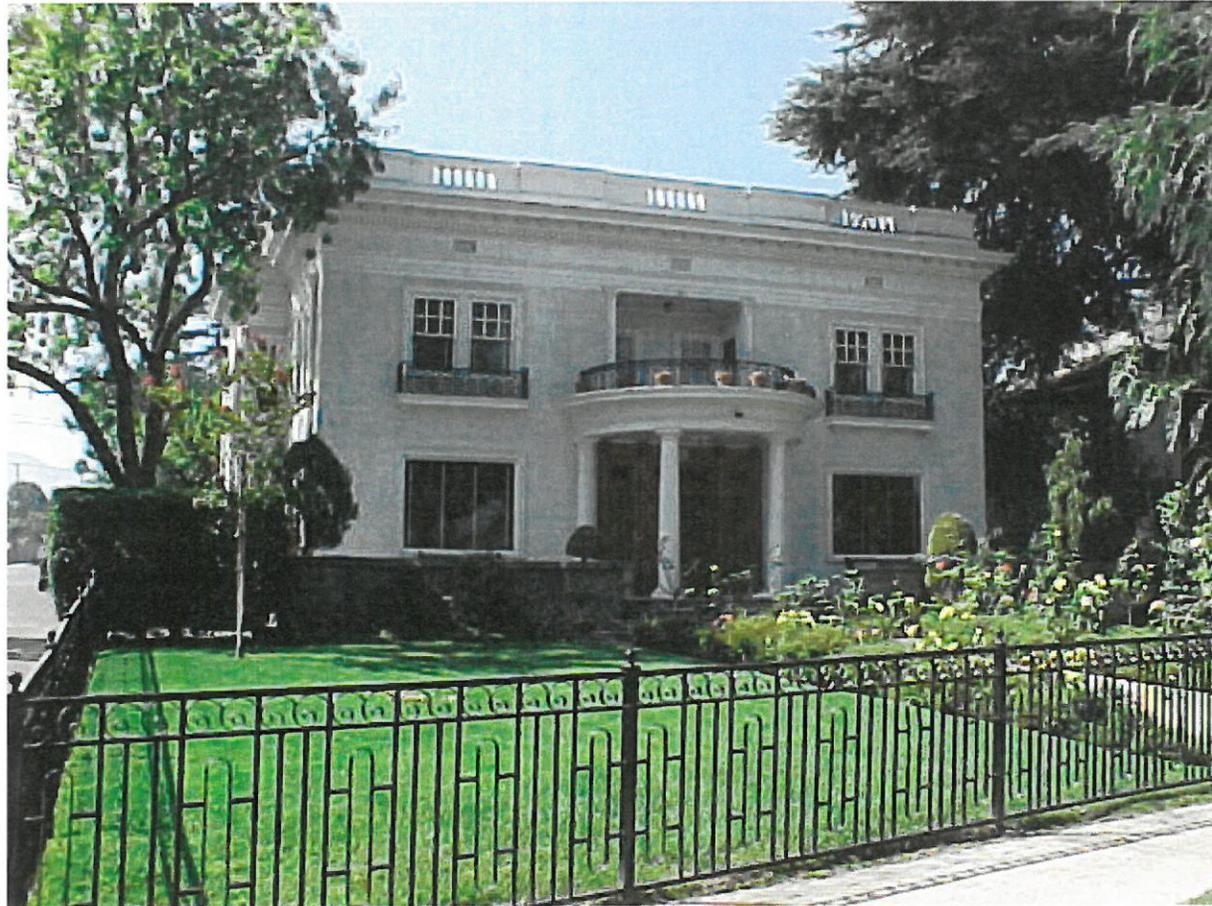
*CORONA EXAMPLE*

*This prominent home is a striking combination of styles with the following identifying features of the Colonial Revival style house: accentuated front door, symmetrically balanced windows and center door, windows with double hung sashes, usually with multi-pane glazing in one or both sashes, windows frequently in adjacent pairs.*

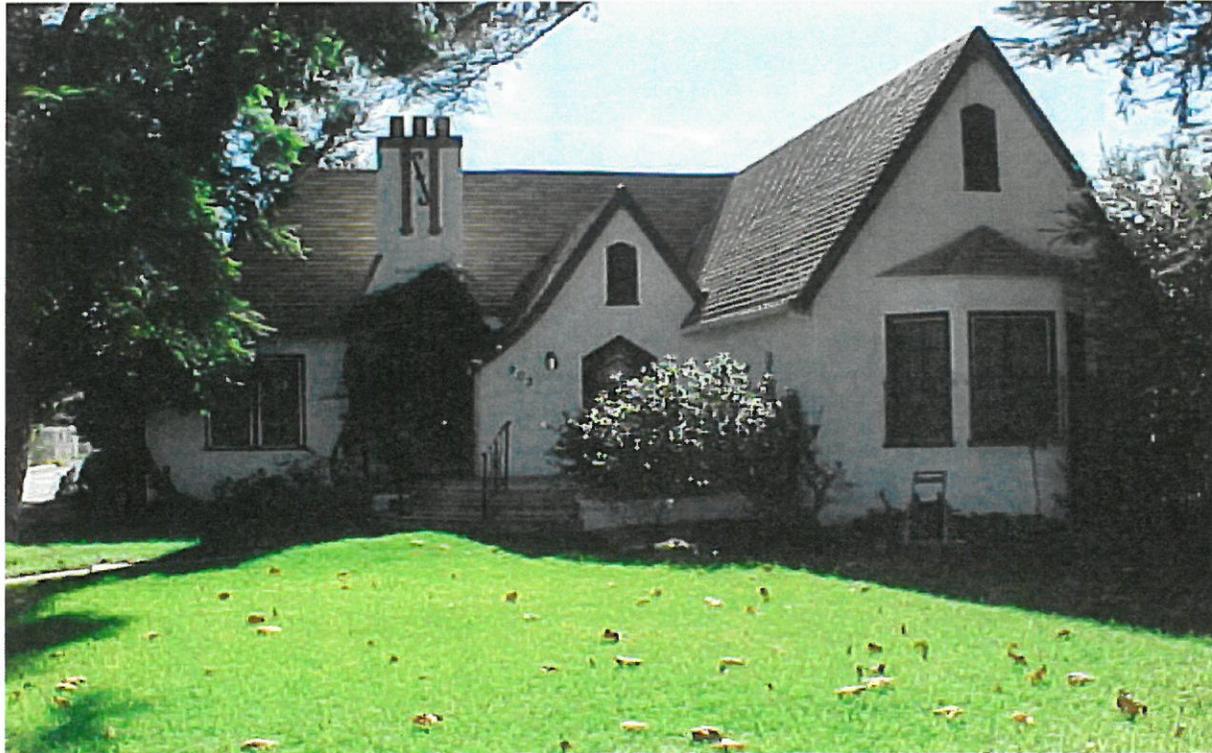
CORONA EXAMPLE

*This 1927 built home displays many of the identifying features of a Provincial Revival style home: steeply pitched roof, façade dominated by one or more prominent cross gables, tall windows in multiple groups (paired) with multi-pane glazing, and massive chimney.*

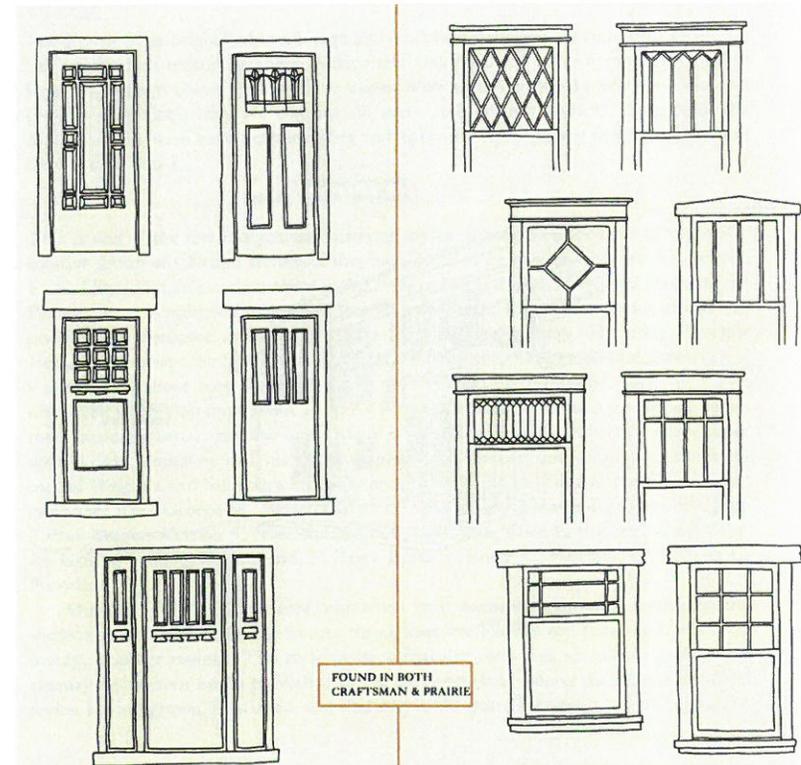
*Typical doors and windows.*

Craftsman Bungalows have a low-pitched, gabled roof (occasionally hipped) with a wide, unenclosed eave overhang. The roof rafters were usually exposed with the ends sometimes cut into decorative shapes. Decorative beams commonly extended from the wall to the roof edge under the

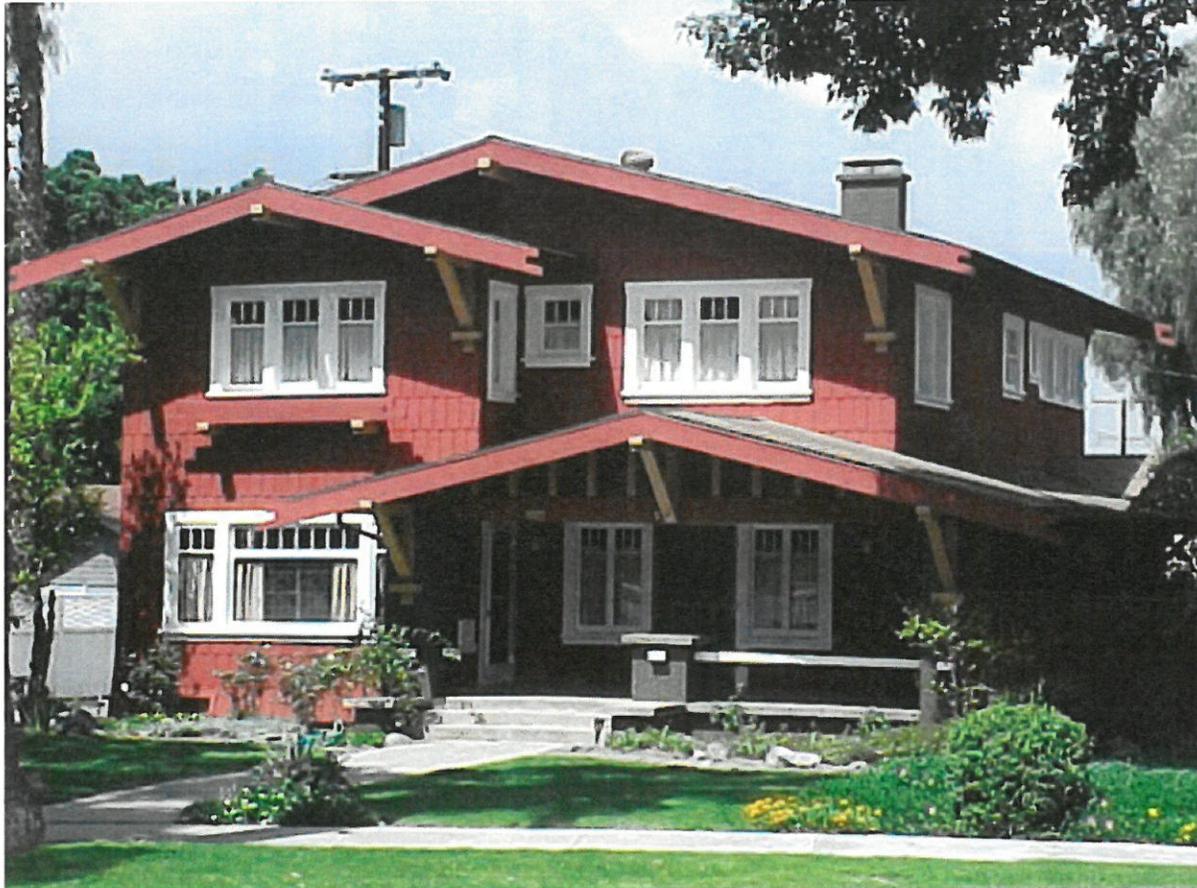
*CORONA EXAMPLE*

*This home displays the identifying features of a Craftsman Bungalow home: low pitched gabled roof with unenclosed eave overhang; exposed rafters with notched ends; decorative beams under the gables; knee braces; wide, open front porch, paired and ribbon windows with multiple panes over a single pane, and shingle wall cladding.*

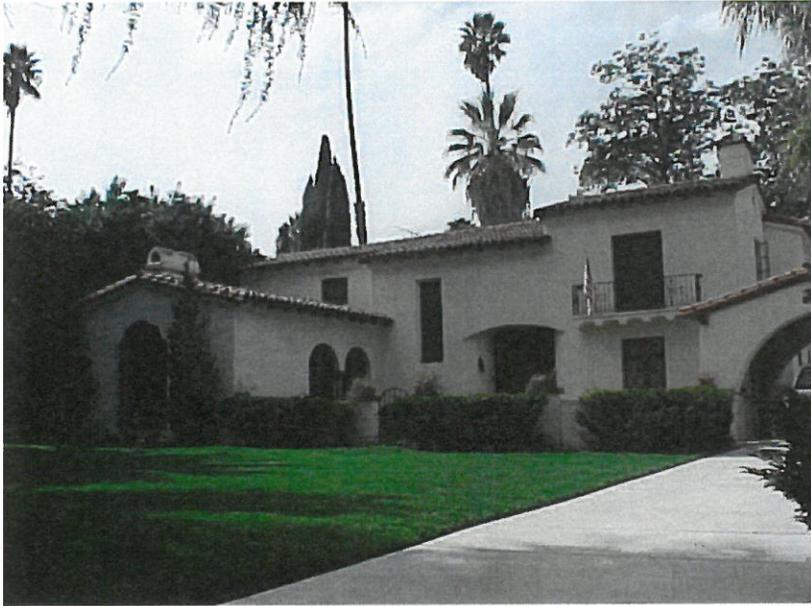
**Example of a “High” Heritage Property**

*This home built in 1931 displays the identifying features of a Spanish Revival home: low pitched roof with little or no overhang, red tile roof covering, arched entries, asymmetrical façade, and stucco wall surface. It displays all original fabric.*

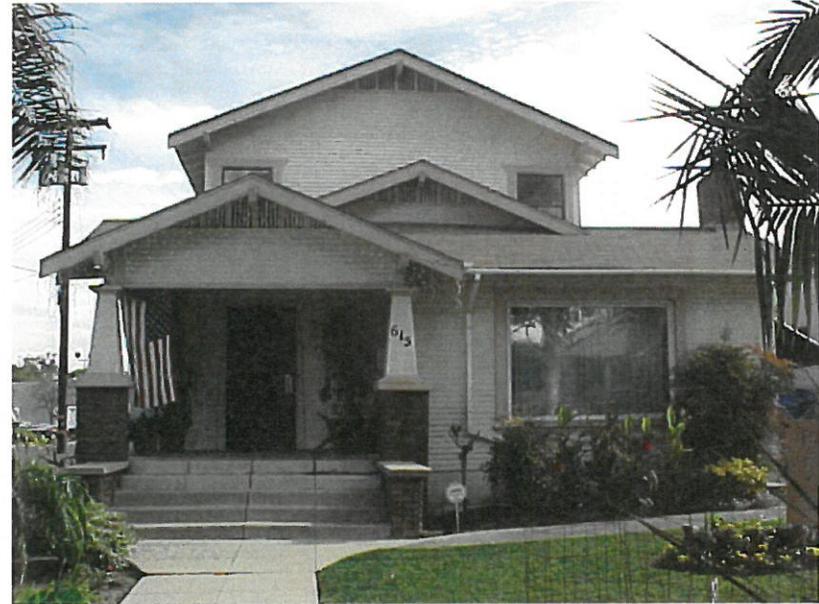
**Example of a “Moderate” Heritage Property**

*This home built in 1927 displays many of the identifying features of a Craftsman Bungalow house: low pitched gabled roof with wide, unenclosed eave overhang; decorative false beams under gables; decorative vents under gables, and porch with roof supported by battered columns set atop a brick pier. However, two alterations may negatively affect this home’s potential for Corona Historic Landmark status. First, the second story addition, while sympathetic to the original architecture, is not an original feature of the house. Second, the front window replaced the original windows of the house.*

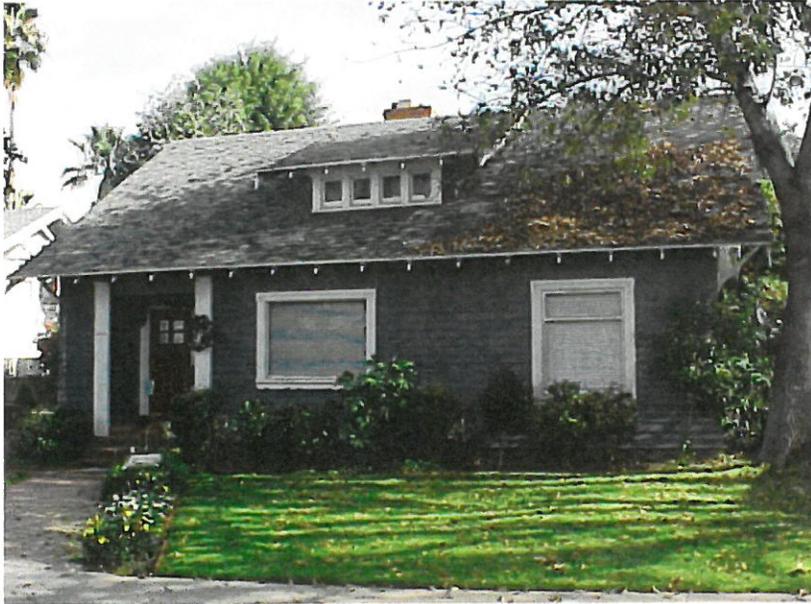
### Example of a “Low” Heritage Property

*This bungalow built in 1929 exhibits several features of period bungalows: exposed rafters, shed roof dormer with ribbon windows, knee brackets under gables, and clapboard siding. However, while retaining historic character worthy of placement on the Heritage Inventory, extensive alterations have effectively eliminated the home from consideration as a Corona Historic Landmark. The open porch was partially enclosed creating a recessed opening and a front window not common for the time period. Additionally, two extensions, architecturally dissimilar, have been added to the rear of the house – a one story addition and a two-story addition.*

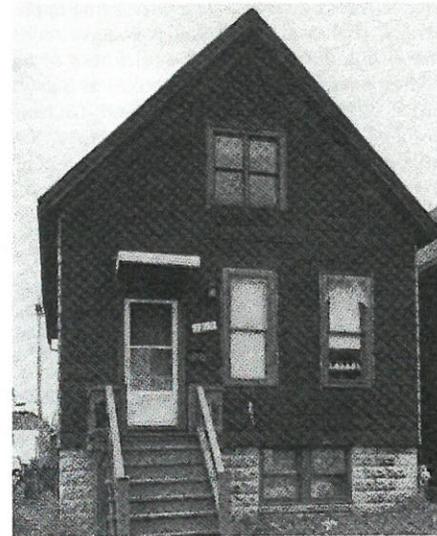
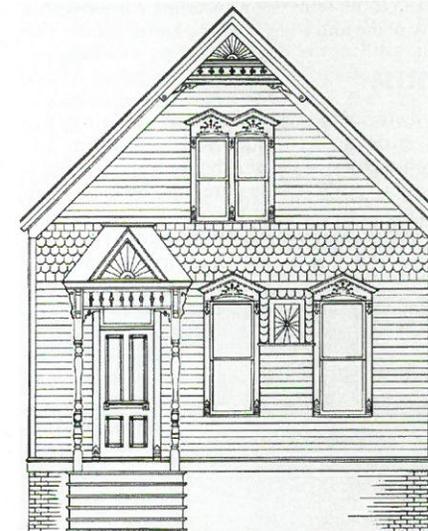
Source: *As Good as New*, City of Milwaukee, Department of City Development

How such a cottage might look with its architectural detailing restored.

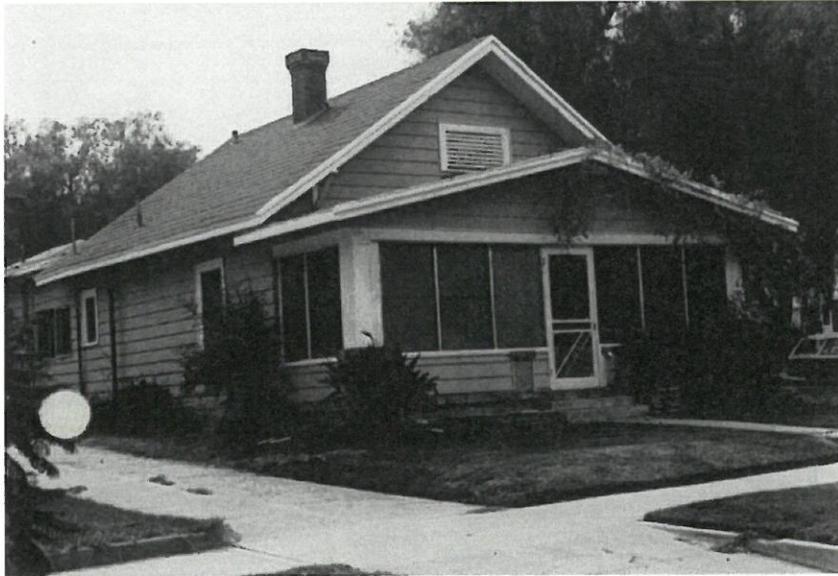
**1986**

*Although altered from its original 1908 construction, in 1986 this home still retained its clapboard siding, original wooden porch supports and concrete piers, triangular knee braces, and double hung windows with decorative exterior frames. By removing the screens and re-opening the porch, this home could have been restored to its original character.*

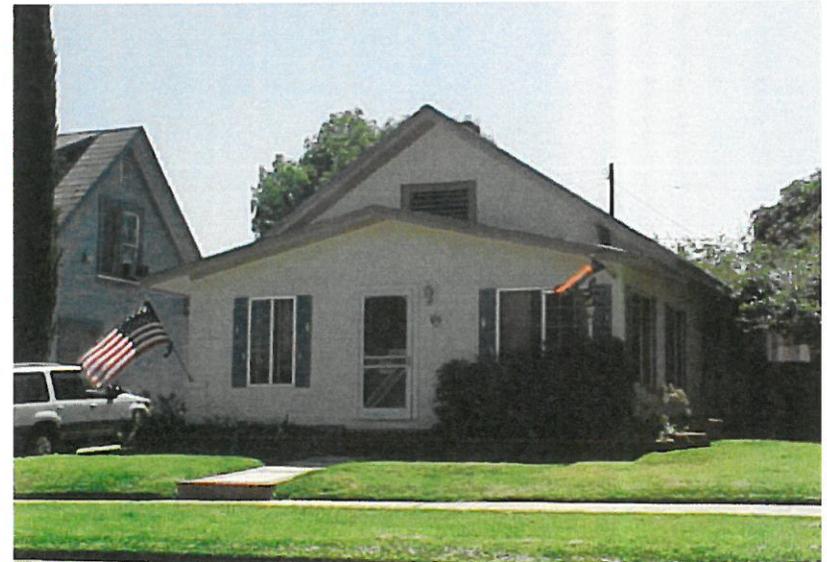
**2002**

*By 2002, many of the features that identified this home as a turn-of-the-century bungalow had been removed. The clapboard has been replaced with stucco, the wooden porch supports, concrete piers, and triangular braces have been removed, and the front porch has been permanently enclosed with modern windows and door. The windows on the sides of the house also have modern replacements. Thus, although attractive, the home has lost its historic significance.*

CURRENT ARCHITECTURAL ELEMENT	HIGH	MODERATE	LOW
Clapboard	<p><b>Stucco is prohibited as a replacement material.</b> The siding should be repaired rather than replaced if feasible. If replacement is necessary, the new material must match the material being replaced in composition, design, color, texture, and other visual qualities. In the case of wood siding, this means wood must be replaced with wood.</p>	<p><b>Stucco is prohibited as a replacement material.</b> Non-wood siding may be used providing the new material match the material being replaced in design, color, and other visual qualities and retain the architectural character identified in the historic survey.</p>	<p><b>Stucco is discouraged as a replacement material.</b> Substitute materials may be used providing the design, color, and other visual qualities retain the architectural character identified in the historic survey</p>
Shingle	<p><b>Stucco is prohibited as a replacement material.</b> Damaged or missing wood shingles must be replaced with wood shingles of the size and design of the old shingle.</p>	<p><b>Stucco is prohibited as a replacement material.</b> Wood shingles may be replaced with substitute materials, as described in the guidelines, providing the historic character of the structure is retained.</p>	<p><b>Stucco is discouraged as a replacement material.</b> Wood shingles may be replaced with substitute materials, as described in the guidelines, providing the historic character of the structure is retained.</p>

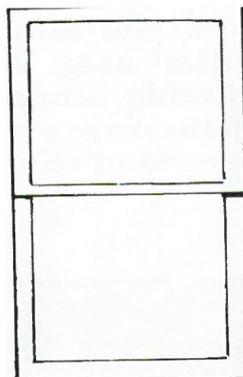
### COMMON DOUBLE-HUNG WINDOWS

One-over one  
1870-1940

The most common type of window, the double-hung, is composed of two movable frames called sash that slide up and down in wooden channels. The number of panes in each sash establishes its character. Replacement windows should match the original in size and configuration of window panes.

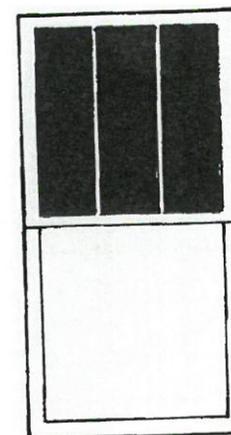
three-over-one  
Craftsman  
1905-1935

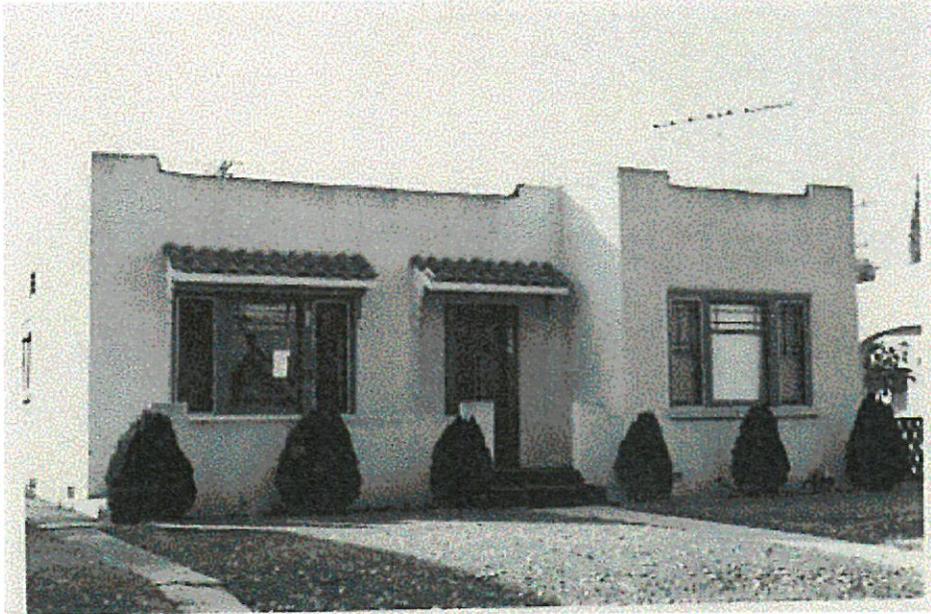
1982

*In 1982, this Spanish Revival home displayed two front windows typical of the time period in which the home was built. The distinctive tripartite windows contain a large fixed center flanked by smaller double-hung windows, all of which contain geometric patterns of small-pane window glazing.*

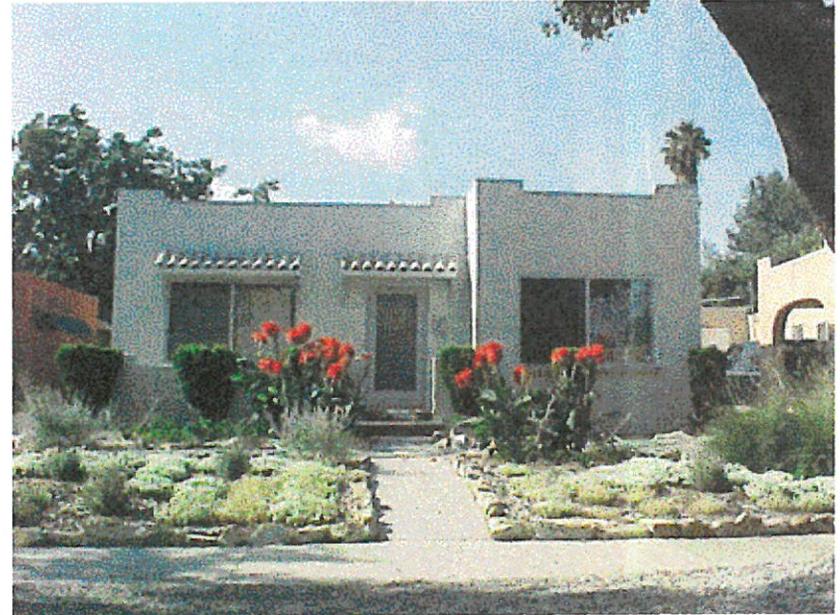
2002

*By 2002, the tripartite windows had been replaced with aluminum sliding windows that detract from the historic appearance of this well-maintained home.*

CURRENT ARCHITECTURAL ELEMENT	HIGH	MODERATE	LOW
<p><b>Windows</b></p>	<p><b>Replacing original windows is prohibited</b> unless damage to the original window is too severe to permit consideration of any other alternative. Structural repair with modern wood epoxies should be considered prior to replacement. New window units must be made of the same style and to the exact dimensions of the old one and preferably made of wood. If possible, replace the sash only, retaining the original frame.</p>	<p><b>Replacing original windows is discouraged.</b> Structural repair with modern wood epoxies should be considered prior to replacement. New window units must be of the same dimensions as the original and complementary to the architectural style of the structure. Non-wood alternatives are acceptable, although wood windows are preferred. If possible, replace the sash only, retaining the original frame. <b>Non-decorative aluminum sliding windows are prohibited.</b></p>

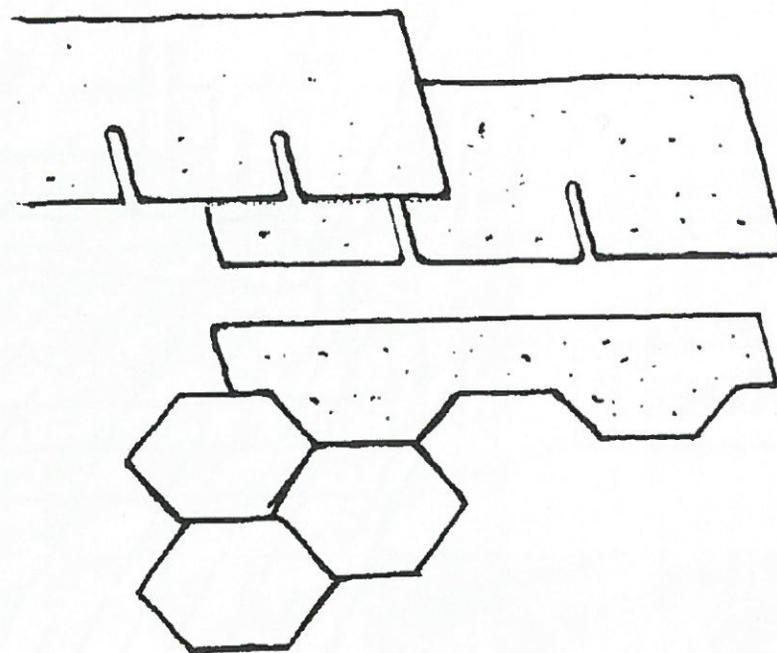
### COMMON ROOFING MATERIALS

Three tab asphalt or fiberglass shingles are the most common roofing material today. Do not use light colors such as white, light green, or beige. Hexagonal shingles are a good choice for bungalows and Craftsman style homes.

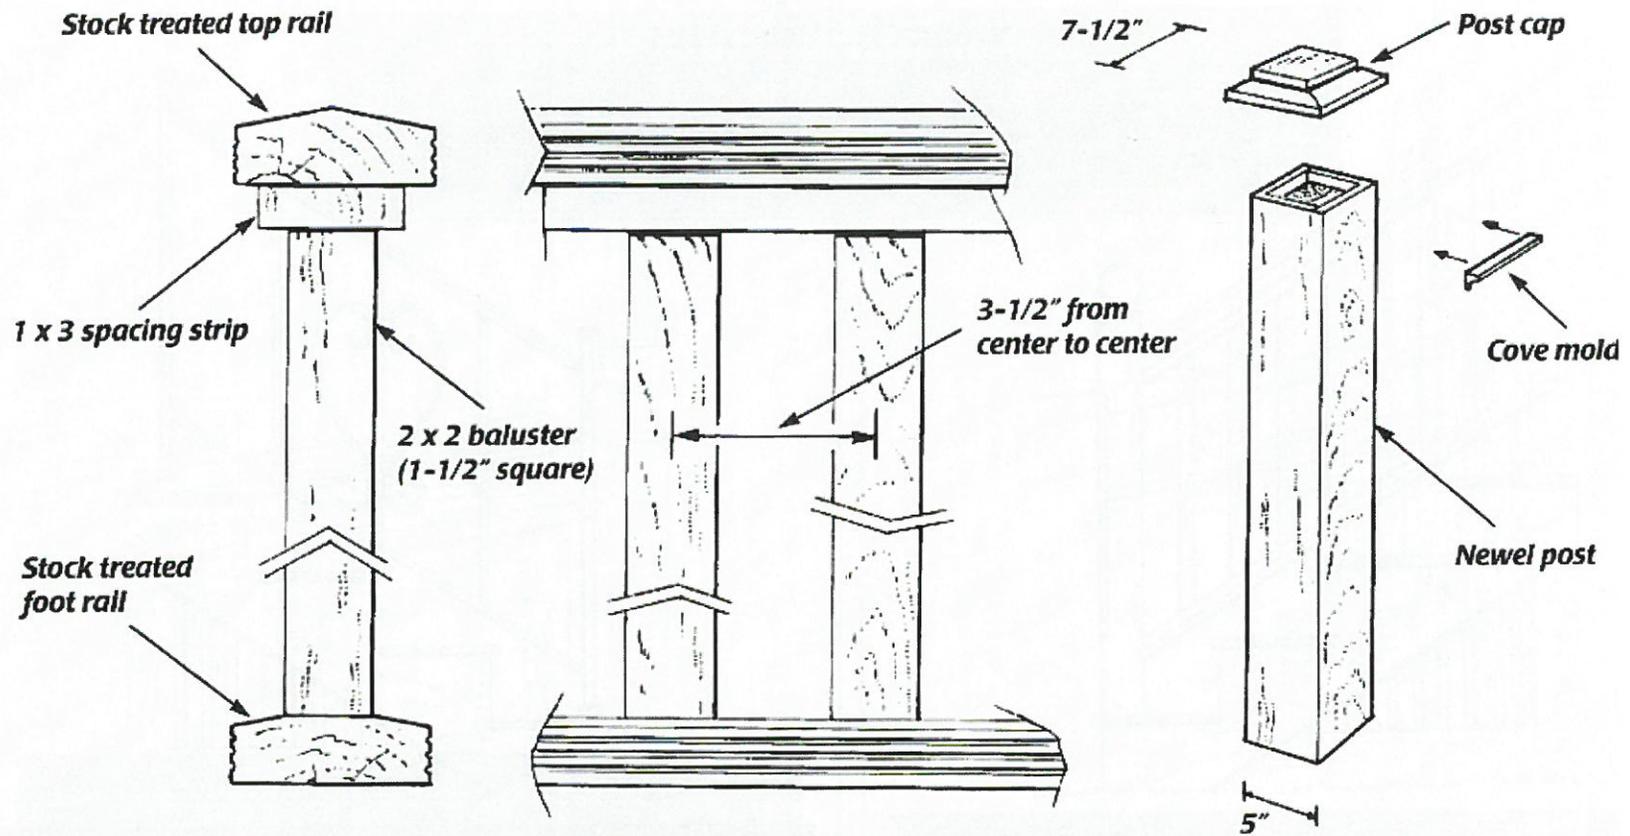
### Basic Railing and Newel Post Design

Porch railings should not exceed 36 inches in height.

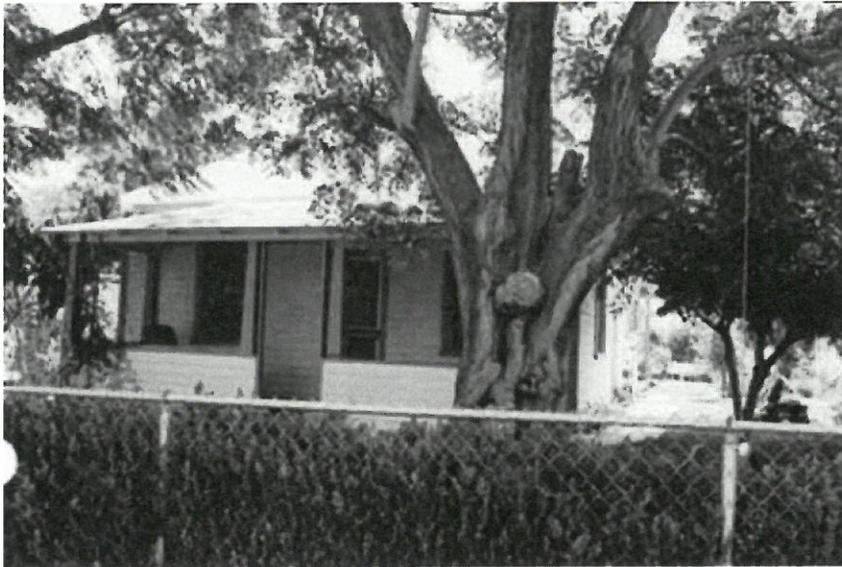
1982

*In 1982, this hipped roof cottage retained its shed roof porch with obliquely (slanted) cut sides leaving only a small edge attached to the main structure. The roof had exposed rafters and was supported by four battered wood columns and two pilasters set on a solid clapboard balustrade. The open porch grants view of the tall, rectangular double-hung windows flanking the front door, which are an identifying feature of the age and style of the home.*

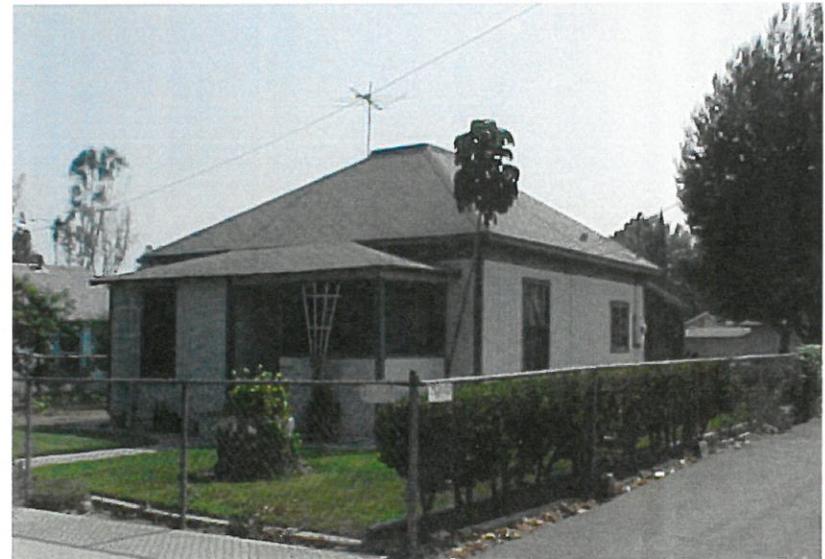
2002

*By 2002, the shed roof porch had been replaced by a hipped roof without exposed rafters. The right side of the porch is enclosed with solid, vertical siding with a front-facing aluminum sliding window. The left side is enclosed with vertical siding topped by aluminum sliding windows. The removal of the porch and clapboard siding combined with the resizing of the windows have effectively eliminated the architectural features that identified this home as a Victorian hipped roof cottage.*

CURRENT ARCHITECTURAL ELEMENT	HIGH	MODERATE	LOW
<b>Removal or enclosure</b>	<b>Removal or enclosure of a front porch is prohibited.</b> Deteriorated porches must be replaced from the foundation in the style and materials of the existing porch and preferably, restored to its original style and architectural character.	<b>Removal or enclosure of a front porch is discouraged.</b> Deteriorated porches should be replaced from the foundation in the style and materials of the existing porch and preferably, restored to its original style and architectural character. Modern roofless decks are prohibited.	
<b>Replacement of missing parts</b>	If replacement of missing parts such as posts, railings, balusters, skirting, or floors, is necessary, the new work should replicate the original treatment, if known, or at the very minimum reflect the proportions, scale, and general detail of the original porch or be appropriate for the style of the house. For example, traditional wood porch floors should be constructed of center matched or tongue-and-groove wooden flooring, which are installed perpendicular to the house.

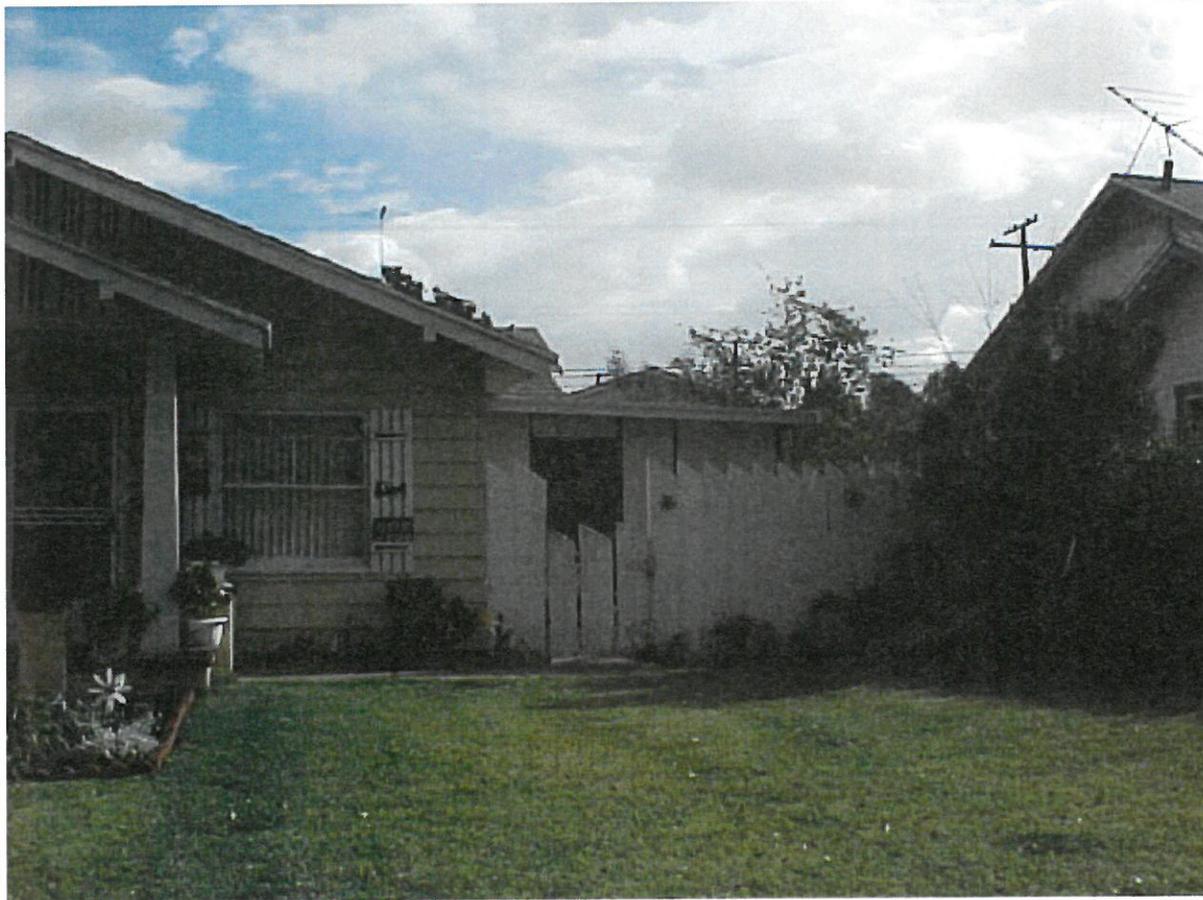
**EXAMPLE OF AN UNSYMPATHETIC ROOM ALTERATION  
TO A CORONA HOME BUILT IN 1926**

*This bungalow was built in 1926 with clapboard siding, front-facing roof and porch gables, multi-pane double hung windows, battered porch supports, and exposed rafters. The addition on the south side of the house was built without regard to these original features. It has synthetic siding, flat roof, aluminum sliding windows, and no overhangs. This addition would not be approved under the current design guidelines.*

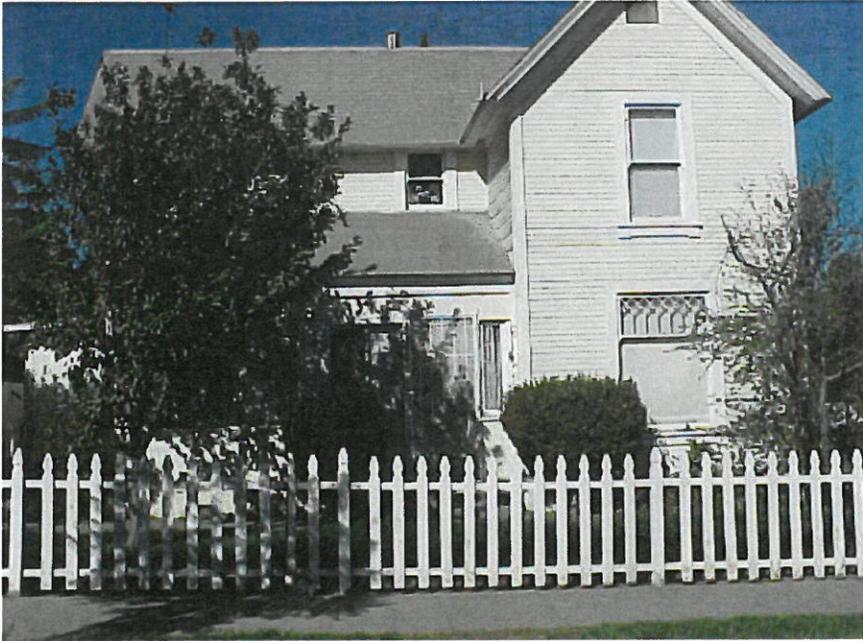
*Basic picket fence.*

CURRENT ARCHITECTURAL ELEMENT	HIGH	MODERATE	LOW
<b>Fences</b>	<p>Fences must meet all applicable height and setback restrictions plus it must complement the style of the house. Victorian era homes, before 1905, commonly were bordered with a small ornamental wooden or iron fence often only about 2 ½ feet tall. Picket fences are traditionally been the most popular type of front yard fence. Standard fence pickets should be spaced no more than 3 ½ inches apart. Metal baluster and picket fences are also permitted in the front yard. <b>Prohibited fences</b> that are not compatible with historic architecture include chain link, split rail, board-on-board, stockade, basket weave, and dog ear vertical board.</p>

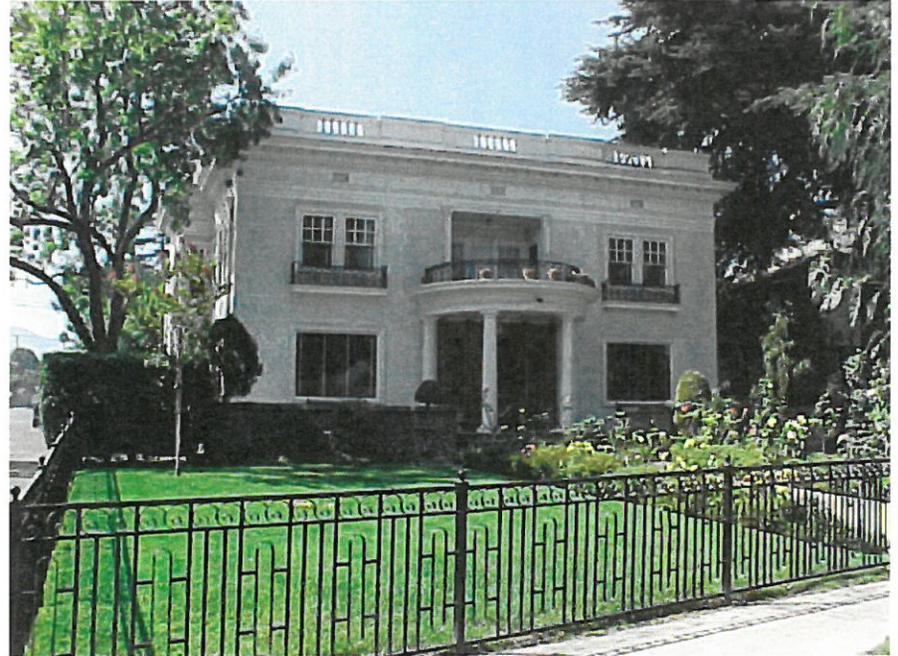
*Ornamental estate type wrought iron fence.*
