**PHASE 1 ENVIRONMENTAL  
SITE ASSESSMENT  
AND LIMITED SITE CHARACTERIZATION  
McMILLAN FARM PROPERTY  
CORONA COUNTY, CALIFORNIA**

**PROJECT NO. 31558.2  
MARCH 21, 2002**

Attached herewith is the Phase 1 Environmental Site Assessment and Limited Site Characterization conducted by this firm for the 530± acre McMillan Farm project generally located southeast of Eagle Glen Parkway and I-15 in the city of Corona, Riverside County, California.

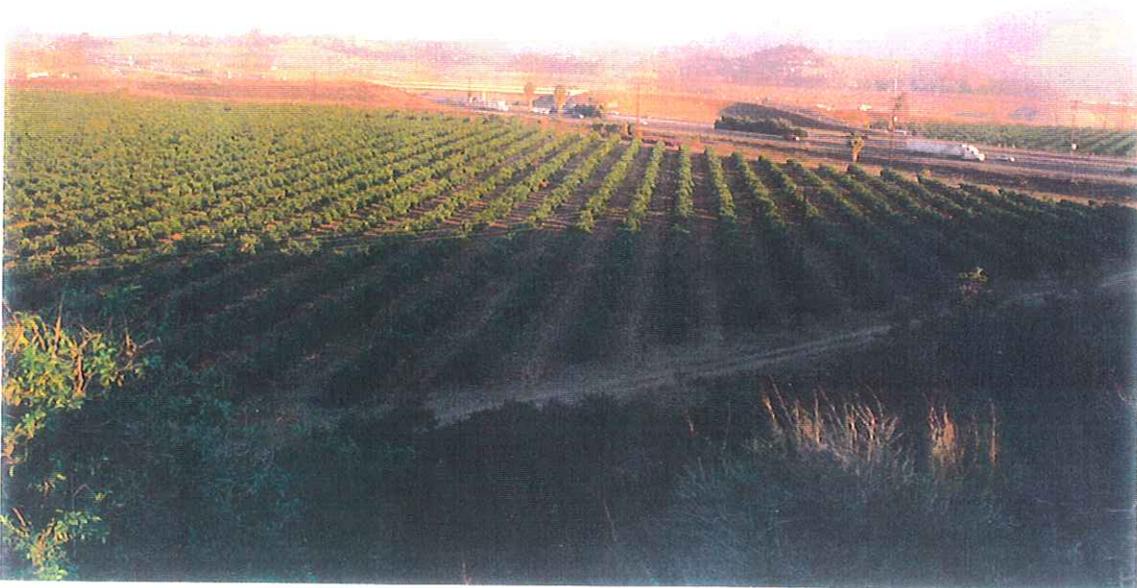
VIEW FACING NORTHWESTERLY FROM PARCEL 2 SHOWING THE NORTH PORTION OF PARCEL 1. OLD SMUDGE POT STORAGE AREA IS VISIBLE IN THE CENTER OF PHOTOGRAPH BETWEEN THE GROVES AND 1-15 FREEWAY.

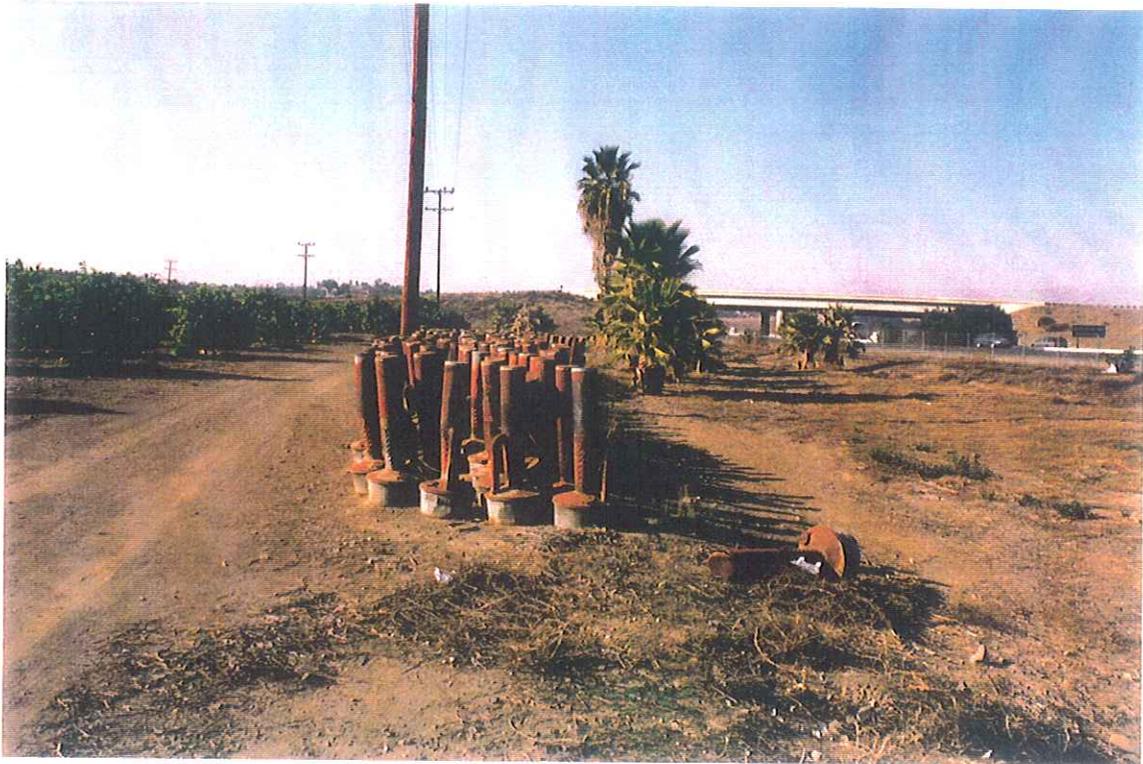
VIEW FACING WEST AT NORTH END OF PARCEL 1 SHOWING THE APPROXIMATELY 400 OLD SMUDGE POTS STORED ON THE SITE. THE SMUDGE POTS WERE DRY AND NO STAINED SOIL WAS VISIBLE. THE I-15 FREEWAY AND CAJALCO ROAD OVERCROSSING IS VISIBLE TO THE RIGHT.

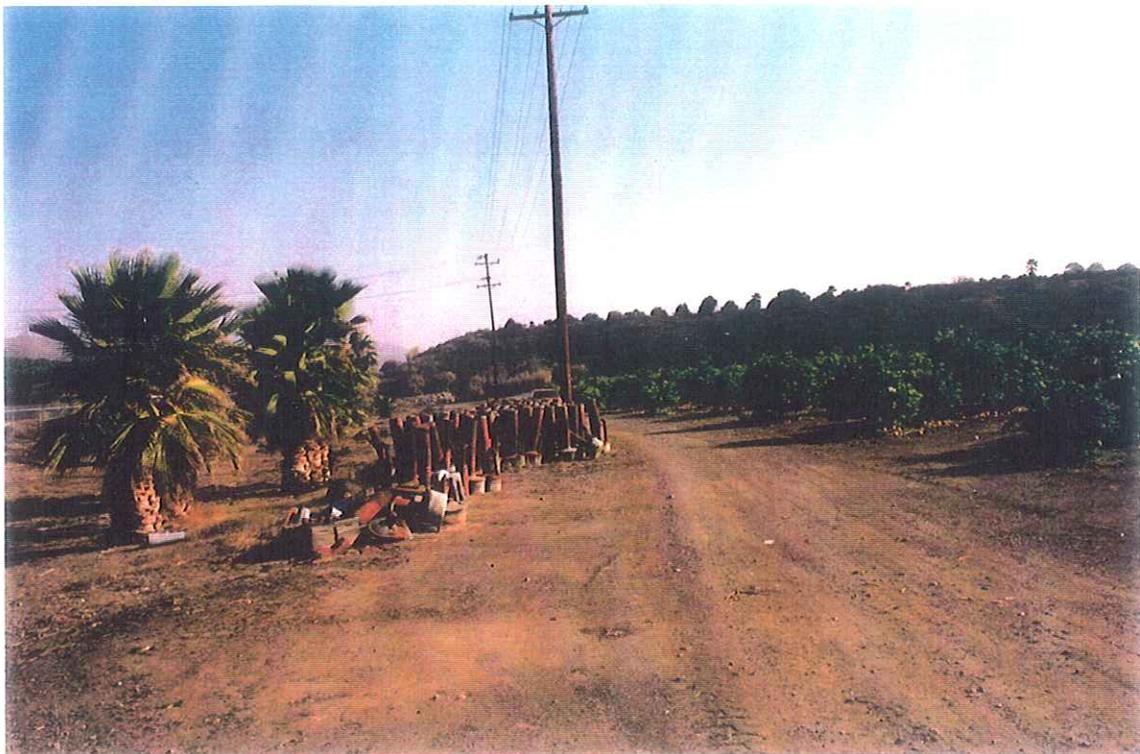
VIEW FACING EAST SHOWING THE OLD SMUDGE POTS WITH PARCEL 2 SHOWN IN THE BACKGROUND (ELEVATED). TWO SAMPLES OF THE SOIL UNDER THE SMUDGE POTS WERE TAKEN FOR HYDROCARBON TESTING.

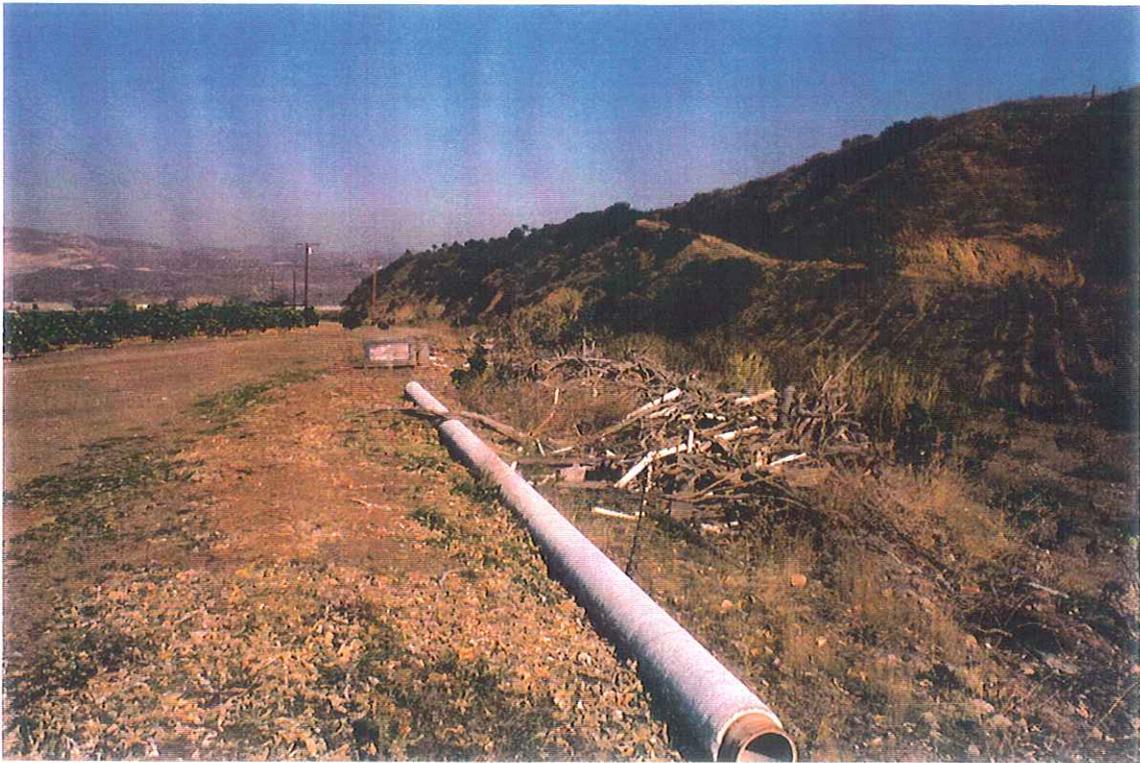
VIEW FACING NORTH AT CHANNEL BETWEEN PARCELS 2 AND 3 SHOWING A SMALL AMOUNT OF GREEN WASTE, CONCRETE COVERED STEEL PIPE AND OLD PACKING BOX. PARCEL 2 IS TO THE RIGHT.

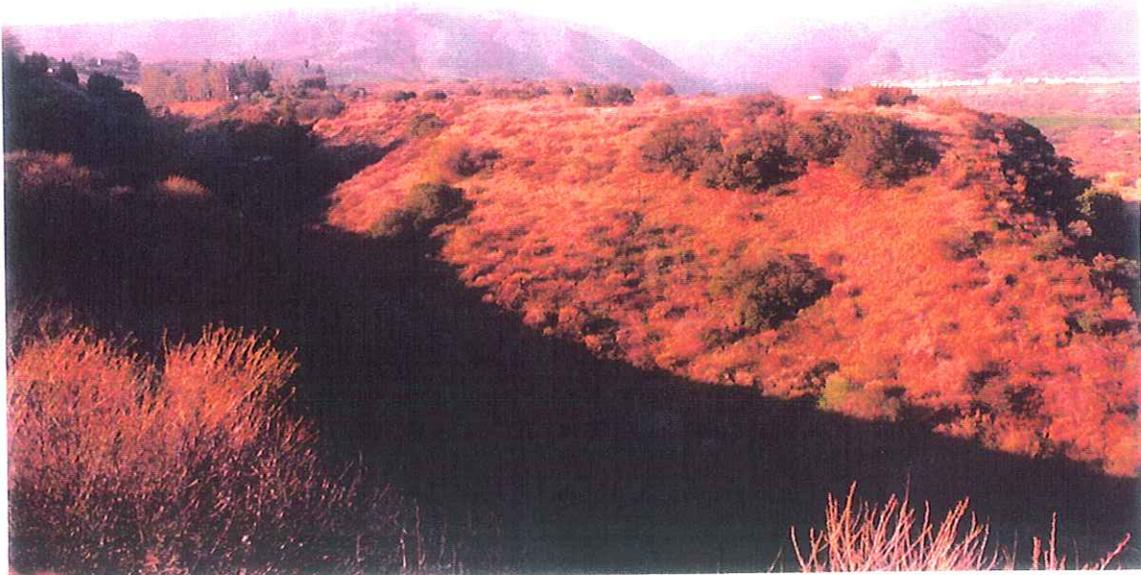
VIEW FACING SOUTH FROM PARCEL 2 SHOWING THE RIDGE EAST OF PARCEL 3 WHICH HAS ALWAYS BEEN VACANT LAND. COVERED STRUCTURE TO THE LEFT IN THE CANYON BOTTOM OWNED BY ADJACENT HOMEOWNER.

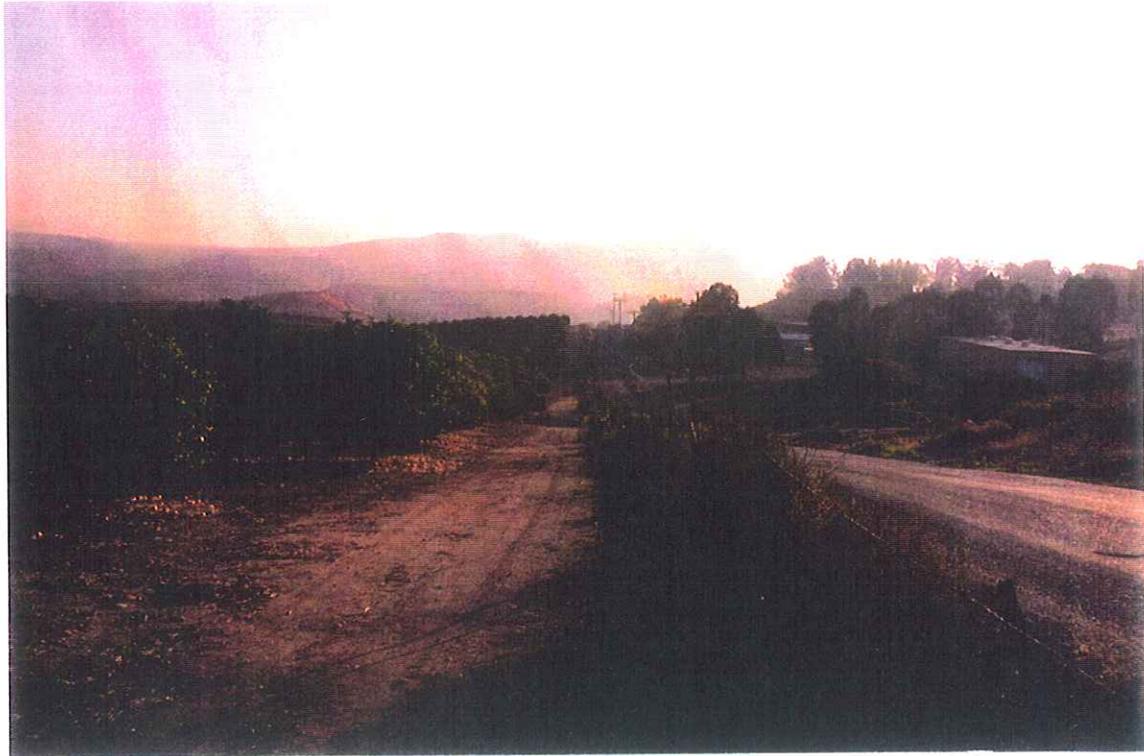
**VIEW FACING NORTH ON THE EAST SIDE OF PARCEL 2 SHOWING THE SITE TO THE LEFT AND SCATTERED RESIDENTIAL/RANCH PROPERTIES TO THE RIGHT (EAST). THE OLD RESERVOIR LOCATED IS LOCATED LEFT OF THE PHOTOGRAPHER.**

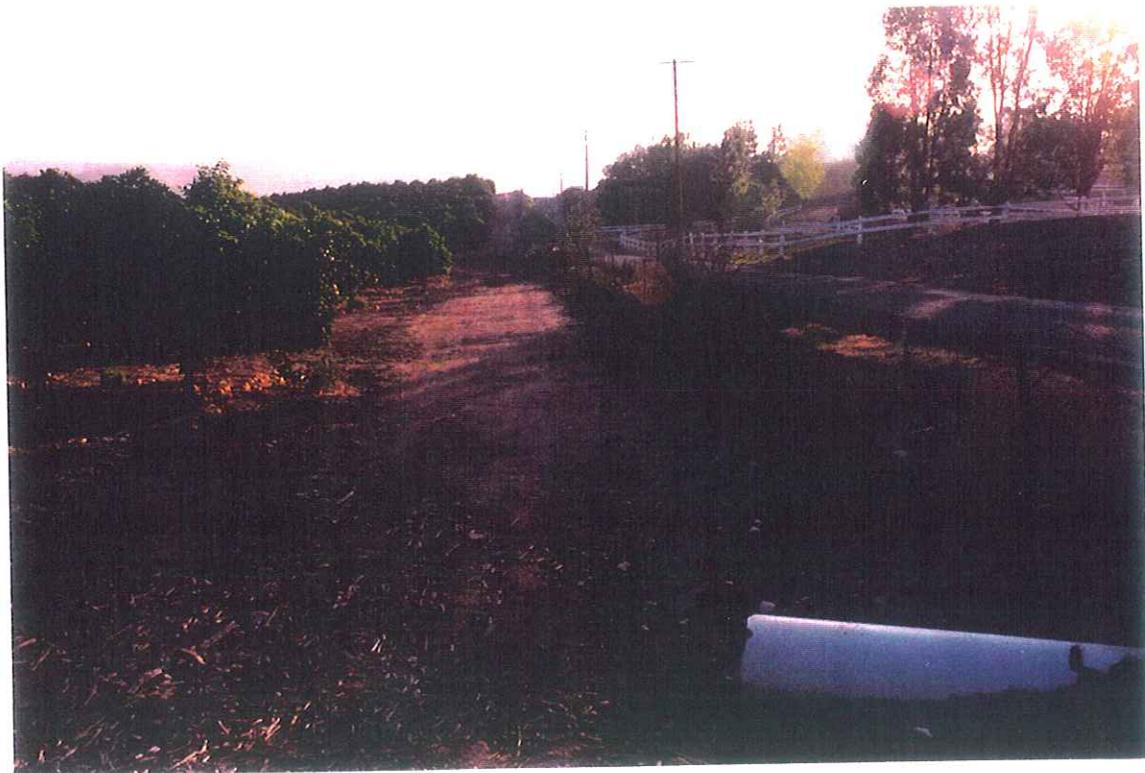
**VIEW OF ONE OF SEVERAL DRAINAGE PIPES THAT ENTER THE EAST SIDE OF PARCEL 2. THEY DRAIN THE SMALL VALLEYS EAST OF THE SITE BETWEEN THE SCATTERED RESIDENTIAL/RANCH PROPERTIES.**

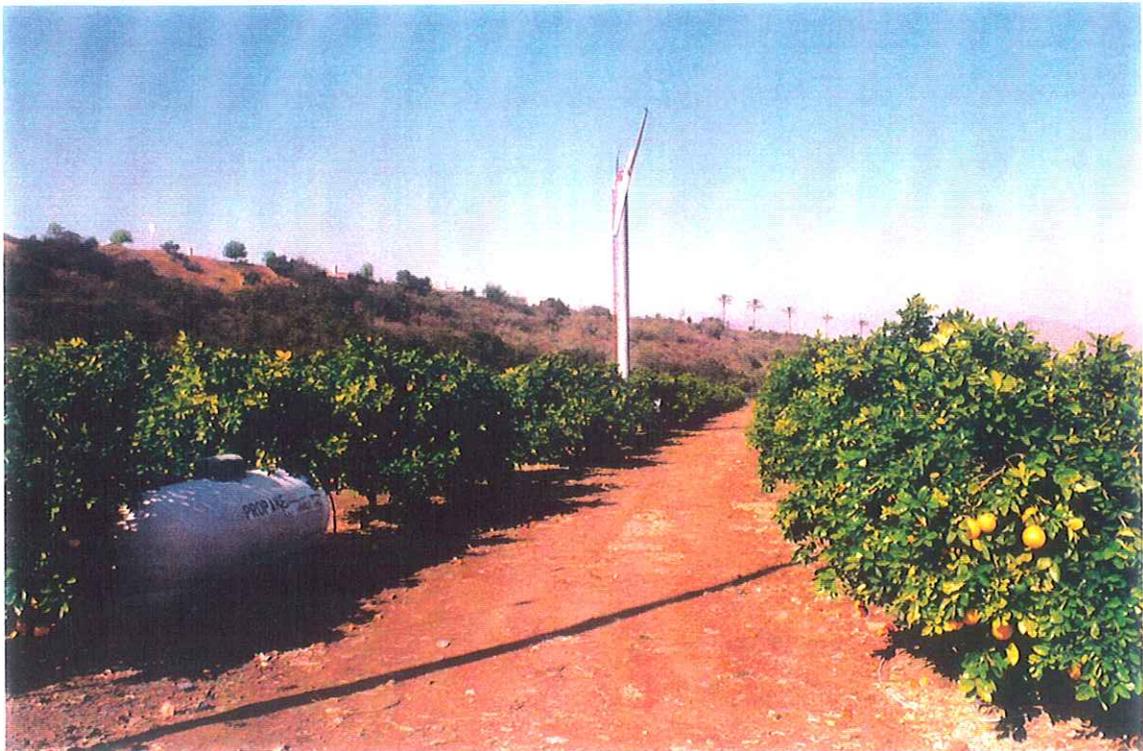
**CLOSE UP OF ONE OF SIX WIND MACHINES ON PARCEL 3 AND PARCEL1 WHICH ARE ALL PROPANE POWERED.**

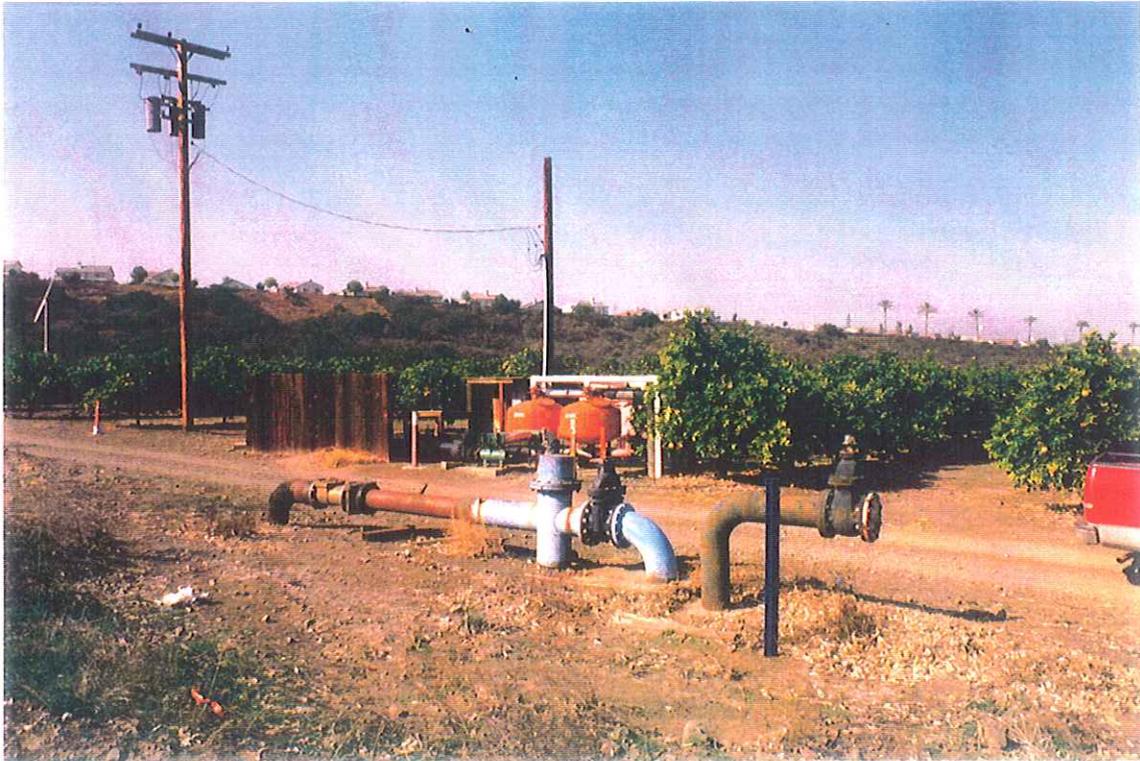
CLOSE UP OF WELL WITH ELSINOR VALLEY PIPELINE WARNING POST (BLUE) IN FOREGROUND. THE RED TANKS ARE FILTER TANKS FOR THE IRRIGATION WATER. ONE OF SEVERAL POWER POLES WITH TRANSFORMERS ON THE SITE ARE ALSO SHOWN.

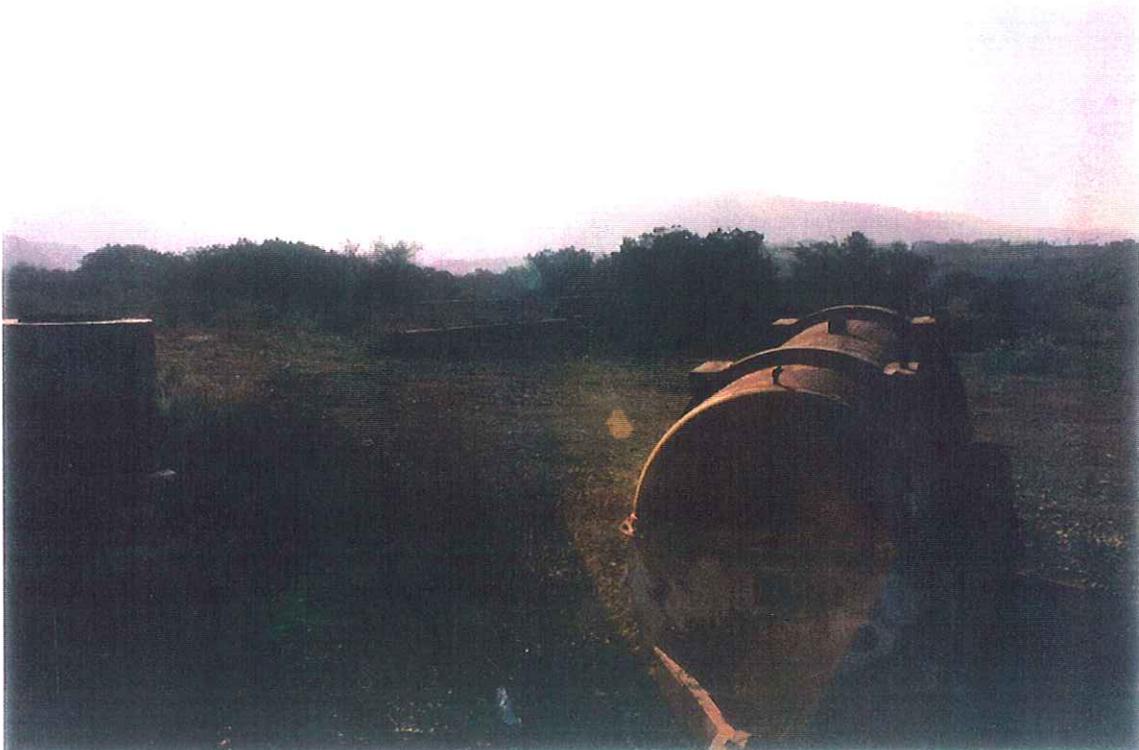
CLOSE UP OF A FALLEN WIND MACHINE (BACKGROUND) WITH LARGE CONCRETE FOUNDATION TO THE LEFT. A WATER TRAILER WAS ALSO PRESENT IN THIS NORTHEAST AREA OF PARCEL 3.

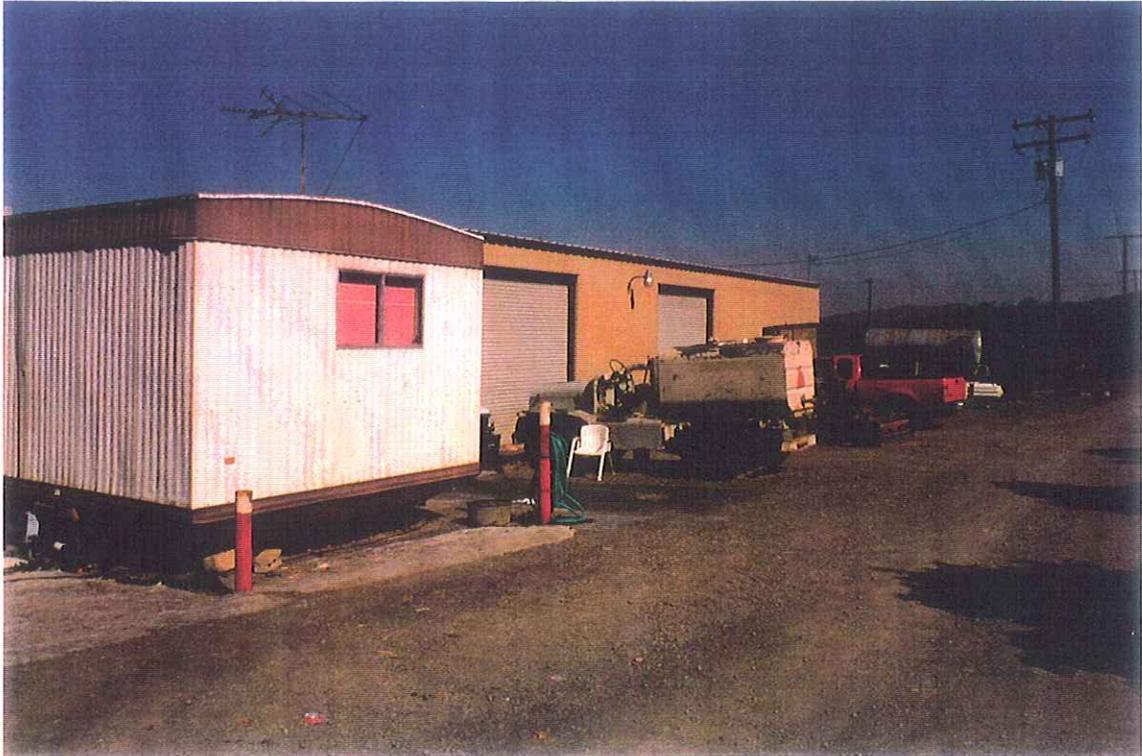
VIEW OF MOBILE HOME AND STORAGE BUILDING LOCATED NEAR THE CENTER OF PARCEL 3. VISIBLE IS A 1,000 GALLON ABOVE GROUND GAS TANK.

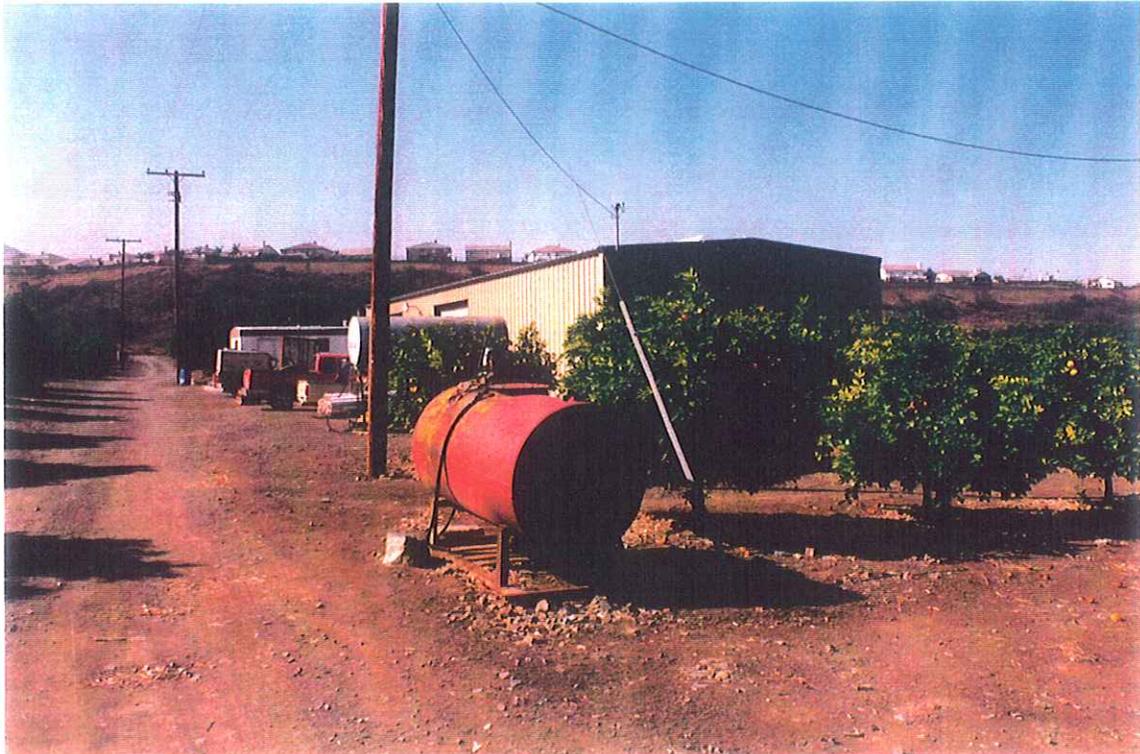
Located outside, at the back of the metal storage building, is a camper shell, three 5-gallon containers of waste oil, metal roofing and an aviary. Located in front of and southeast of the metal storage building is a 1,000 gallon above ground gasoline fuel tank and to the east a 500-gallon above ground diesel tank. The tanks are for on-site equipment operations. No significant staining of the soil was noted beneath either of the above ground fuel tanks.

VIEW OF 500 GALLON DIESEL ABOVE GROUND FUEL TANK, 1,000 GALLON GASOLINE TANK AND OLD TRUCKS AT THE STORAGE BUILDING AND MOBILE HOME.

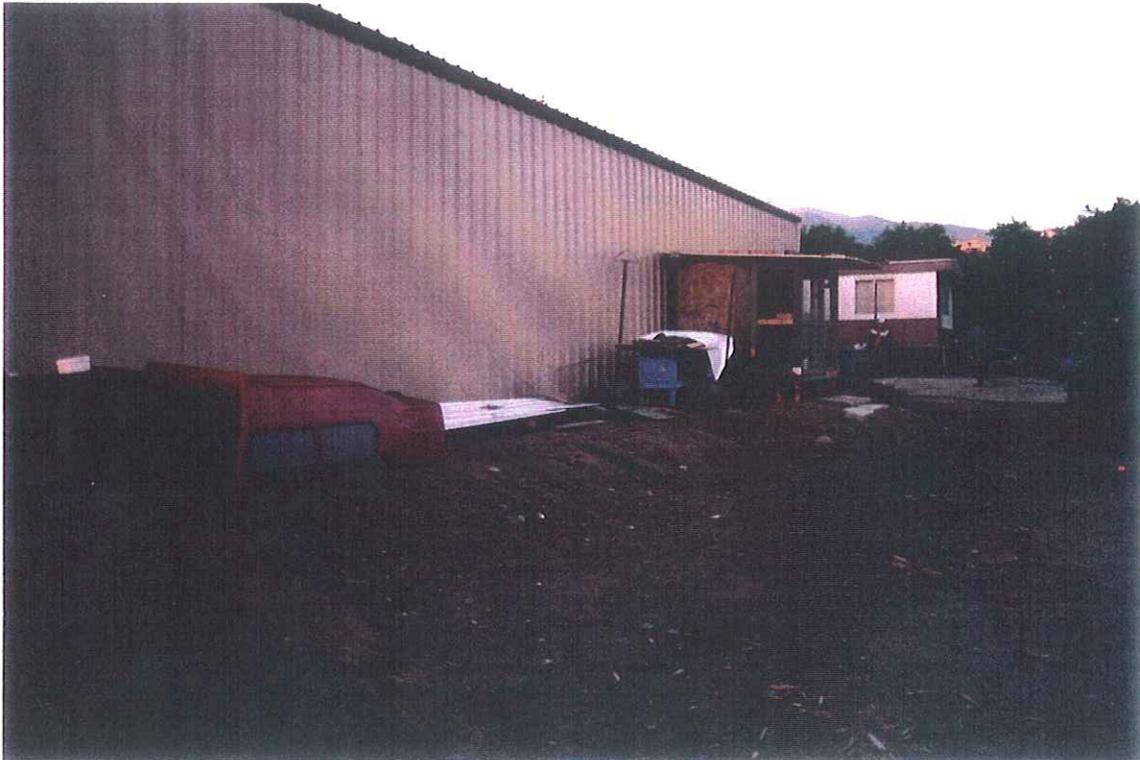
VIEW OF THE BACK OF THE STORAGE BUILDING WHICH HAD THREE 5 GALLON GAS CANS FILLED WITH USED OIL NEXT TO THE RED TRUCK TOP. METAL ROOFING AND AVIARY FOLLOWED BY THE MOBILE HOME ARE SHOWN.

We would recommend the following: The shed located on the west side of Parcel 4 if on the site should have the chlordane powder and 30 gallon drum of diesel fuel removed and properly disposed of, the shed should be dismantled and the wood shed floor and all pesticide contaminated soil under and around the shed removed and properly disposed of. The three 5 gallon cans of waste oil located behind the metal storage building on Parcel 3 should be recycled.

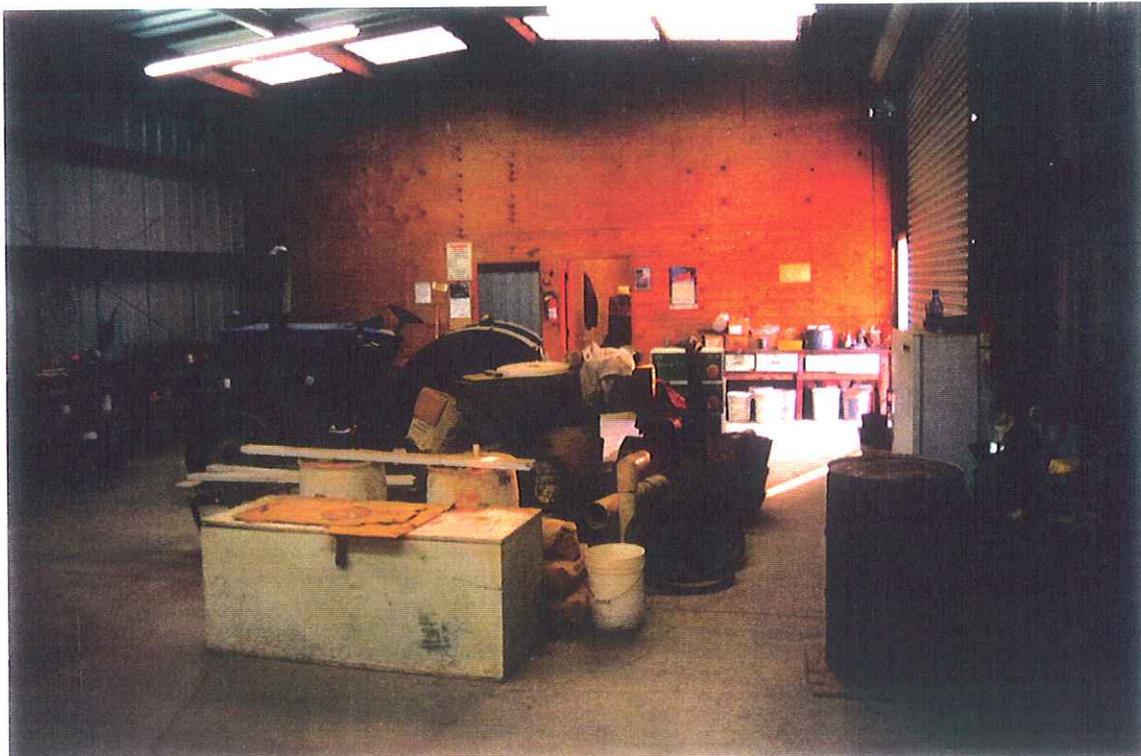
The remaining area of the metal storage building (approximately 30 foot by 50 foot) is used to store a small tractor, a welder, grinder, air compressor, and other small machines. We noted a 30-gallon drum used for trash, two 5-gallon containers, one for

nuts and bolts and one for gasoline, five boxes of Krovar, two 30-gallon plastic containers of roundup, two bags of Urea 46 fertilizer, three 55-gallon drums, one for new oil, one for waste oil, and one empty drum, and three 5-gallon containers of specialty oil for the wind machines. Also noted was a 50-gallon spray tank that mounts onto a truck, a 30-gallon plastic drum of quick absorb and several spray hoses.

VIEW FACING EAST INSIDE OF STORAGE BUILDING SHOWING TOOLS, TRACTOR AND 3, 55 GALLON DRUMS OF NEW OIL, USED OIL, AND ONE EMPTY DRUM.

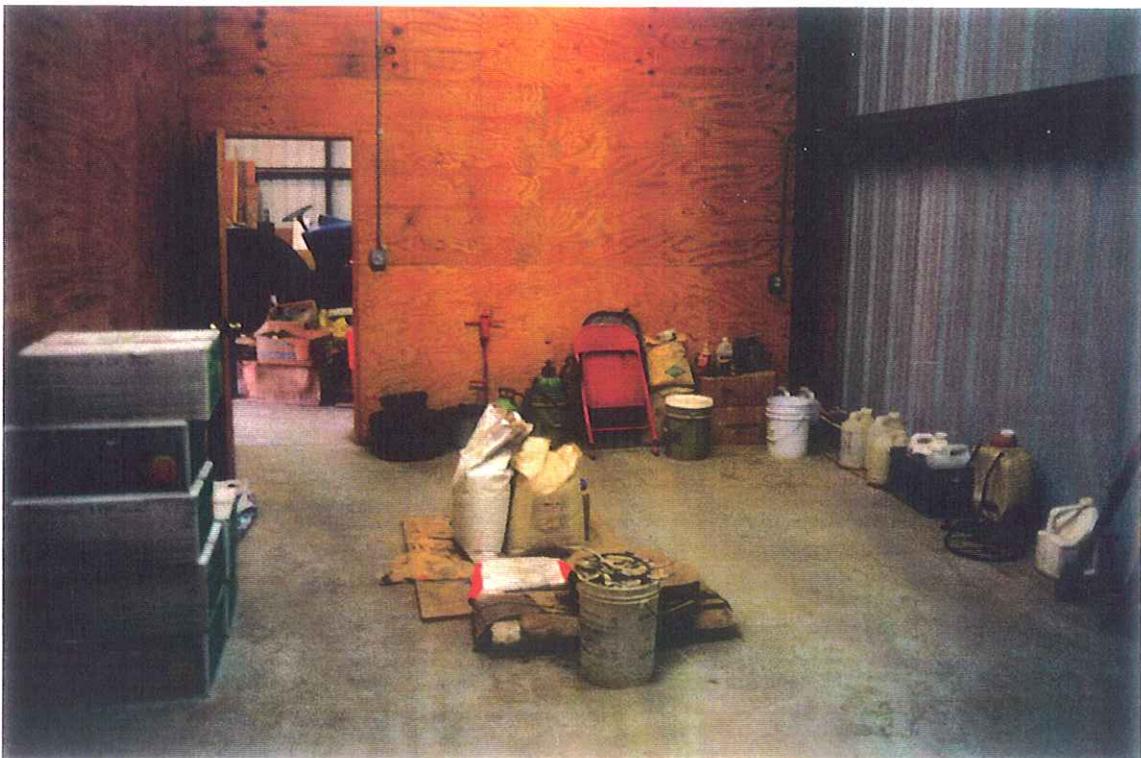
VIEW OF THE LOCKED PESTICIDE STORAGE AREA IN THE NORTHEAST CORNER OF THE STORAGE BUILDING.

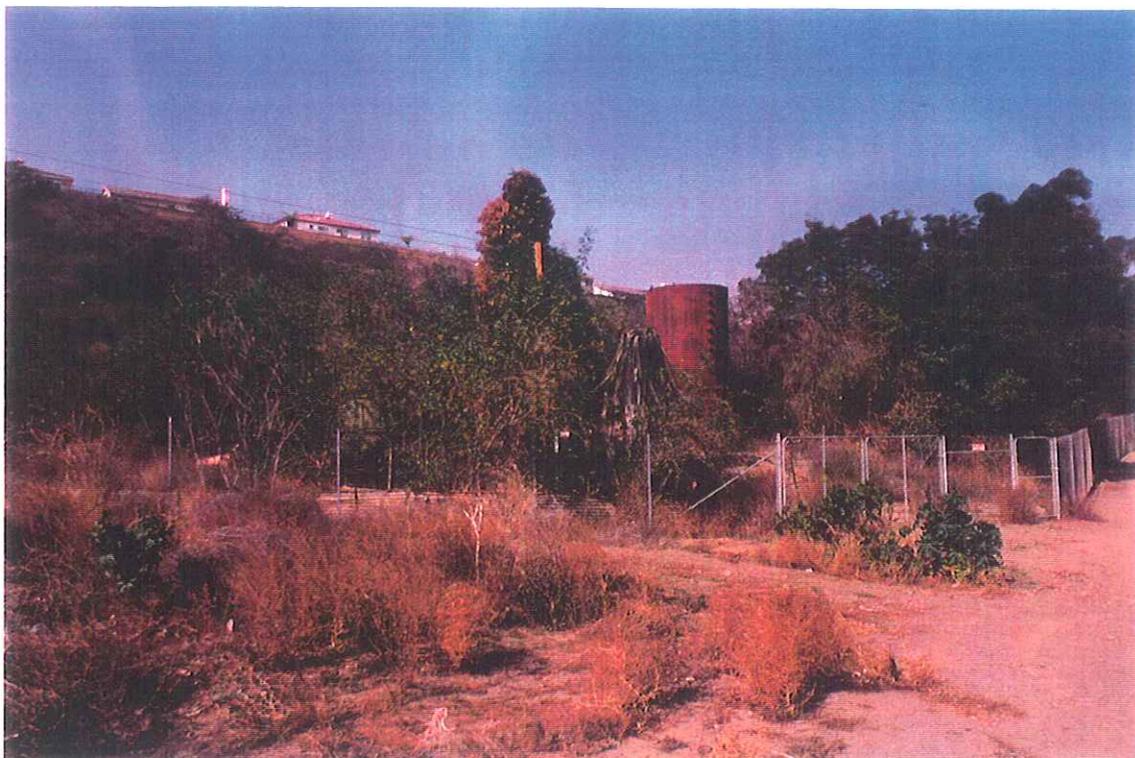
The remaining 10,000 ± gallon above ground tank appeared to be empty. It was constructed on or had gravel around it. We noted some staining of the gravel at the outflow pipe but this may have been from the tar used at the pipe joint. We took a soil sample where the outlet pipe exited the tank and at the end of the outlet pipe where it would empty into the trucks. The samples were tested for total petroleum hydrocarbons and resulted in none detected and 110 ppm, respectively. Located immediately south of the 10,000 ± gallon above ground tank is what appears to be an old well or water pump set up and a water tank trailer. According to the grove manager, the water tank was for fertilizer and he indicated they had also used the

**VIEW OF APPROXIMATELY 10,000 GALLON OLD ABOVE GROUND DIESEL/SMUDGE POT OIL STORAGE TANK ON RIGHT. WHAT APPEARED TO BE AN OLD WELL IS VISIBLE OF THE LEFT OF THE TANK, FOLLOWED BY A GREEN WATER TRAILER. THESE ARE LOCATED ON THE WEST SIDE OF PARCEL 3 DOWN FROM EAGLE GLEN ROAD.**

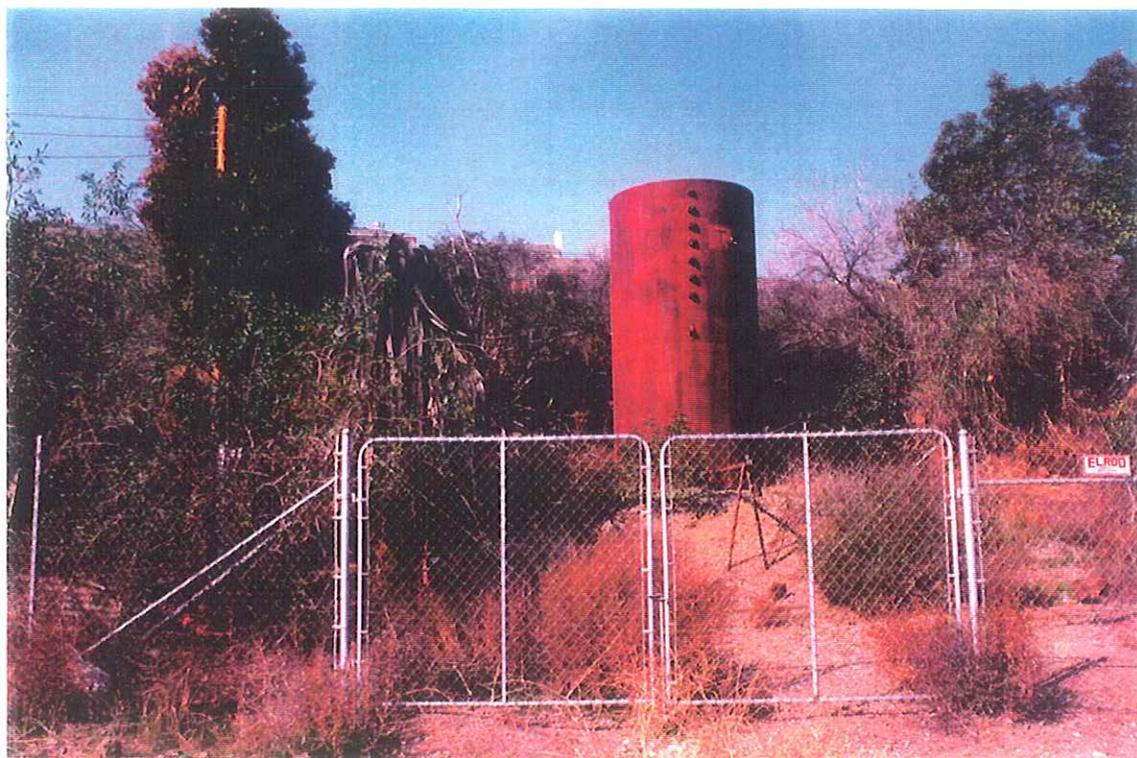
- The former 10,000 gallon above ground storage tank that may or may not be on the site does not have any residual hydrocarbons at the area where the outlet pipe enters the tank. The stained soil in this area appears to be from the joint compound. A minor amount of petroleum hydrocarbons was detected where the trucks filled at the outlet pipe. This appears to be a very shallow staining on the order of six inches deep. In any case it does not appear to be at a level or amount to be of regulatory concern.

**CLOSE UP OF THE OLD ABOVE GROUND DIESEL/SMUDGE POT OIL STORAGE TANK. SOIL SAMPLES TO BE TESTED FOR HYDROCARBONS WERE TAKEN BELOW THE RAISED FILL PIPE AND WHERE THE FILL PIPE ENTERS THE TANK.**

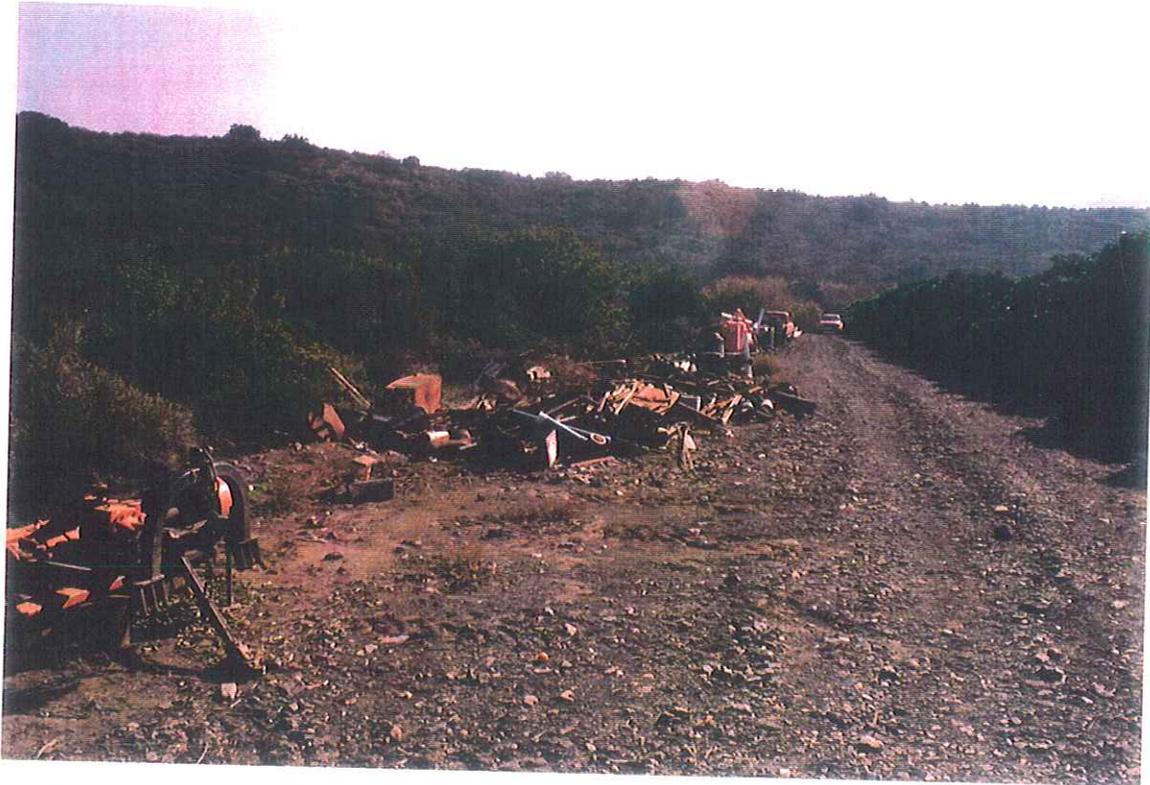
VIEW FACING SOUTH OF OLD EQUIPMENT AND MATERIALS STORED ON THE SOUTHEAST PORTION OF PARCEL 3. WE NOTED PLASTIC AND STEEL PIPE, OLD FARM EQUIPMENT, AND A TRUCK, WOOD, ROOFING, BARBED WIRE, WATER TANK, FILTER TANKS, AND PACKING BOXES.

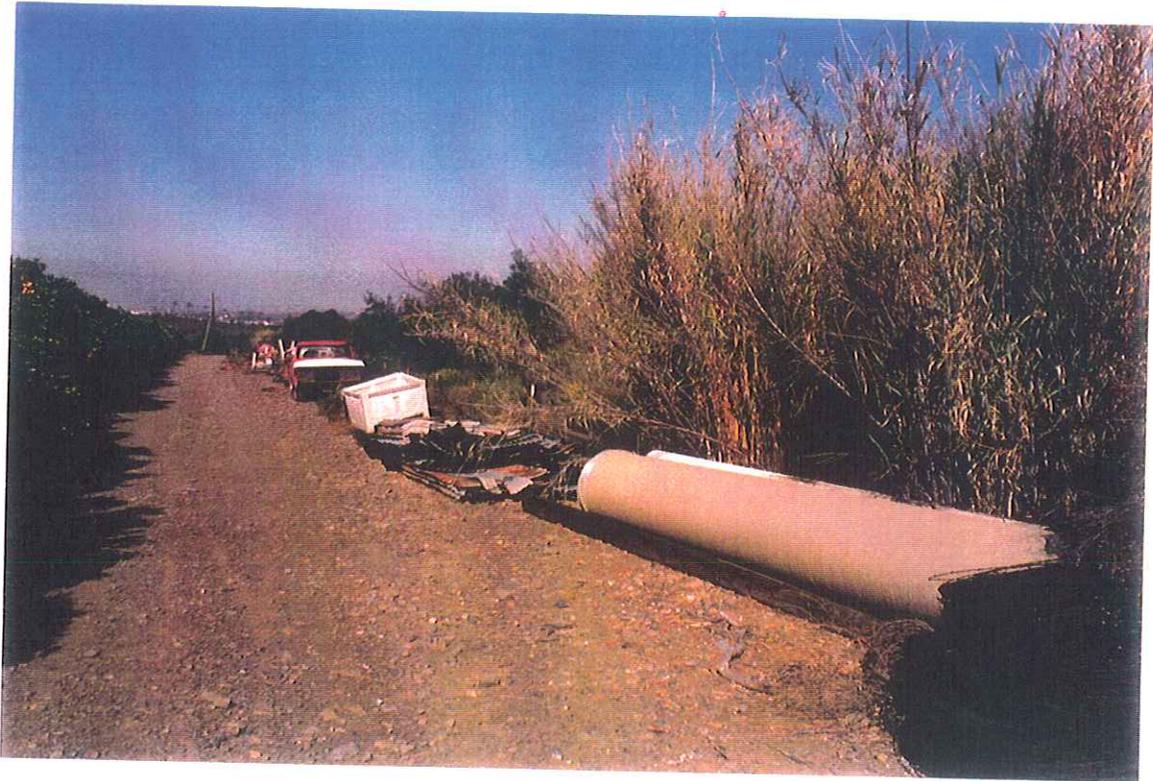
VIEW FACING NORTH OF THE OLD STORED EQUIPMENT AND MATERIALS ON THE SOUTHEAST PORTION OF PARCEL 3.

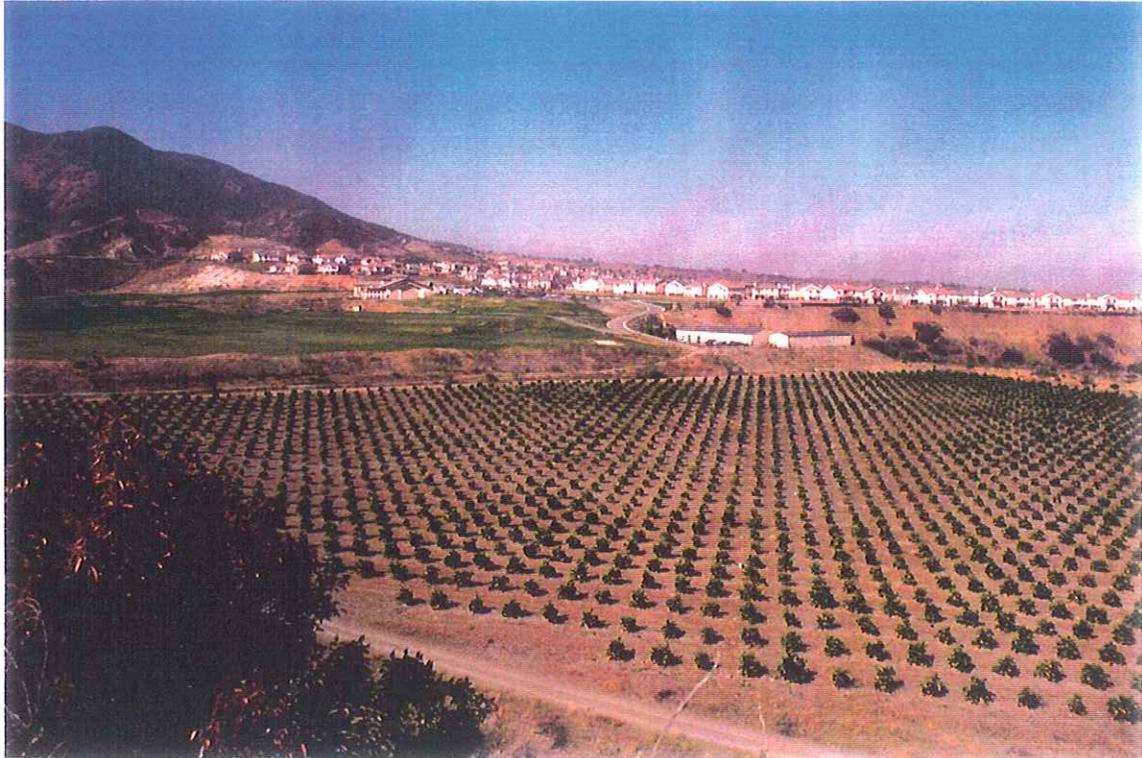
VIEW FACING NORTHWESTERLY FROM PARCEL 5 SHOWING THE SOUTH HALF OF PARCEL 4 WITH THE GOLF COURSE TO THE LEFT (SOUTHWEST) OF THIS PORTION OF THE SITE. THE TWO LARGE BUILDINGS ARE THE GOLF COURSE MAINTENANCE BUILDINGS. RESIDENCES ARE VISIBLE IN THE BACKGROUND.

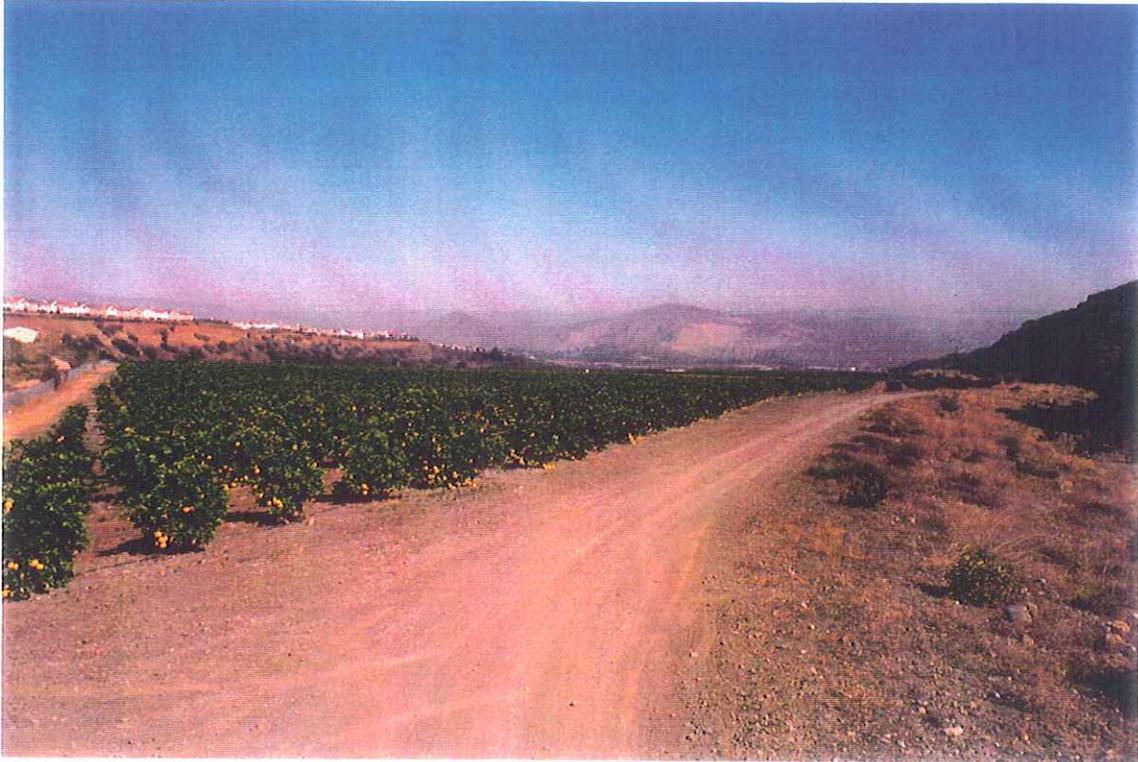
GROUND VIEW OF THE SOUTH PART OF PARCEL 4 WITH BEDFORD CANYON WASH TO THE RIGHT AND GOLF COURSE MAINTENANCE BUILDING TO THE LEFT.

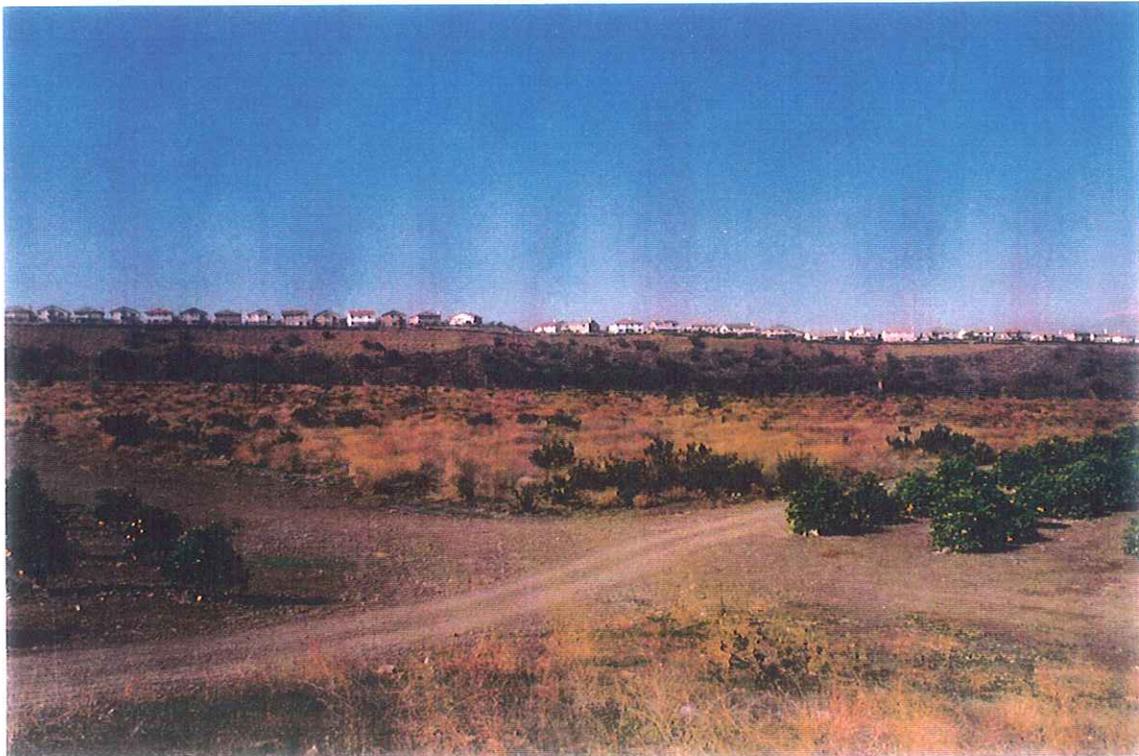
CLOSE UP OF THE VACANT PART OF PARCEL 4. NOT SEEN BUT LOCATED IN THE BACKGROUND OF THE PICTURE ADJACENT THE PALM TREE IS AN OLD SHED.

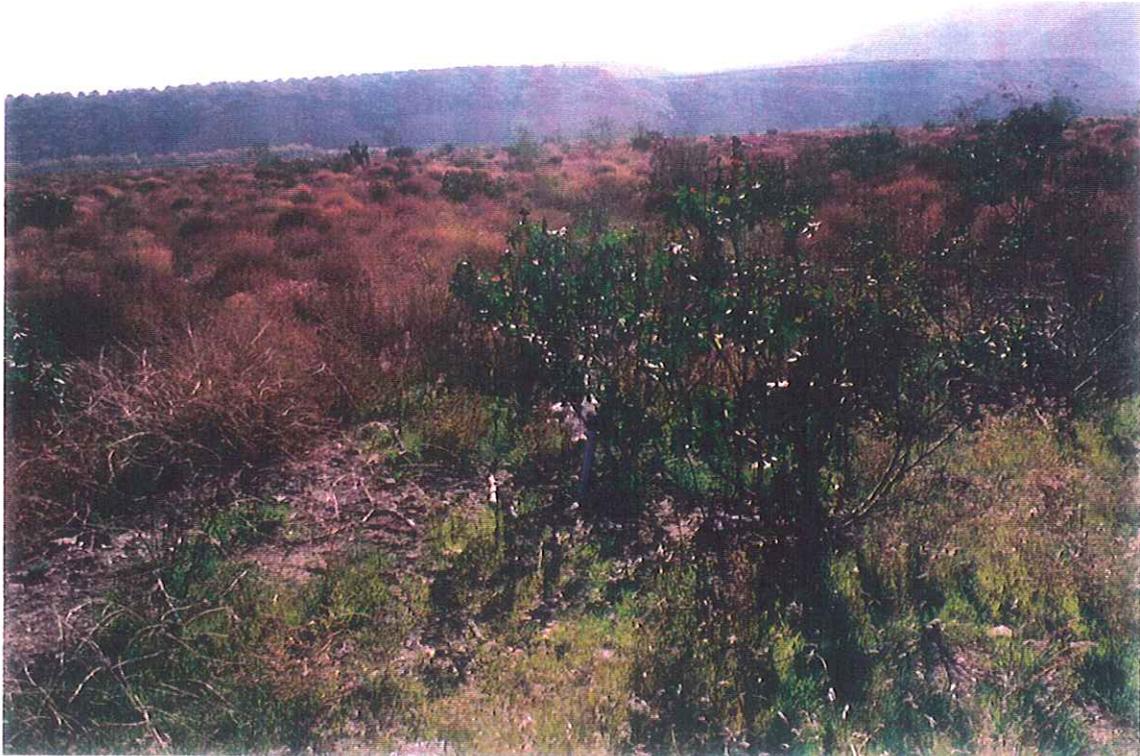
LOCATED ON THE WEST SIDE OF PARCEL 4 IN THE UNDEVELOPED AREA ARE SEVERAL PVC PIPES WHICH ARE PAINTED BLUE. THESE INDICATE SOME DEVELOPMENT OF THE AREA.

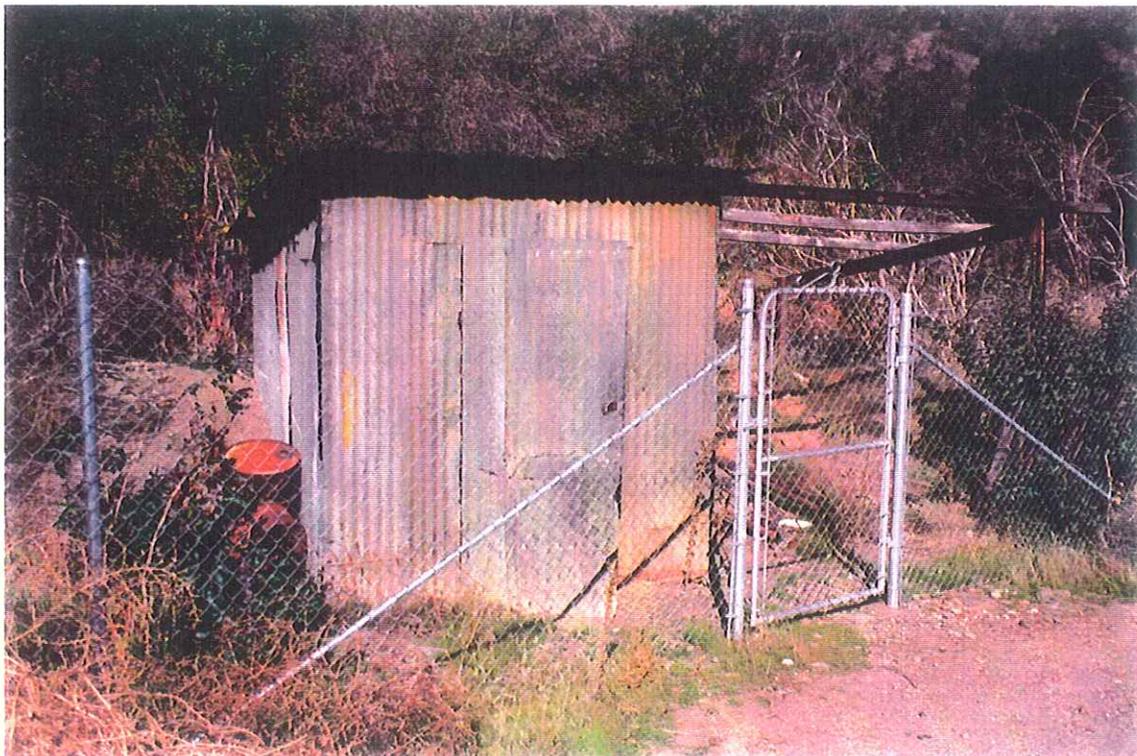
VIEW OF THE OLD SHED LOCATED ON THE NORTHWEST SIDE OF PARCEL 4. METAL PIPE IS LOCATED TO THE NORTH OF THE SHED. A 30 GALLON DRUM APPROXIMATELY TWO-THIRD FULL OF DIESEL FUEL IS LOCATED TO THE SOUTH.
