**PHASE 1 ENVIRONMENTAL  
SITE ASSESSMENT  
AND LIMITED SITE CHARACTERIZATION  
McMILLAN FARM PROPERTY  
CORONA COUNTY, CALIFORNIA**

**PROJECT NO. 31558.2  
MARCH 21, 2002**

Attached herewith is the Phase 1 Environmental Site Assessment and Limited Site Characterization conducted by this firm for the 530± acre McMillan Farm project generally located southeast of Eagle Glen Parkway and I-15 in the city of Corona, Riverside County, California.

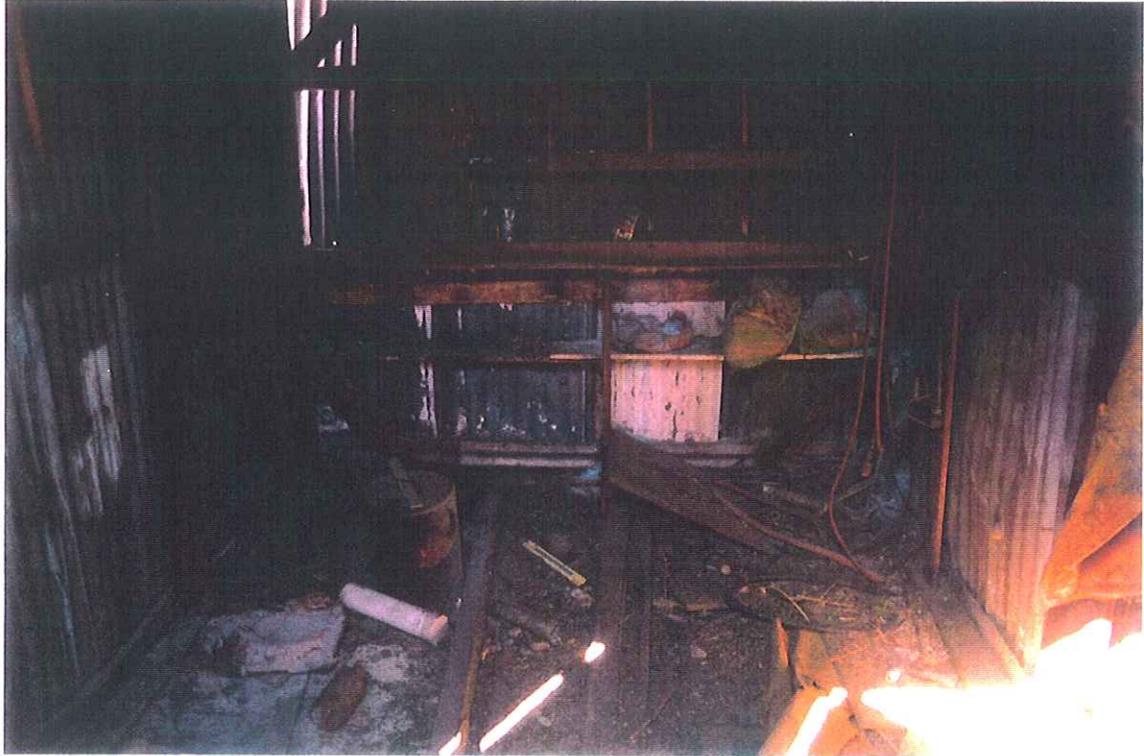
We noted a small pile of roof shingles in the area of the shed on Parcel 4 and took two samples to test for asbestos. Both samples were negative for asbestos. Several small ½ to ¾" PVC pipe were also noted in this area. The pipe was painted blue and appeared to be for irrigation.

VIEW OF INSIDE OF THE OLD SHED WHICH HAD A WOODEN FLOOR. THREE BAGS OF COPPER SULFATE, PIPE FITTINGS, SILICA SAND, SEVERAL 1 AND 5 GALLON CANS (UNMARKED), WERE ALSO PRESENT. A SAMPLE WAS OBTAINED BENEATH THE WOOD FLOOR AND OF A WHITE POWDER IN THE SHED.

We would recommend the following: The shed located on the west side of Parcel 4 if on the site should have the chlordane powder and 30 gallon drum of diesel fuel removed and properly disposed of, the shed should be dismantled and the wood shed floor and all pesticide contaminated soil under and around the shed removed and properly disposed of. The three 5 gallon cans of waste oil located behind the metal storage building on Parcel 3 should be recycled.

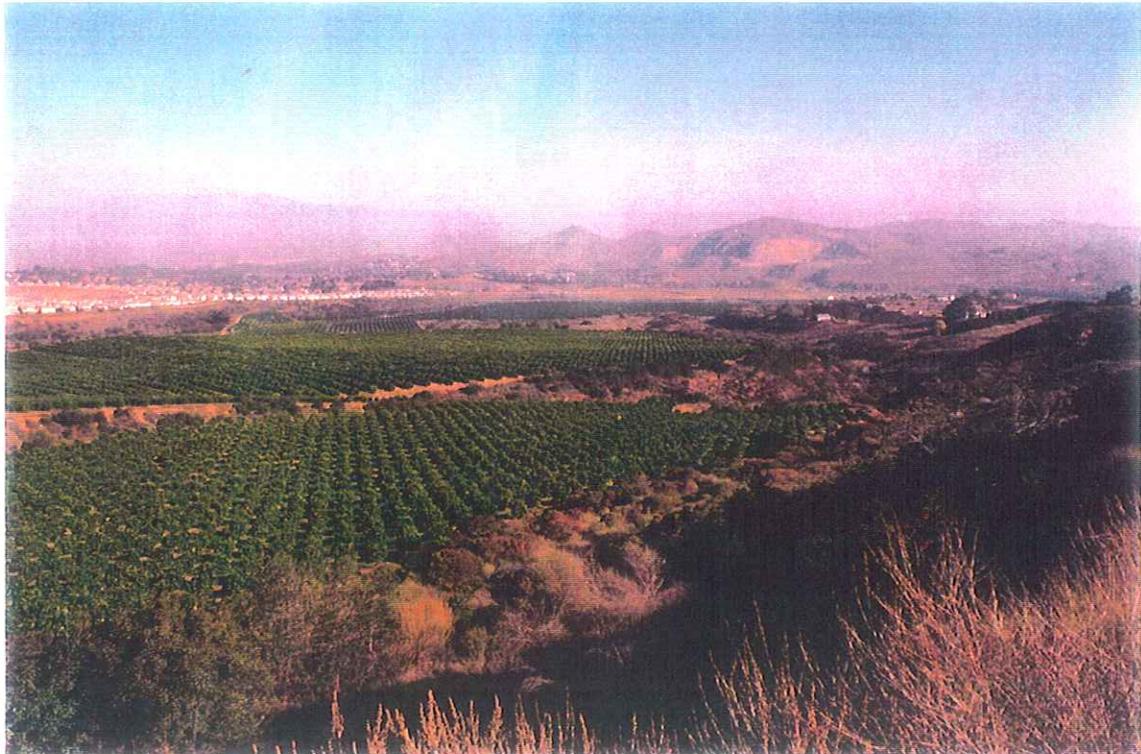
VIEW FACING NORTHERLY SHOWING PARCEL 6 IN FOREGROUND AND PARCEL 5 IN BACKGROUND. VACANT LAND IS SHOWN EAST OF PARCEL 6 FROM WHERE THE PICTURE WAS TAKEN.

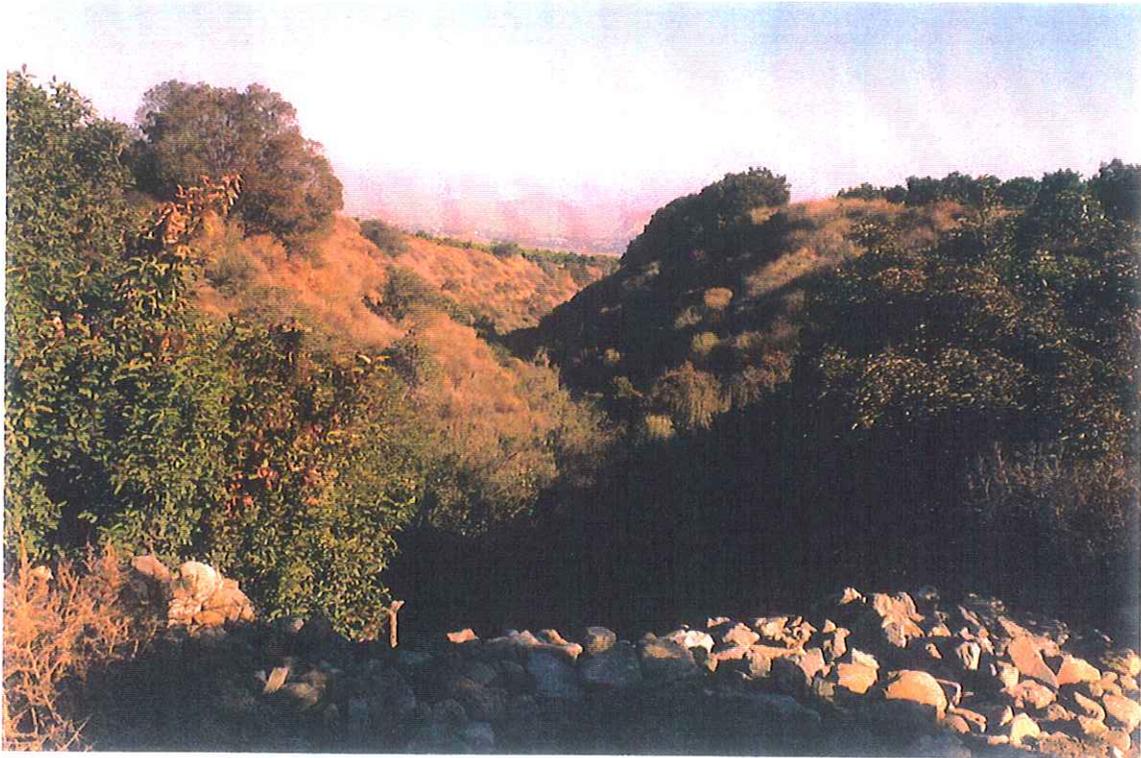
VIEW FACING NORTH AT THE DRAINAGE BETWEEN PARCEL 5 AND PARCEL 6. THE ROCK IN FOREGROUND IS FOR EROSION CONTROL OF THE FILL PLACED TO CROSS THE DRAINAGE.

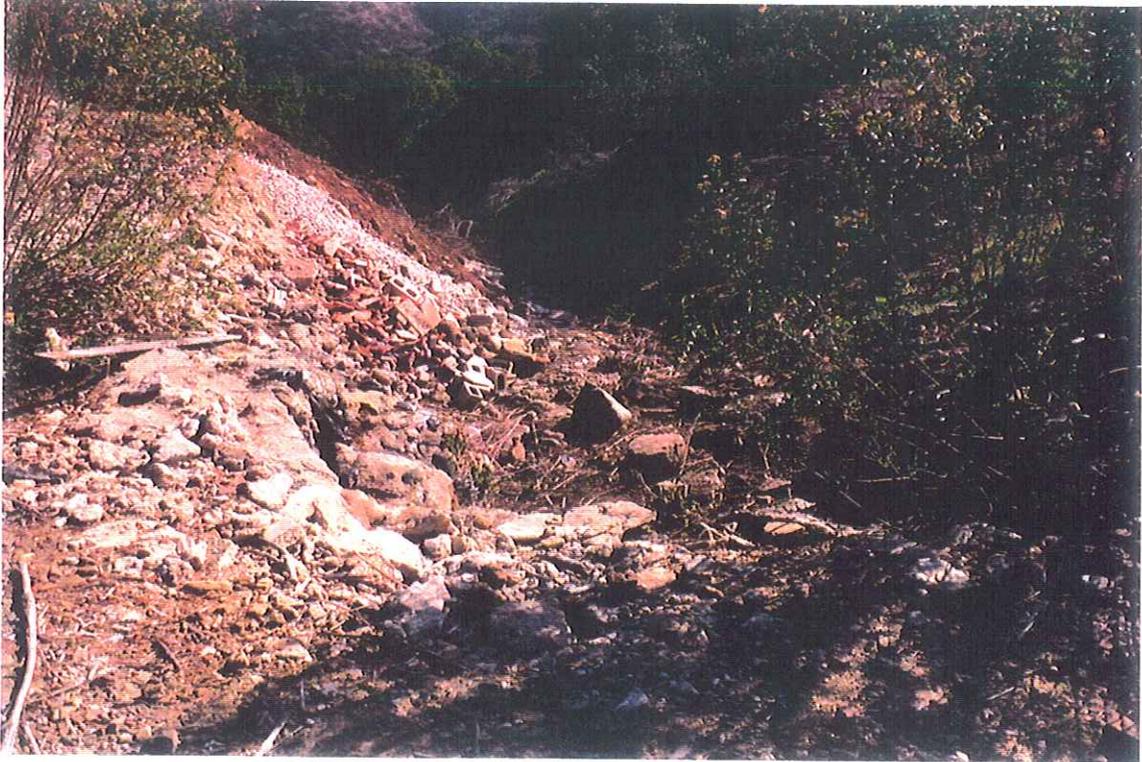
VIEW OF BROKEN CONCRETE AND BLOCK USED FOR EROSION CONTROL AT ONE OF THE DRAINAGES ON THE NORTHEAST SIDE OF PARCEL 5. NO TRASH WAS NOTED.

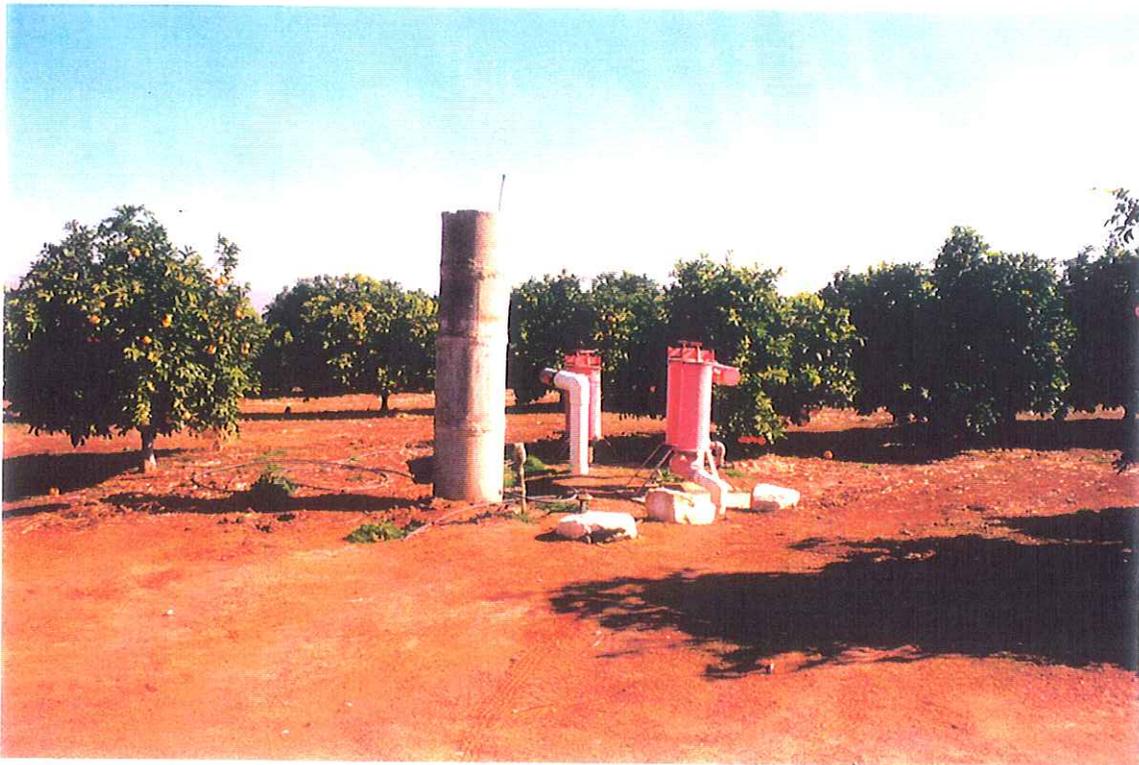
VIEW OF IRRIGATION FILTERS ON THE WEST SIDE OF PARCEL 5.

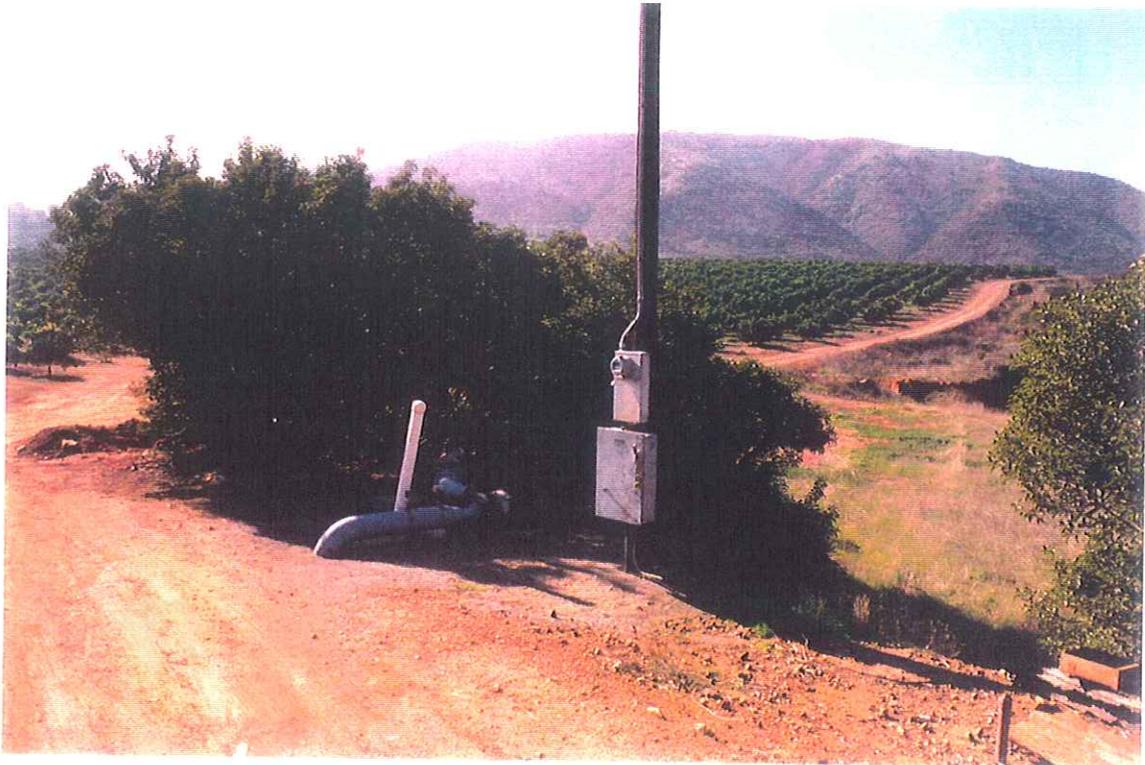
VIEW OF PUMP ON THE WEST SIDE OF PARCEL 5 WITH GROVES IN THE BACKGROUND.

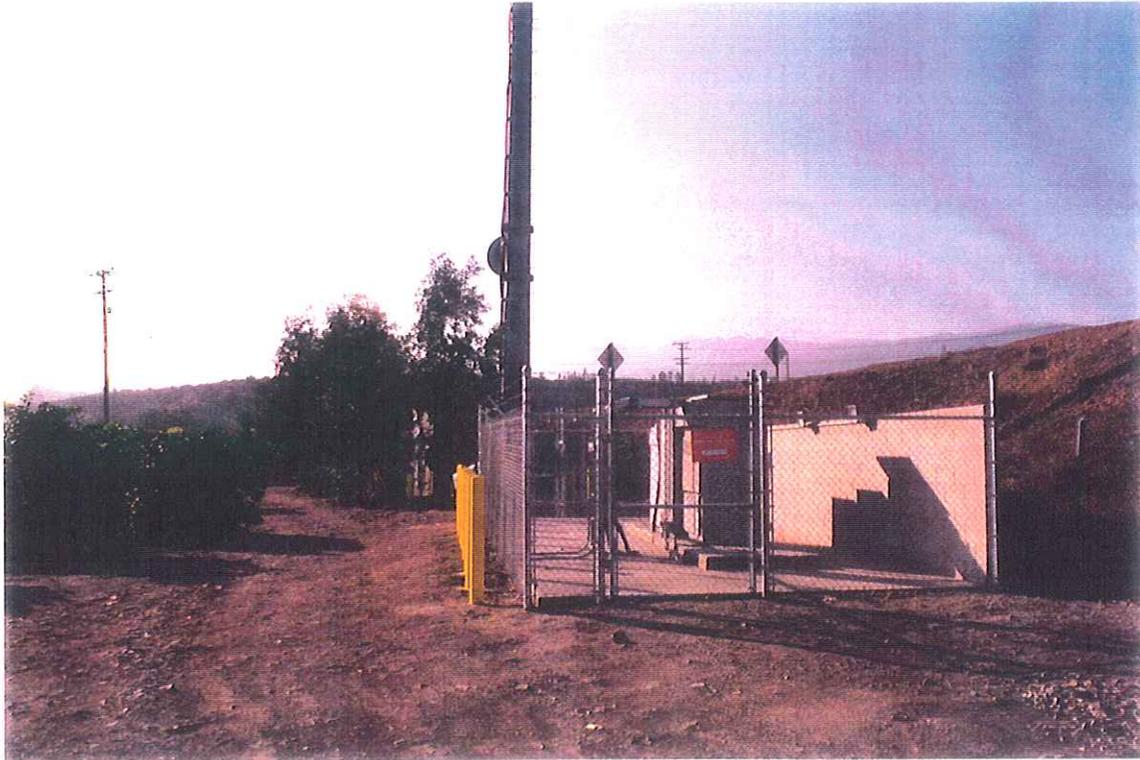
CLOSE UP OF THE CELL TOWER AND EQUIPMENT LOCATED ON THE NORTHWEST PORTION OF PARCEL 7 ADJACENT THE CAJALCO ROAD OFFRAMP.

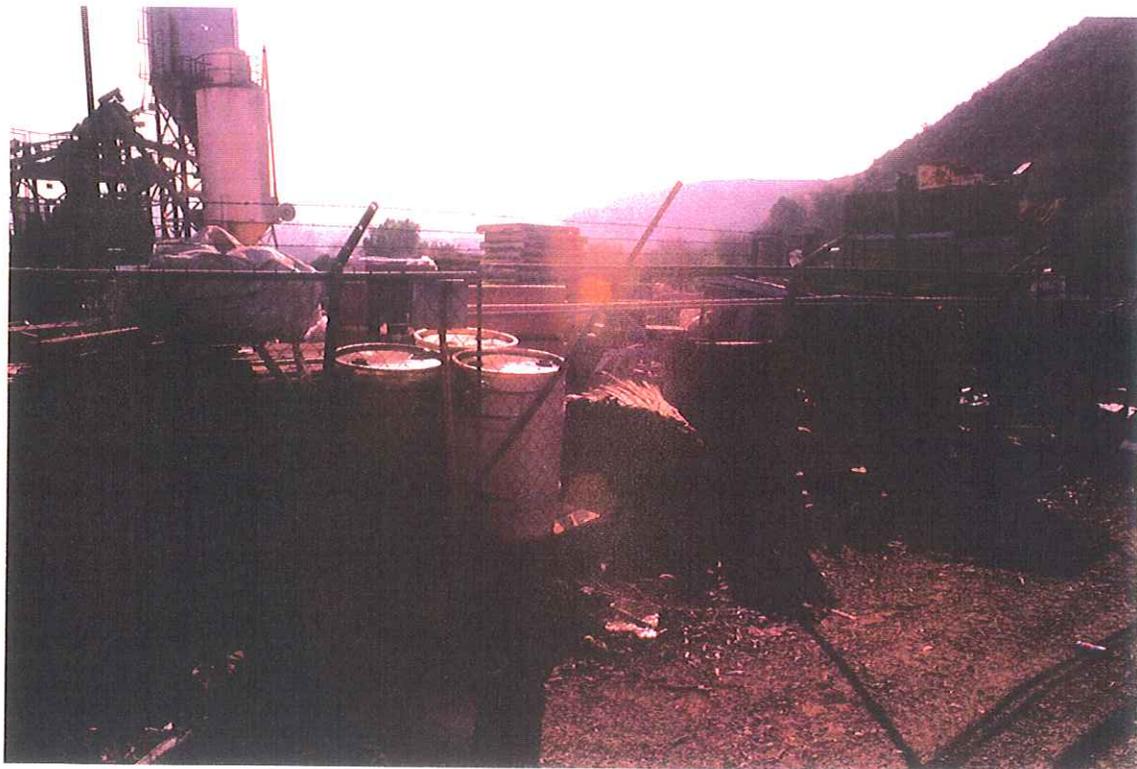
CLOSE UP OF SOME OF THE MATERIALS STORED NEXT TO PARCEL 8 ON THE QUICKCRETE PROPERTY. THE 55 GALLON DRUMS APPEAR TO HAVE WASTE OIL. THEY HAVE NOT LEAKED AND ARE SET UP ON A PALLET.

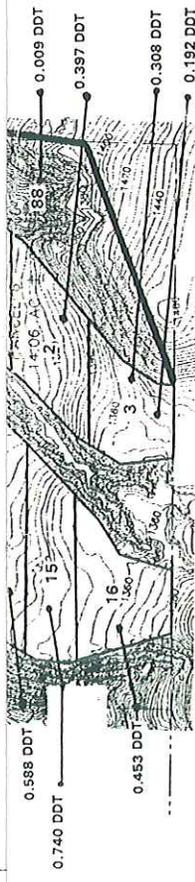
## SOIL SAMPLE LOCATION MAP

The field sampling equipment consisted of hand shovels, several small stainless steel scoops, and clean glass jars. A total of 385 discrete soil samples were obtained and composited into 77 samples. Of these 77 composite samples, 8 samples were tested discretely. The approximate location of our soil samples are presented on the attached Soil Sample Location Map, Enclosure E-1, within Appendix E.
