# Western Riverside County Multiple Species Habitat Conservation Plan Consistency Analysis

**WESTERN RIVERSIDE COUNTY MULTIPLE SPECIES  
HABITAT CONSERVATION PLAN CONSISTENCY  
ANALYSIS**

**SKYLINE VILLAGE  
CORONA, CALIFORNIA  
ASSESSOR'S PARCEL NUMBERS 275-050-014 AND 275-080-041**

**December 17, 2020**

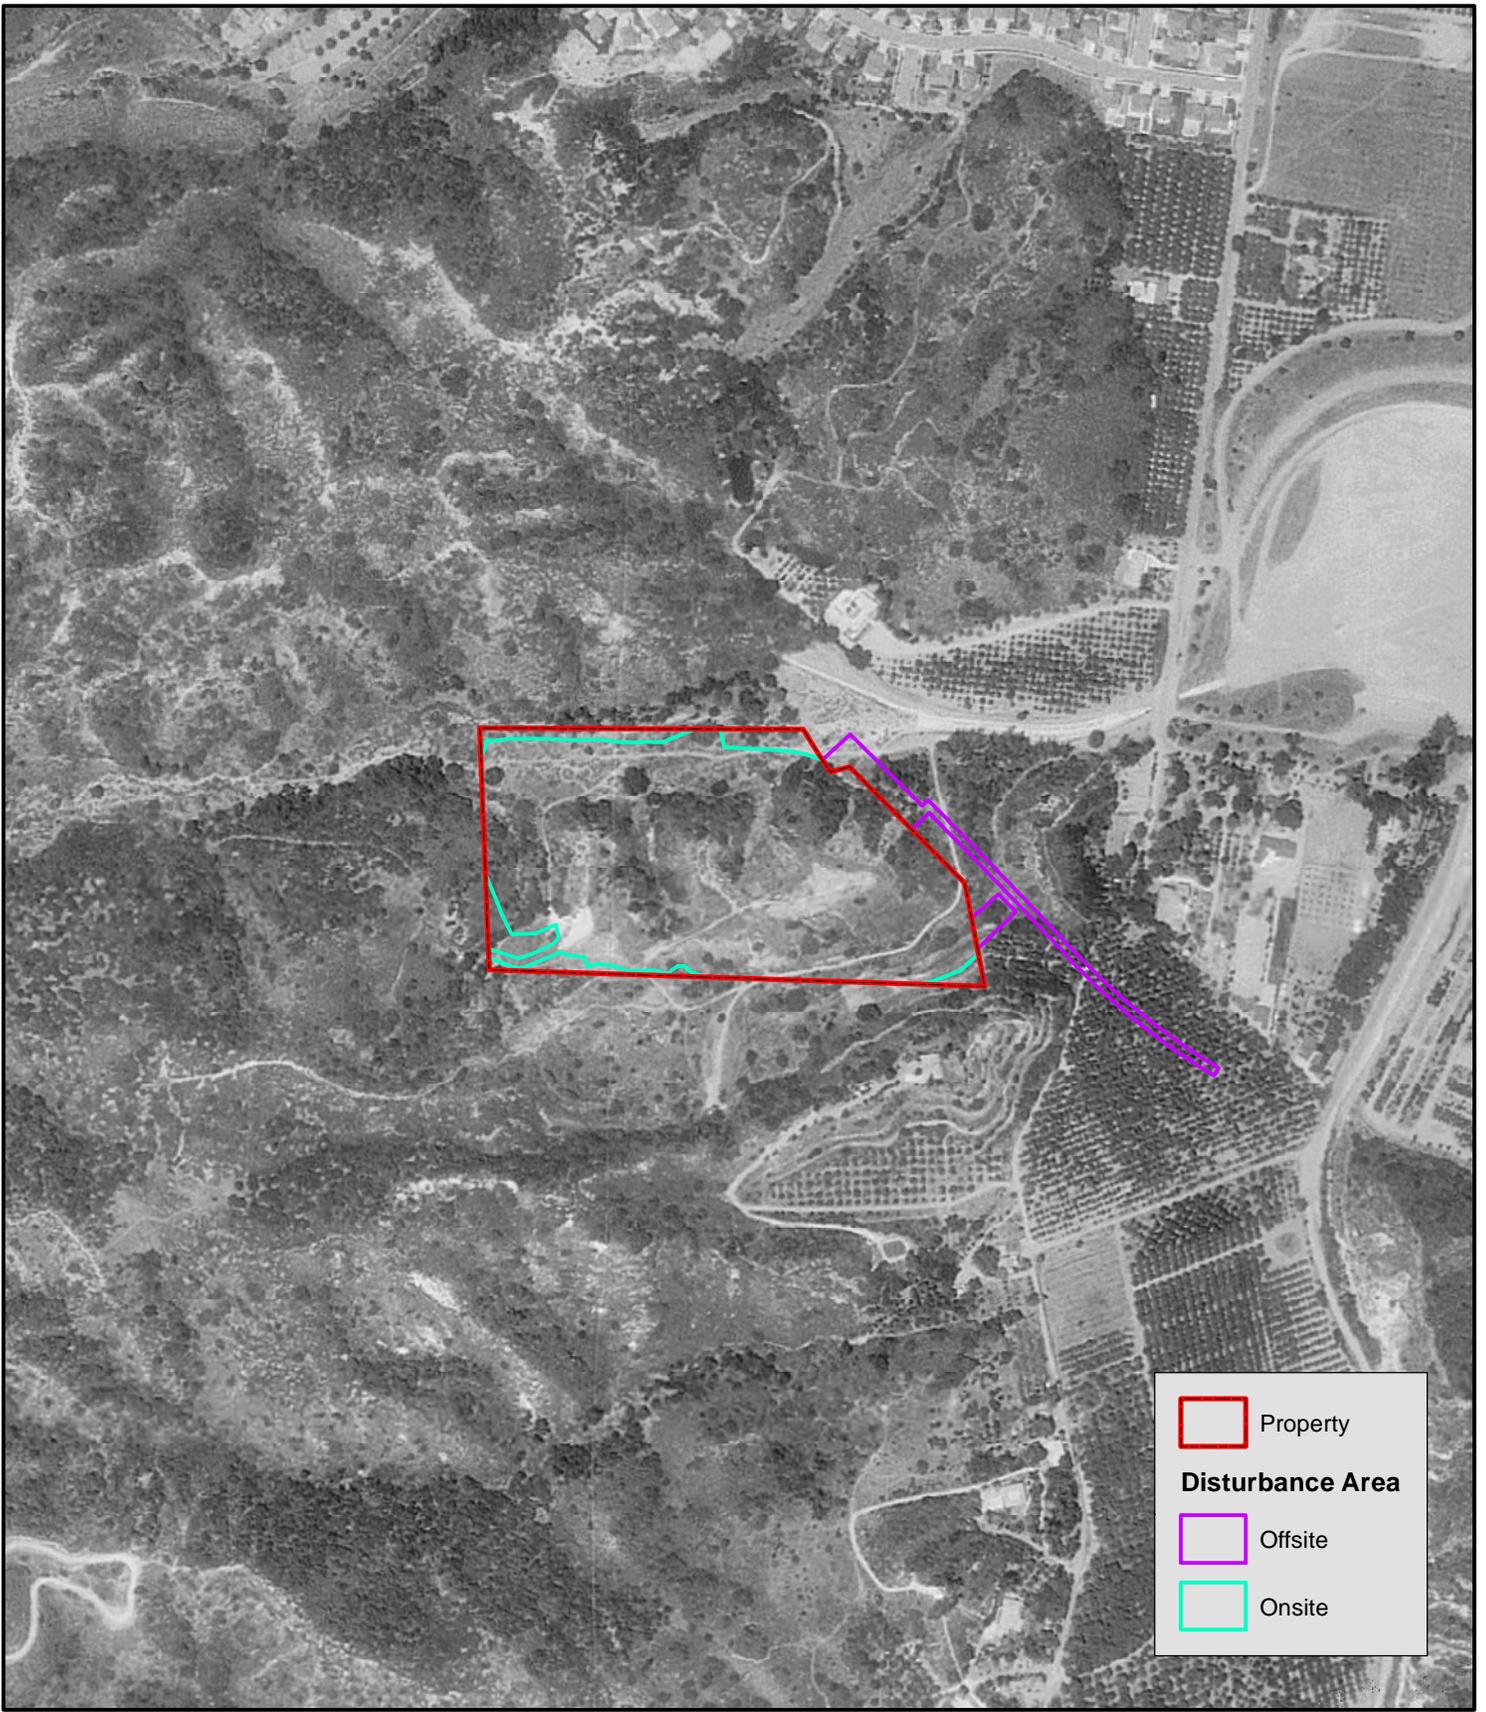
**FIGURE 10**  
**1994 Aerial**  
**Photograph**

In 1994 much of the agricultural areas were still present east of the Site; however, areas northeast of the Property were being developed for residential lots and the Oak Street Reservoir had also been developed east of the Site, along with what appears to be a concrete channel to collect flows from the USGS blue line stream. Conditions on the Property were relatively similar to those present in 1946 with dirt roads/trails present and the USGS blue line stream present in the northern portion. *Figure 10 – 1994 Aerial Photograph* (Page 19) depicts the conditions described above.

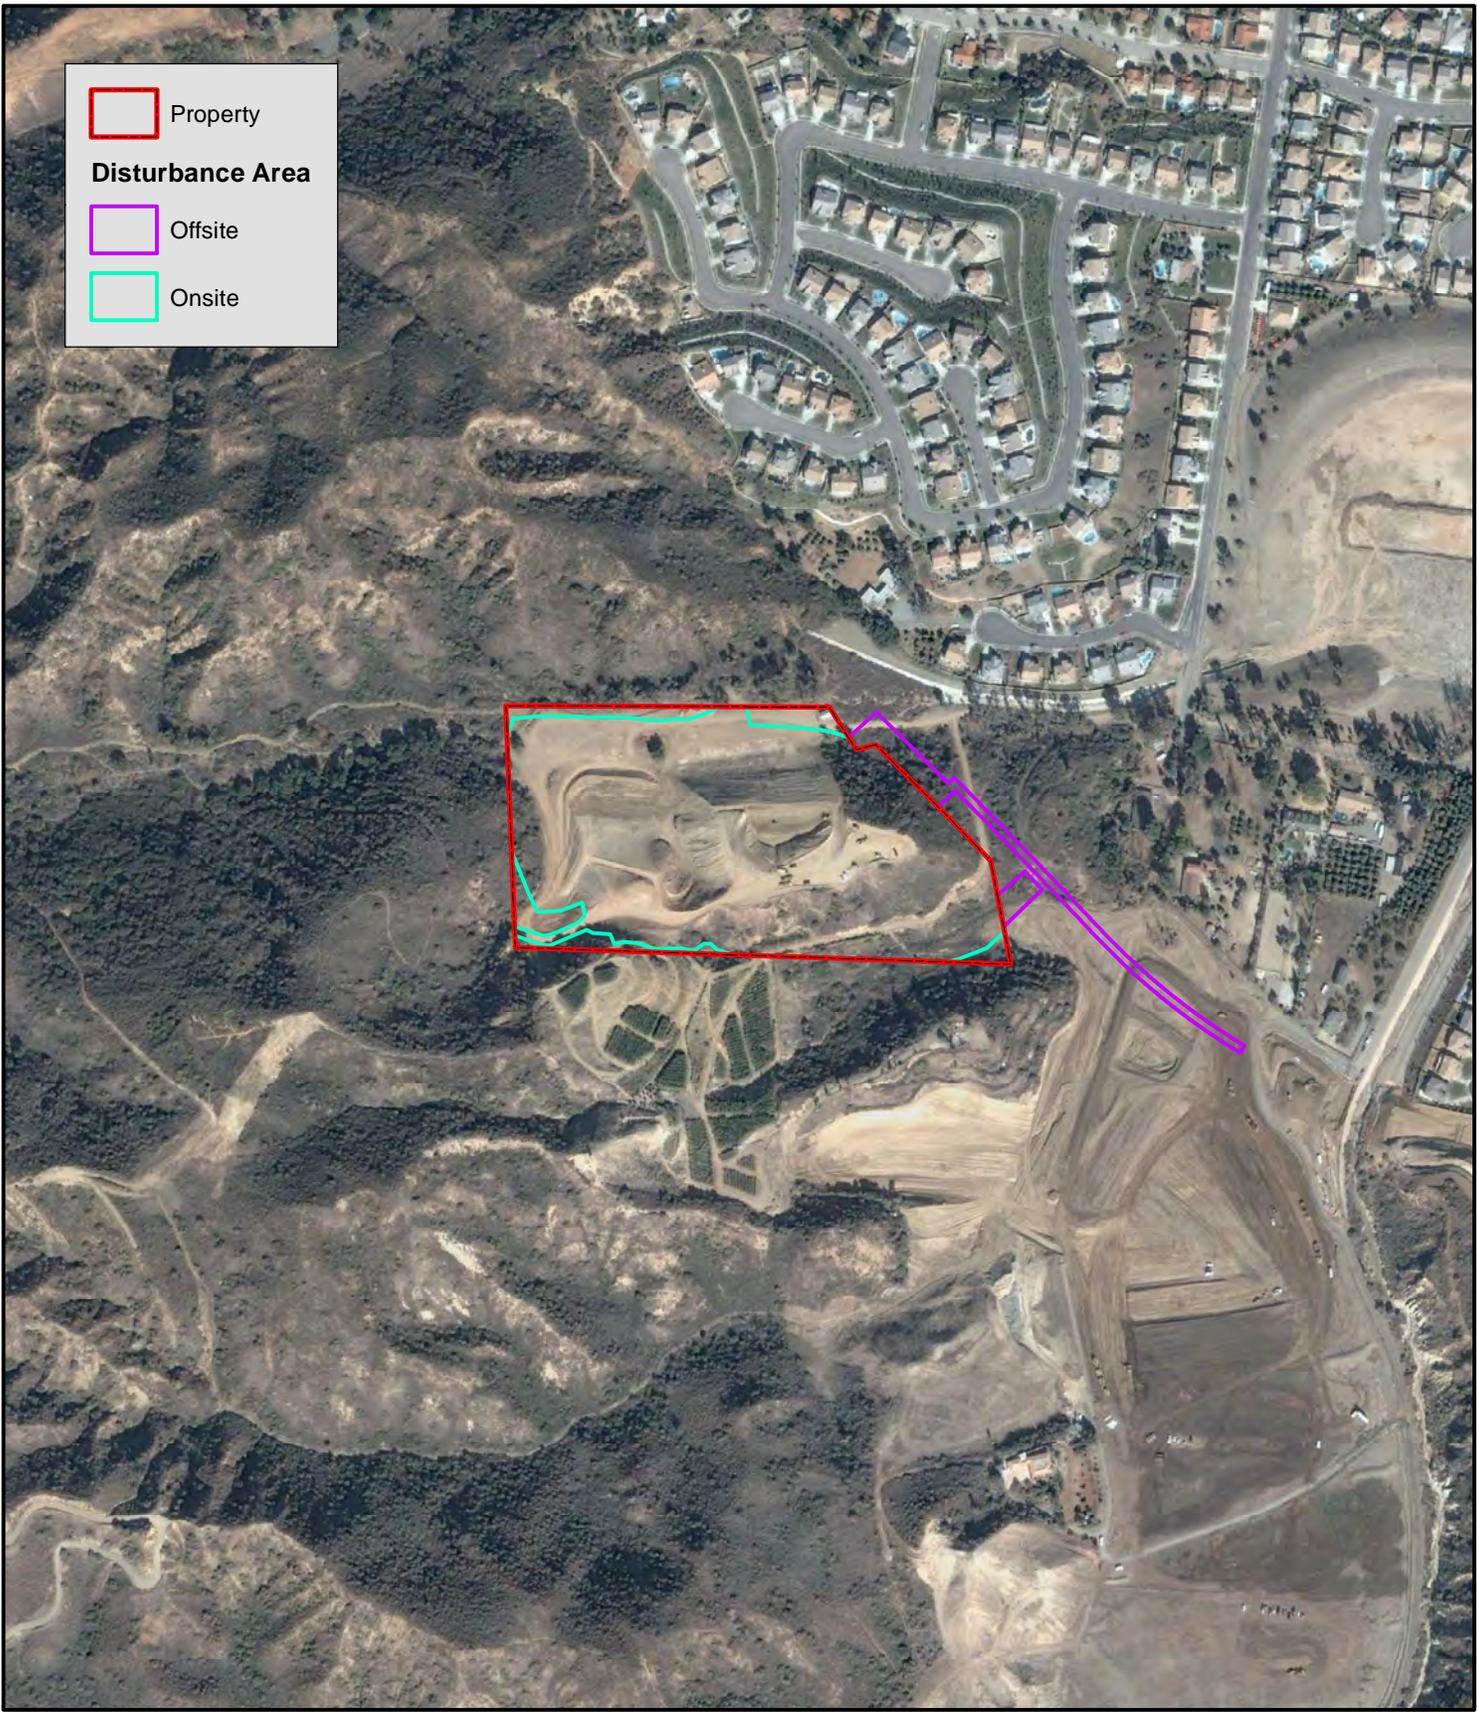
**FIGURE 11**  
**2006 Aerial**  
**Photograph**

Agriculture was no longer present east of the Site in 2006 with those areas consisting of residential lots and active grading for what would become future residential lots. Much of the area within the proposed Project area was being actively graded as well as creating the north-facing manufactured slopes on the Site. The USGS blue line stream on the Property was not clearly evident due to the grading operations. *Figure 11 – 2006 Aerial Photograph* (Page 20) depicts the conditions described above.

Figure 11, portions of Reach 2 were graded in 2006. This disturbance likely accounts for the conditions observed. Substrates consisted of cobbly sand in the upstream end then to a mix of cobbly sand along the southern edge and sandy loams along the northern portion. Reach 2 also supported evidence of flow throughout its breadth consisting of surface relief and drift and debris, but Reach 2 also contained a deeply incised low-flow channel in some areas unlike Reach 1 that consisted of several braided channels. Sage scrub species, which primarily consisted of Laurel sumac with a few scattered California sagebrush and California buckwheat, were in the upstream end with Reach 2 transitioning to a Eucalyptus woodland with non-native grasses and forbs, such as cheat grass (*Bromus tectorum*) and tocalote, in the understory of the downstream half.

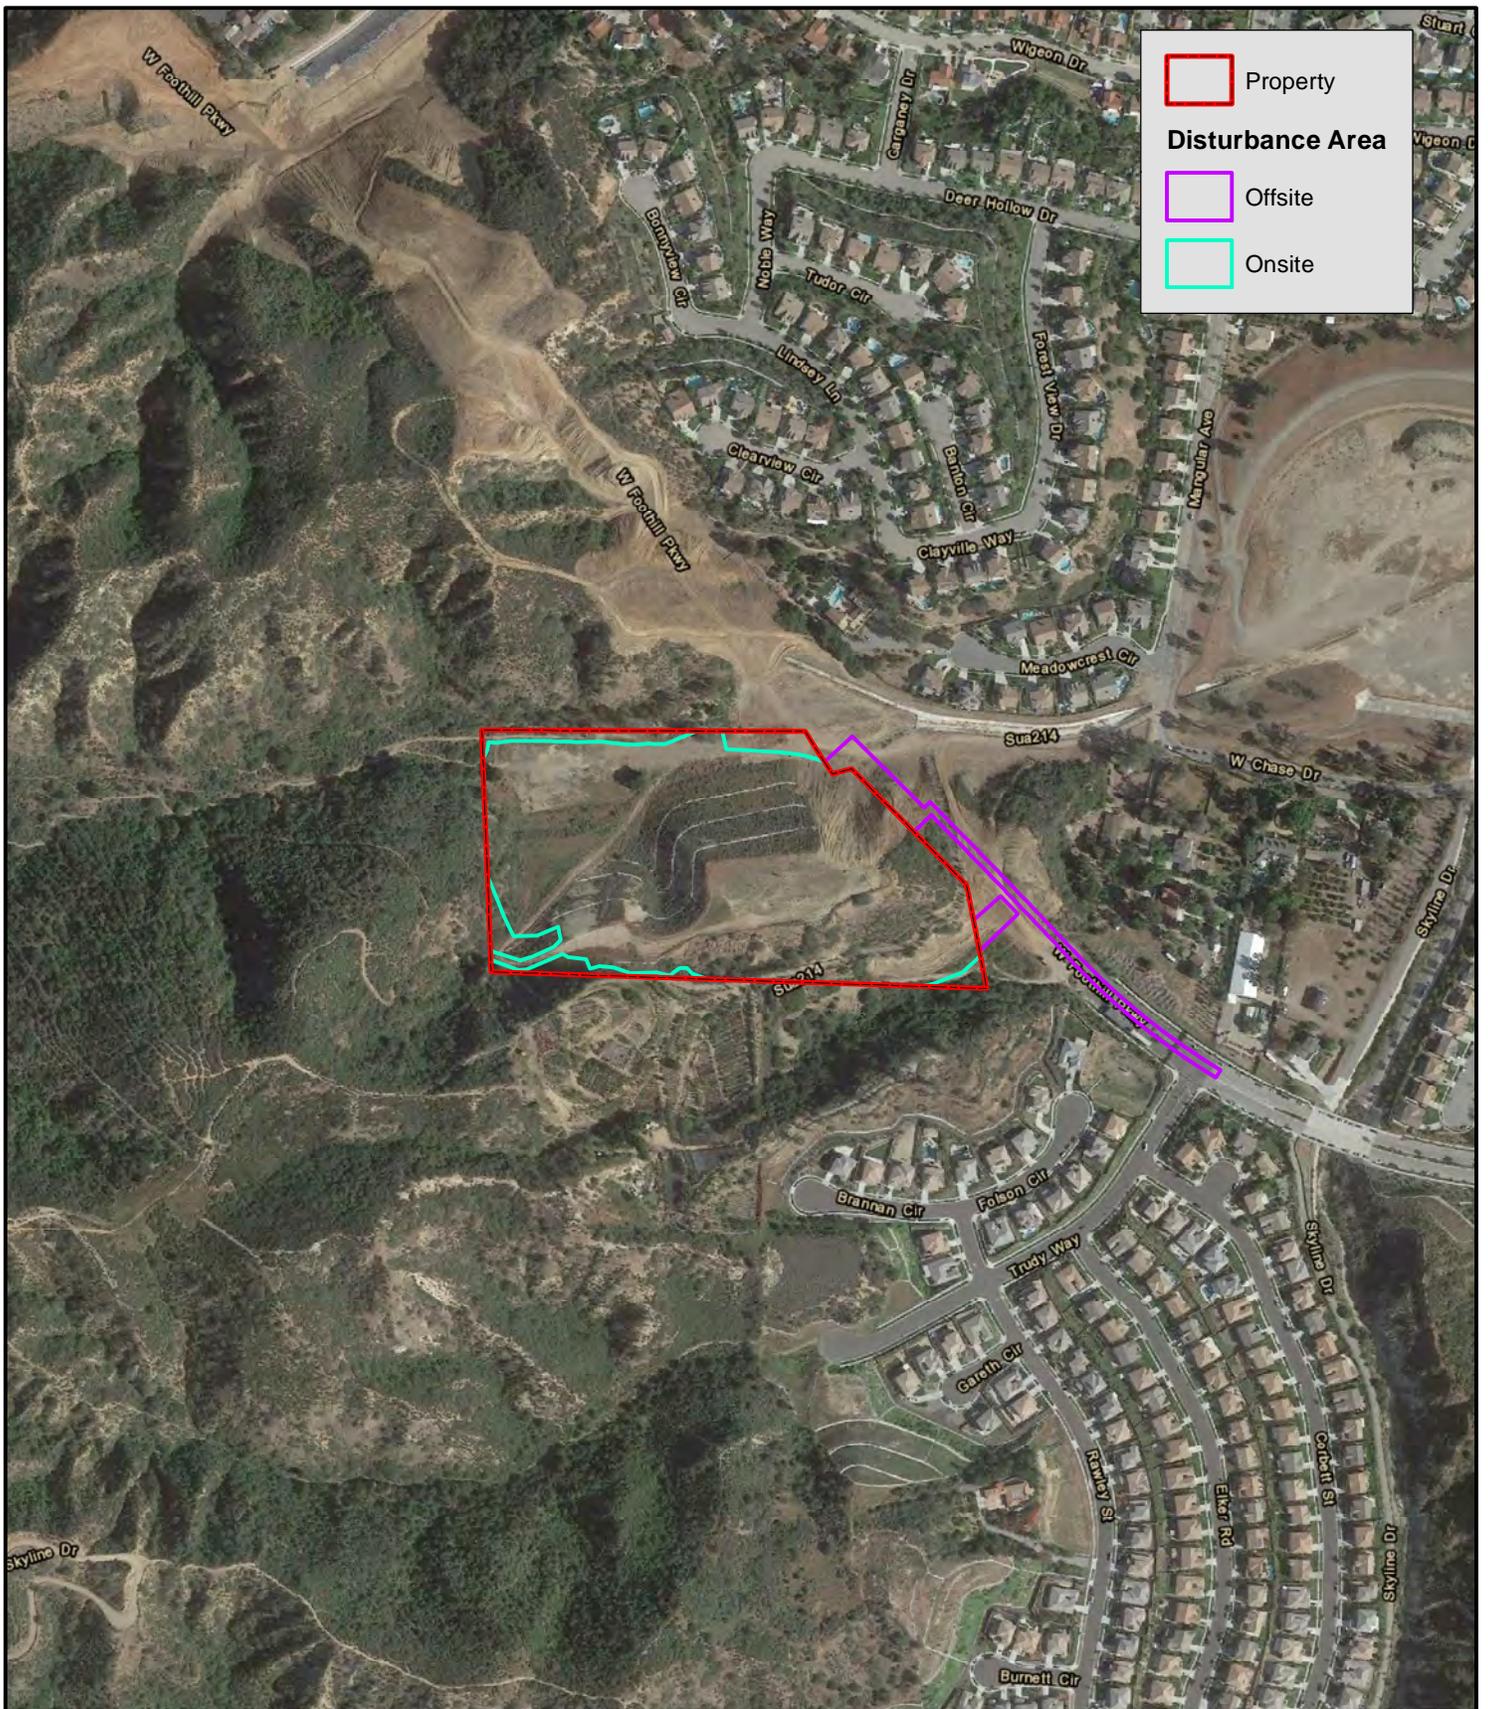
**FIGURE 12**  
**2015 Aerial**  
**Photograph**

In 2015 the extension and future alignment of Foothill Parkway was actively being graded. This grading included much of the eastern portion of the Property that consisted of the additional manufactured slopes and the flood control rip rap and culvert that are present today. *Figure 12 – 2015 Aerial Photograph* (Page 21) depicts the conditions described above.

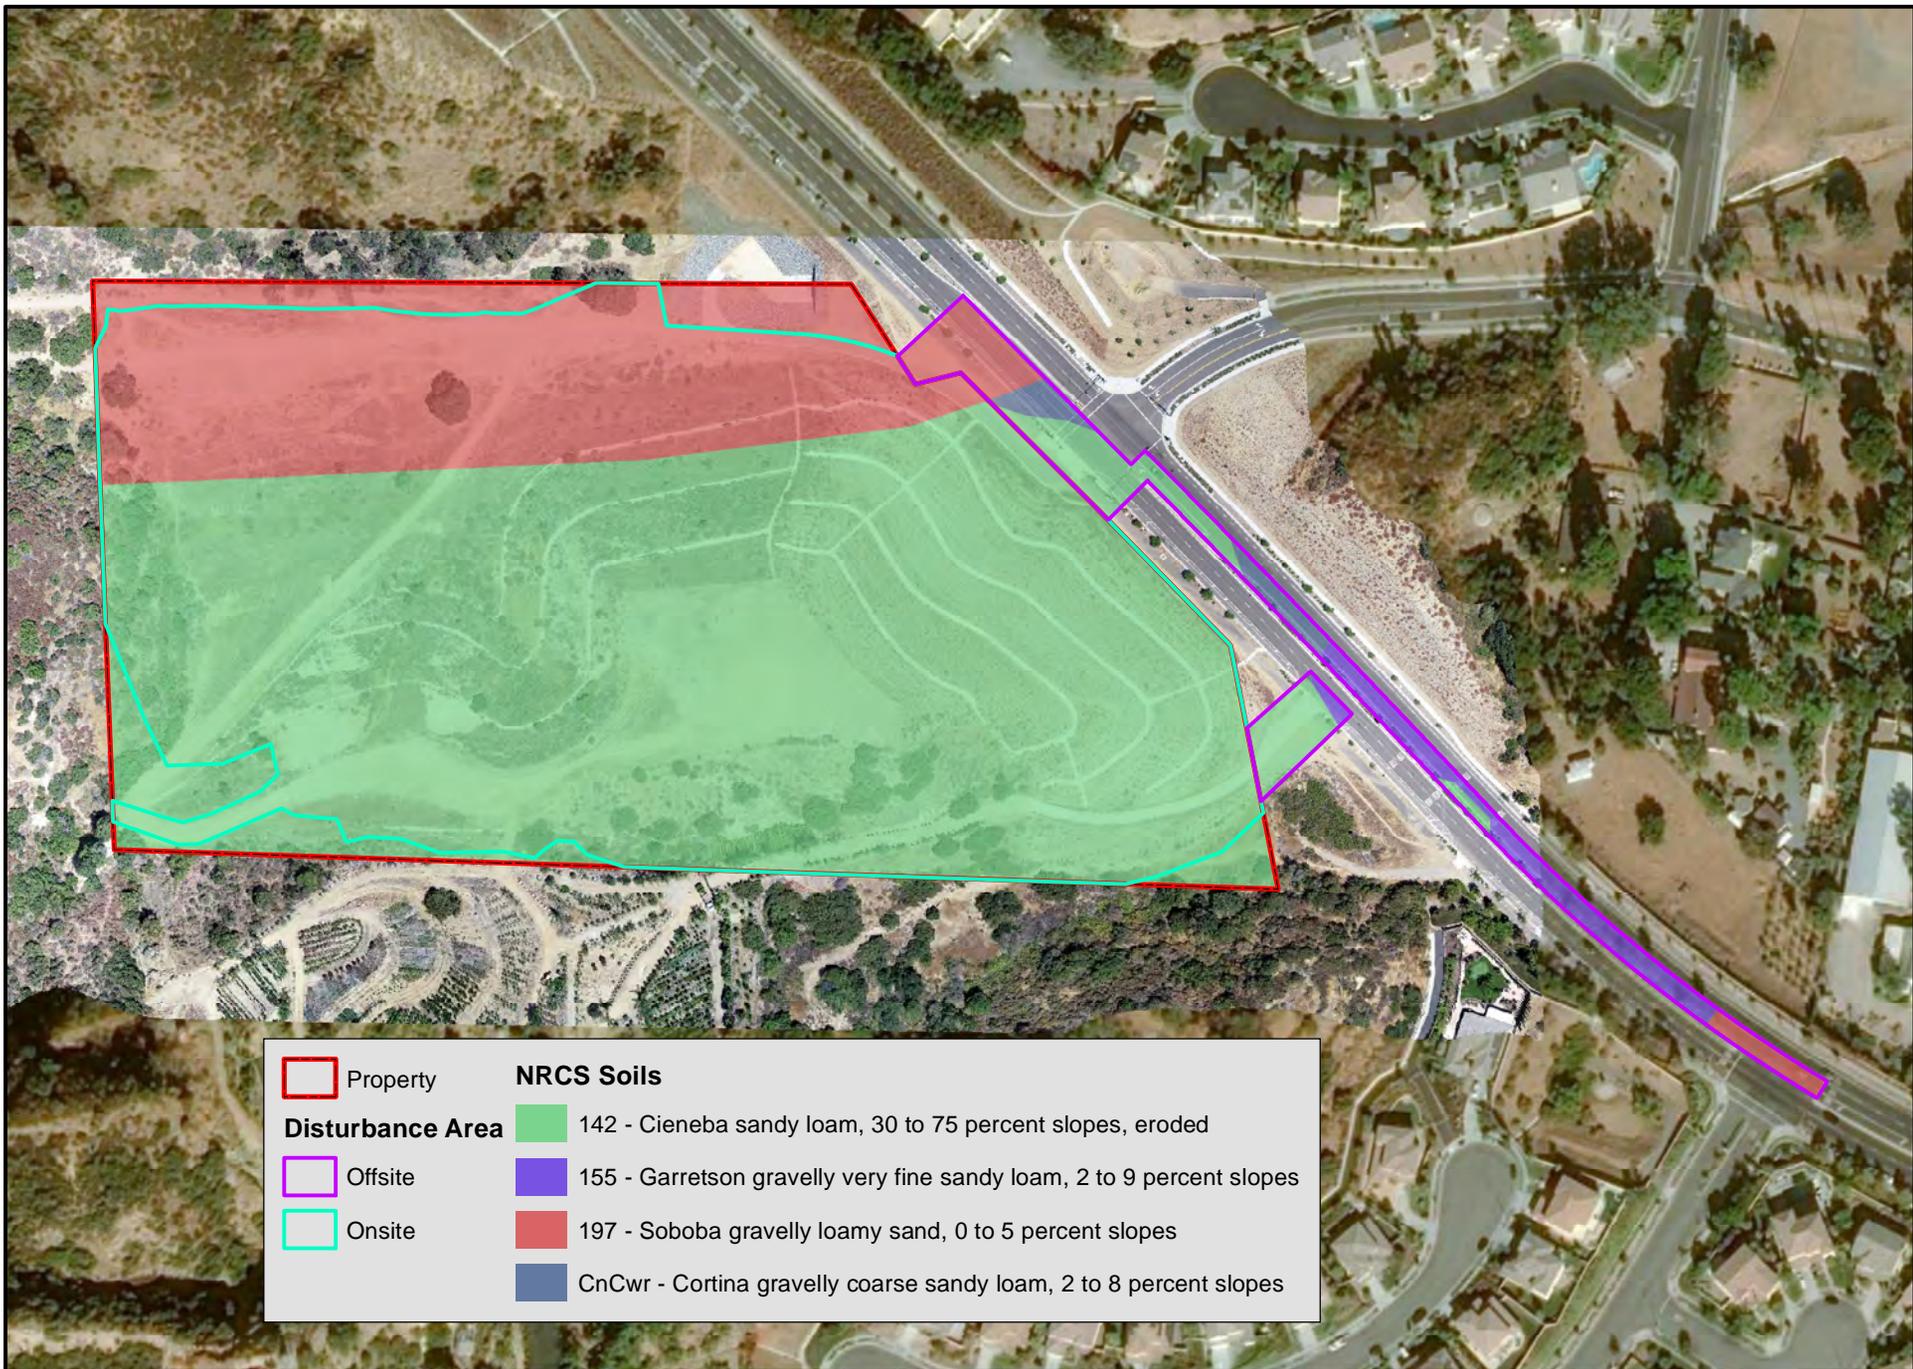
**FIGURE 14**  
**NRCS Soils**

The Property/Project consisted of three soil series as depicted by *Figure 14 – NRCS Soils* (Page 23). A brief description, as described by the NRCS (United States Department of Agriculture Natural Resources Conservation Service, 2020) is presented in Table 3 (below). No hydric, clay, or saline-alkali soils were present on the Property/Project.

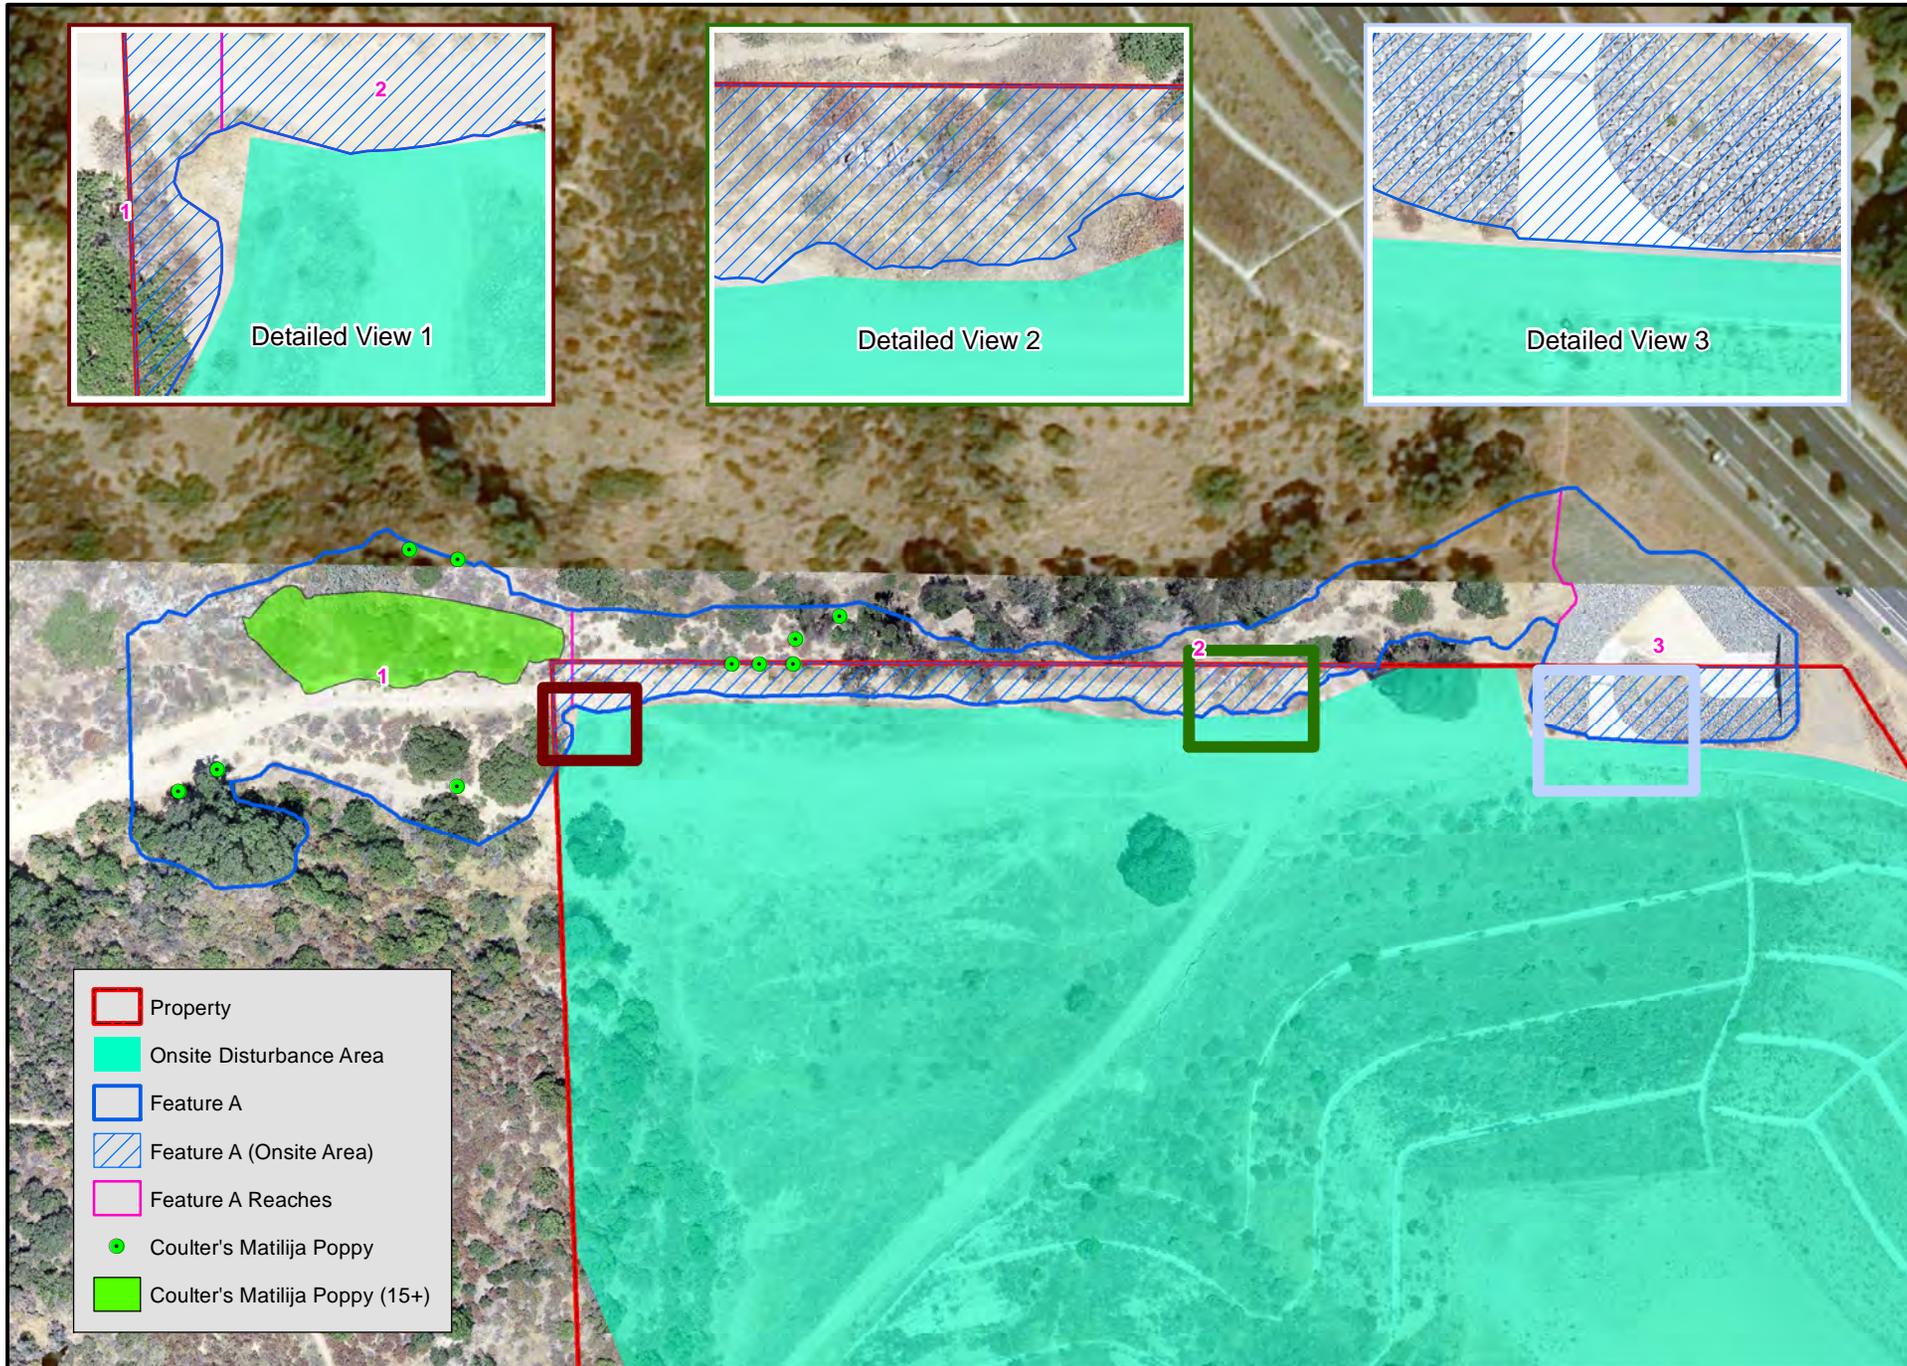
**FIGURE 16**  
**Feature A**

Feature A has been divided into three drainage “reaches” to simplify the description below due to the drainage transitioning from a relatively natural alluvial wash (Reach 1), disturbed alluvial wash with a Eucalyptus woodland (Reach 2), and the developed rip rap/culvert collection area (Reach 3). *Figure 16 – Feature A* (Page 26) provides a detailed view of Feature A.

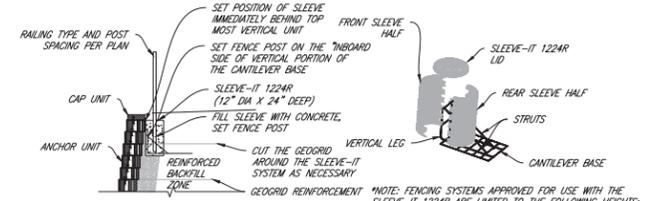
DETAIL OF FENCE POST INSTALLATION USING SLEEVE-IT 1224R

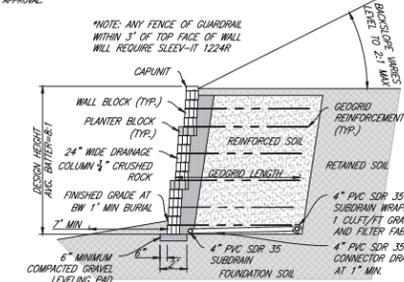
PLANTABLE GEOGRID REINFORCED WALL SECTION

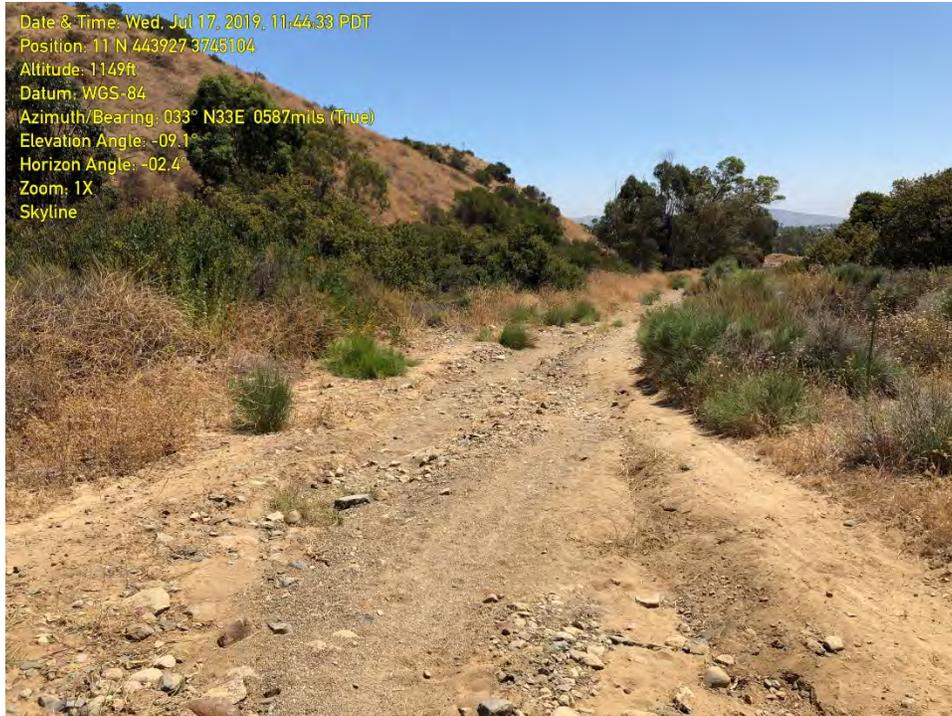
**PHOTOGRAPH 1:** A downstream view of Reach 1 in a braided channel/trail area.

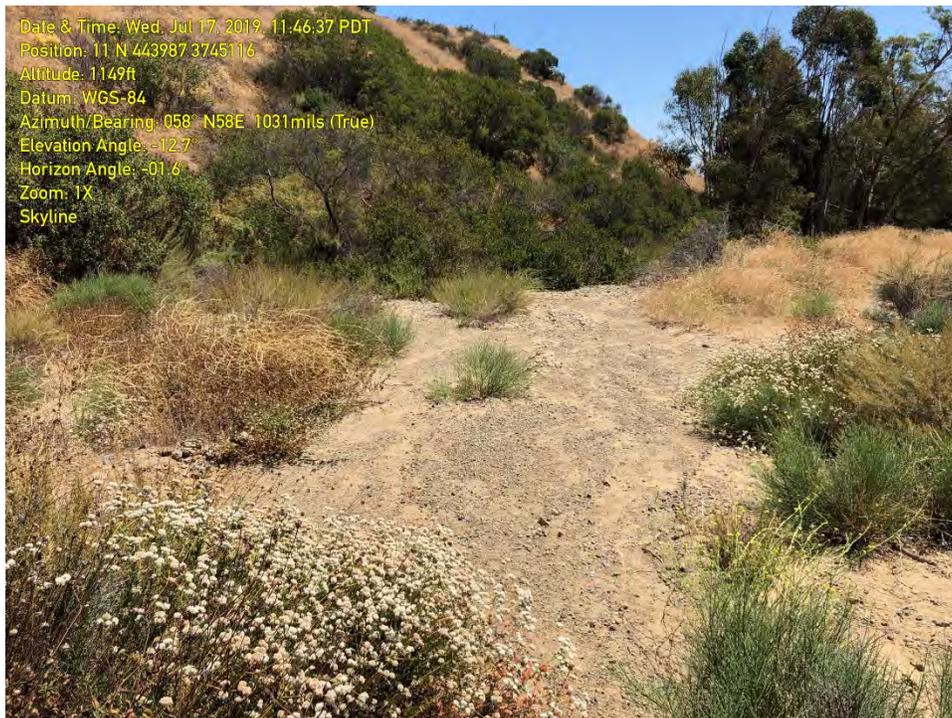
**PHOTOGRAPH 2:** Evidence of broad surface flow near the terminus of Reach 1 and the beginning of Reach 2.

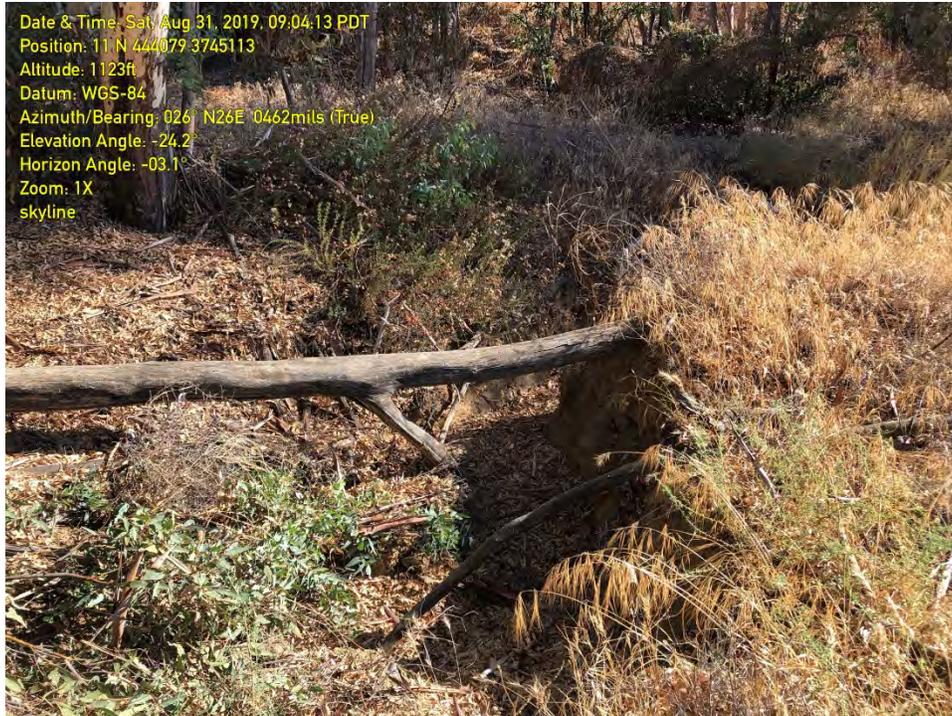
**PHOTOGRAPH 3:** The understory of Reach 2. A deeply incised channel/erosional gully was present in portions of Reach 2.

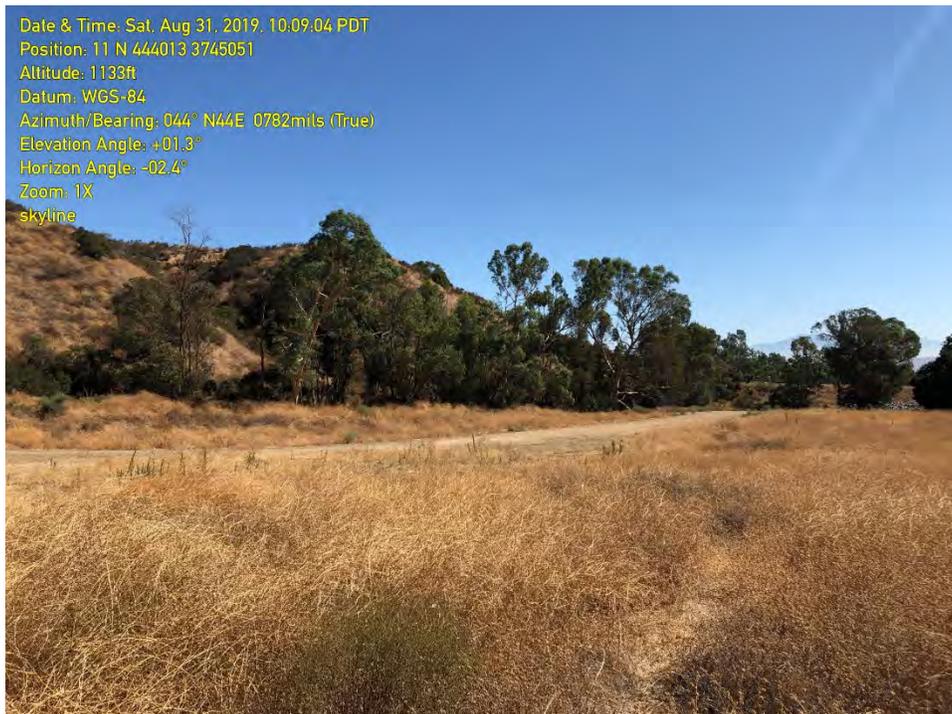
**PHOTOGRAPH 4:** A view of the Eucalyptus woodland in Reach 2.

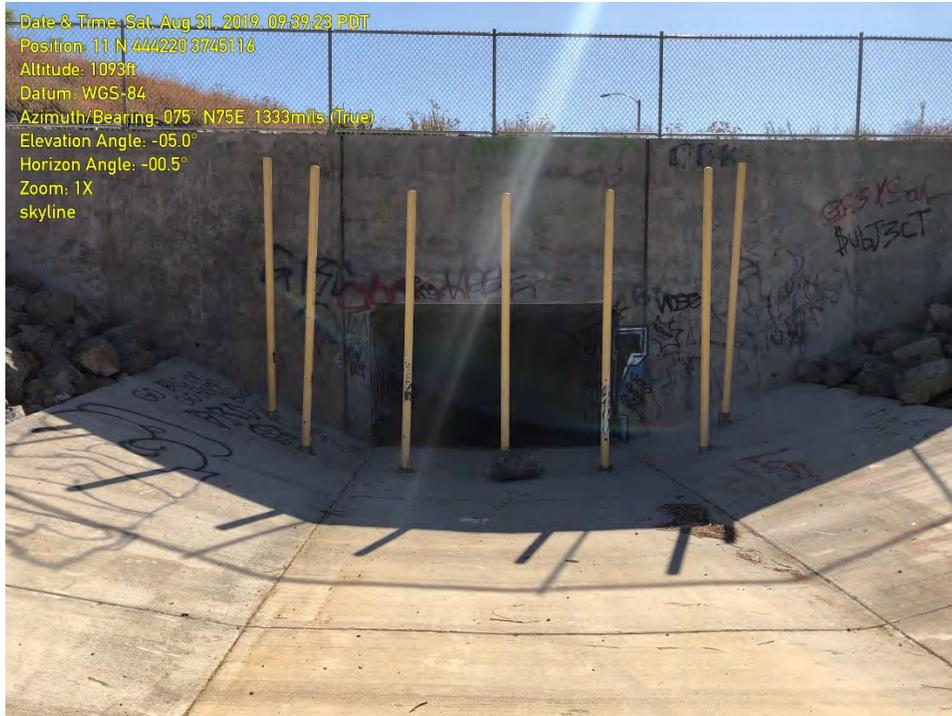
**PHOTOGRAPH 5:** The culvert in Reach 3.

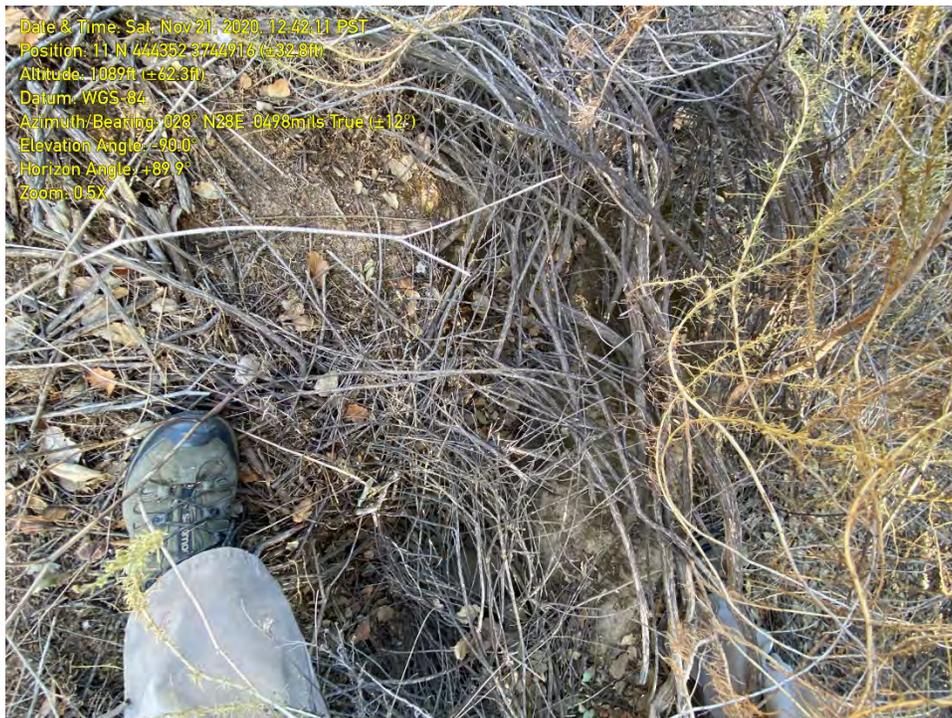
**PHOTOGRAPH 6:** The small incised channel of Feature B on the Property.

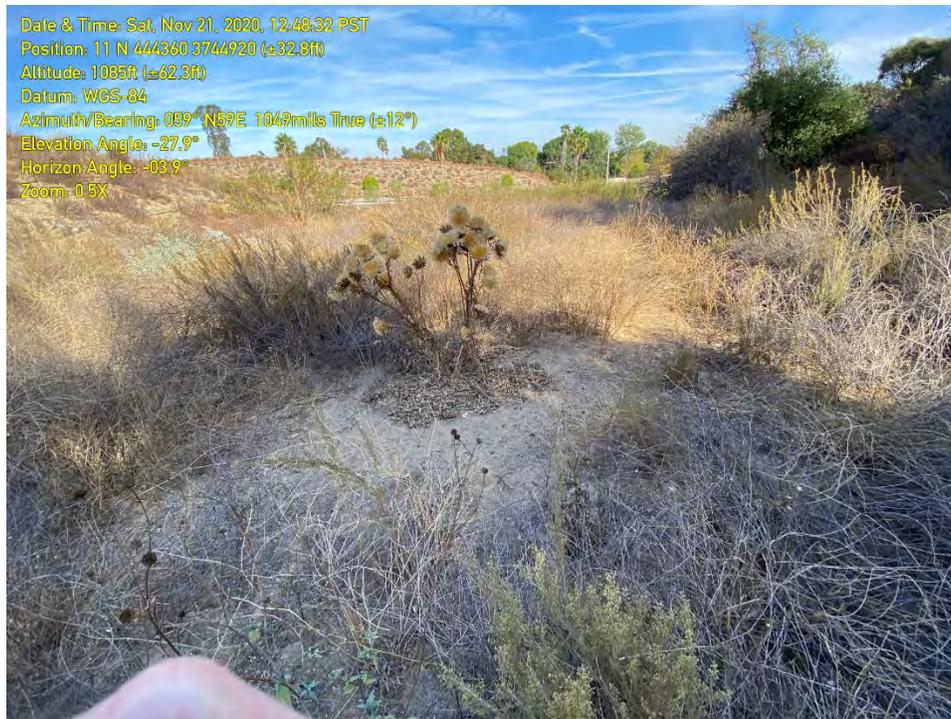
**PHOTOGRAPH 7:** A view looking east from the terminus of Feature B. No evidence of flow was present.

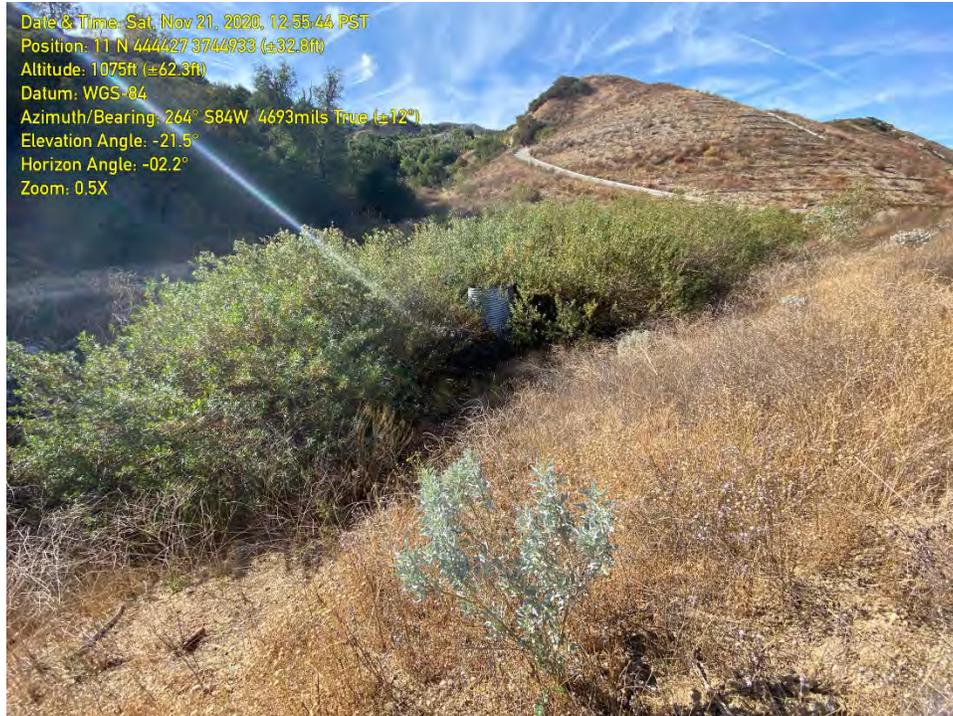
**PHOTOGRAPH 9:** A westerly view of Feature C.

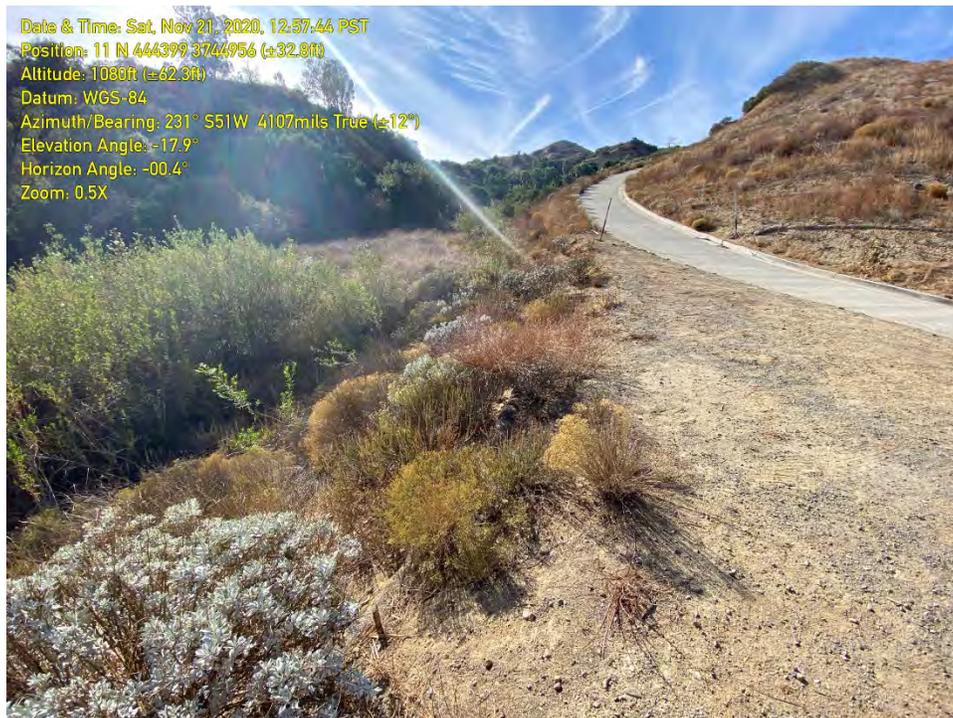
**PHOTOGRAPH 10:** A graded pad and associated 2:1 slope graded in association with the extension of Foothill Parkway in 2015.

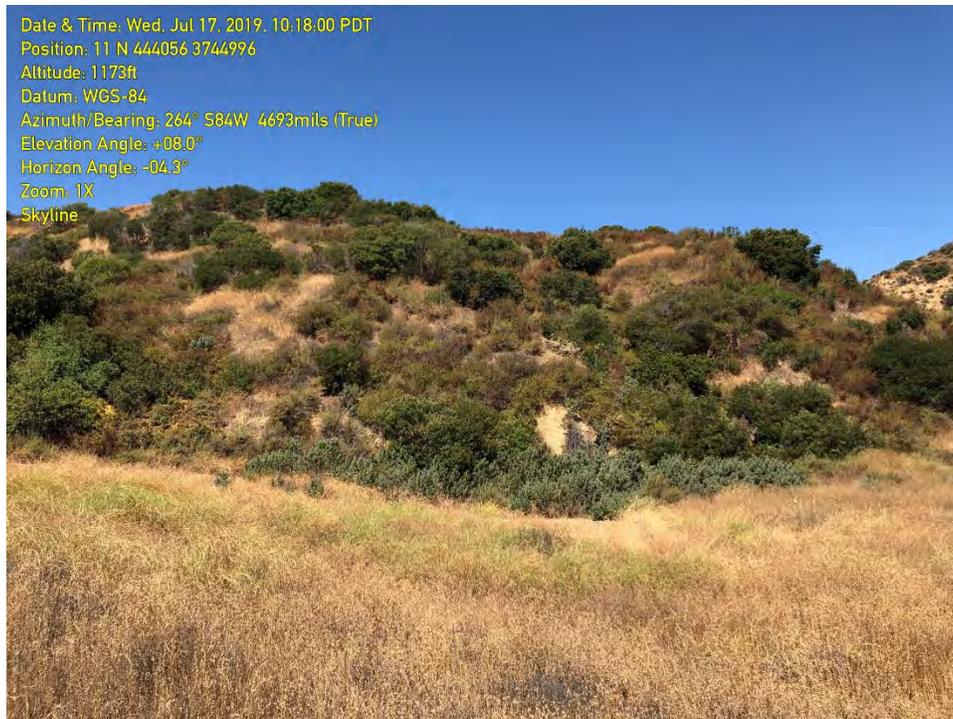
**PHOTOGRAPH 3:** Ruderal habitat in the foreground with coastal sage scrub in the background.

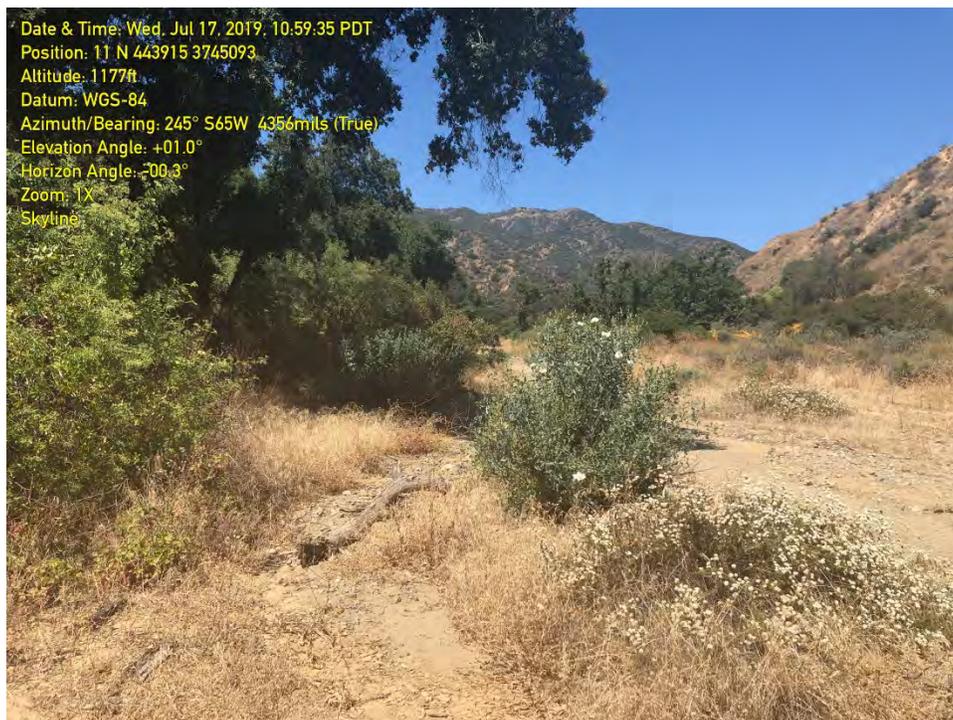
**PHOTOGRAPH 4:** A view offsite to the west. Coulter's matilija poppy is depicted with the large white flower petals.
