***UPDATED GEOLOGIC FAULT HAZARD EVALUATION FOR THE PROPOSED 17-ACRE MULTI-USE
"SKYLINE VILLAGE" DEVELOPMENT, LOCATED AT WEST CHASE DRIVE AND FOOTHILL
PARKWAY IN THE CITY OF CORONA, RIVERSIDE COUNTY, CALIFORNIA; APNS: 275-050-014-6
AND 275-080-041-3***

*Dated: July 16, 2020
Project No. G19-1802-10*

Project No. G19-1802-10

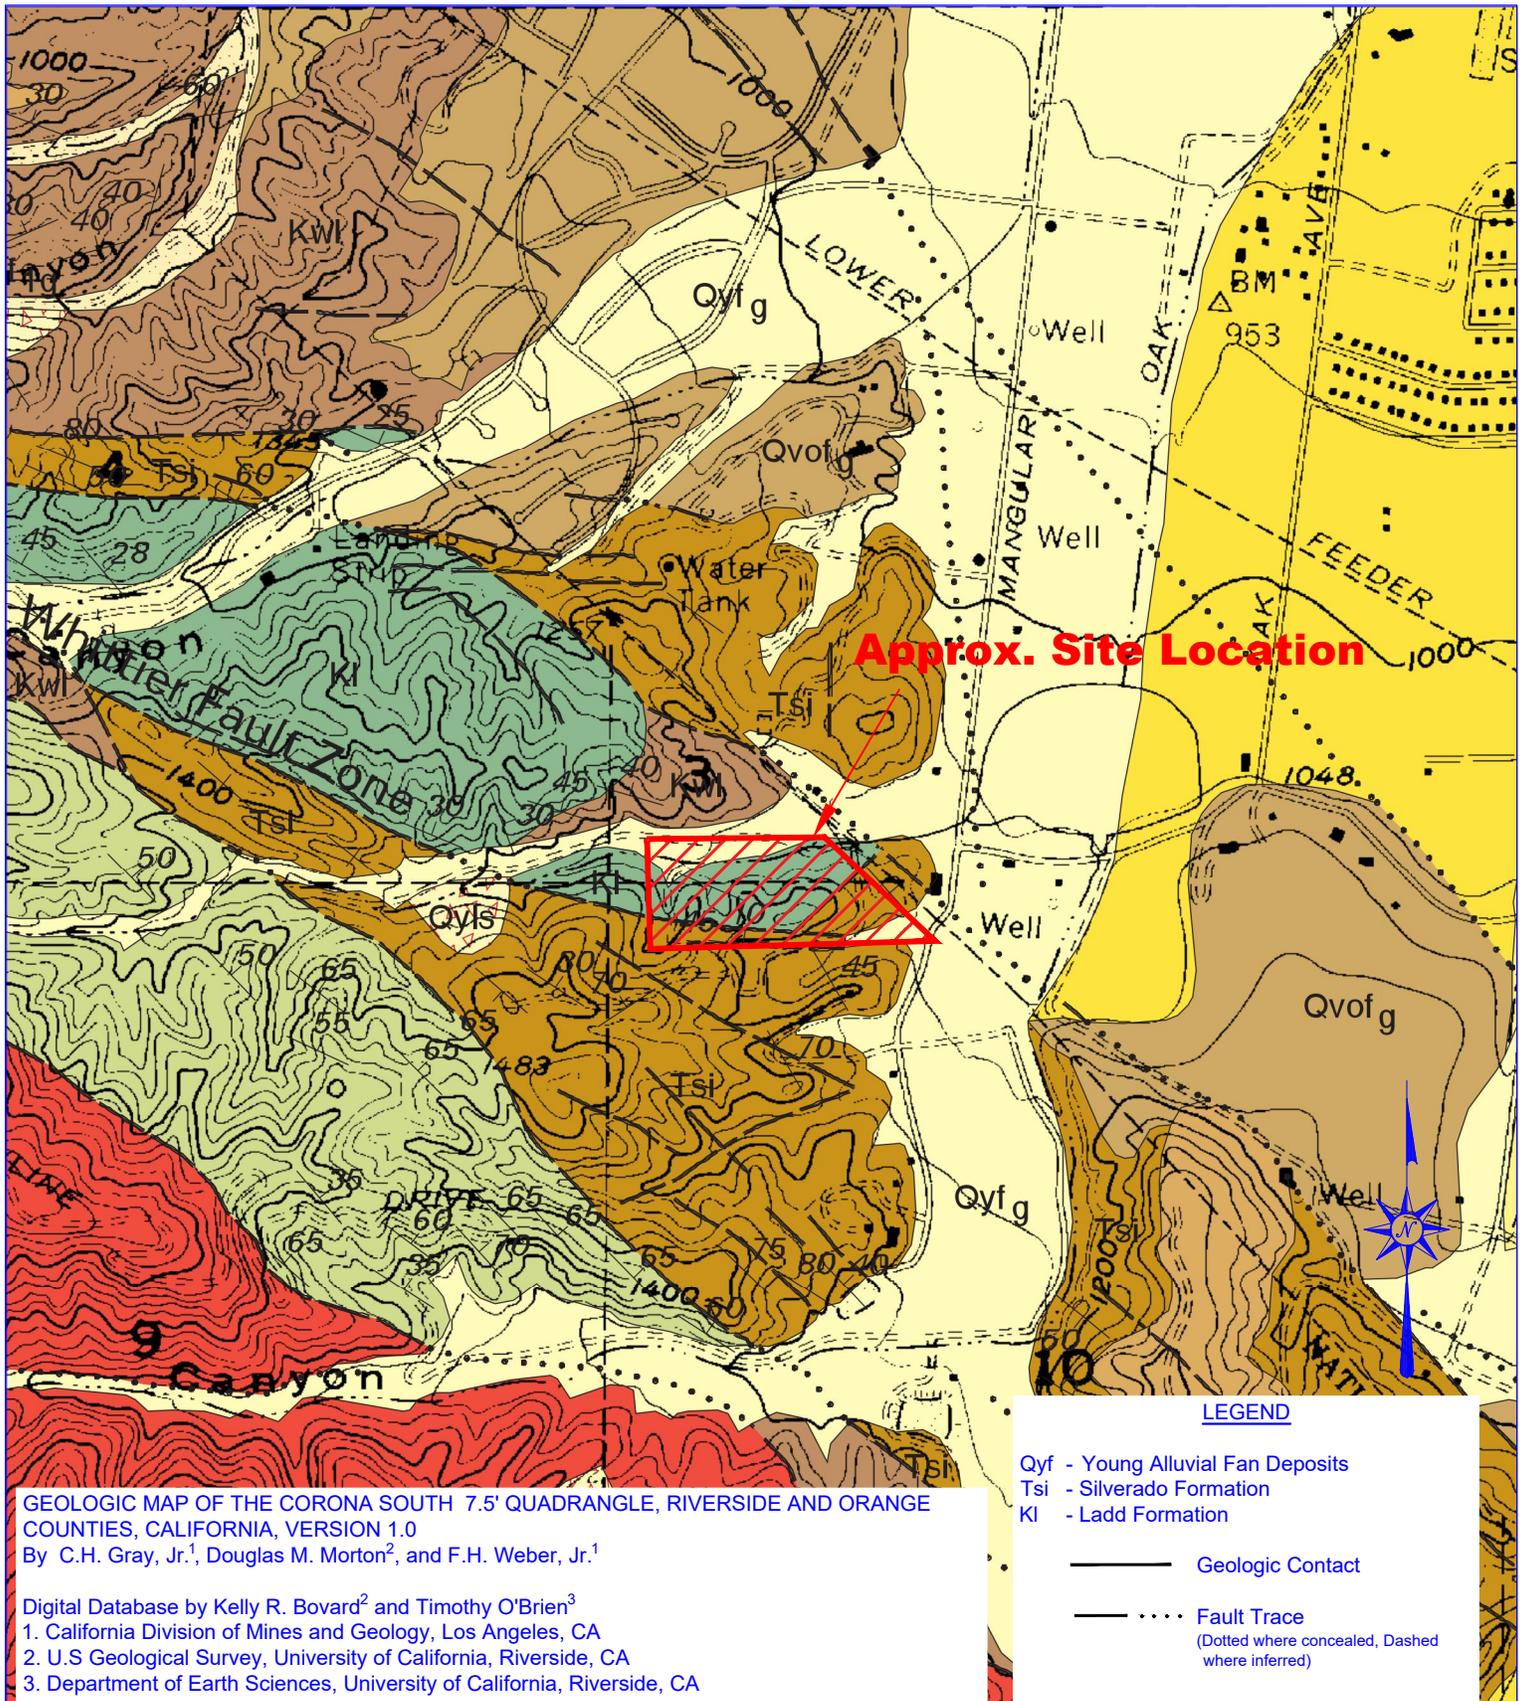
FIGURE 2
REGIONAL GEOLOGIC MAP

Regionally, the site is located in the Peninsular Ranges Geomorphic Province of California. The Peninsular Ranges are characterized by steep, elongated valleys that trend west to northwest. The northwest-trending topography is controlled by the Elsinore fault zone, which extends from the San Gabriel River Valley southeasterly to the United States/Mexico border. The Santa Ana Mountains lie along the western side of the Elsinore fault zone, while the Perris Block is located along the eastern side of the fault zone. The mountainous regions are underlain by Pre-Cretaceous, metasedimentary and metavolcanic rocks and Cretaceous plutonic rocks of the Southern California Batholith. Tertiary and Quaternary rocks are generally comprised of non-marine sediments consisting of sandstone, mudstones, conglomerates, and occasional volcanic units. A map of the regional geology is presented on the Regional Geologic Map (Figure 2).

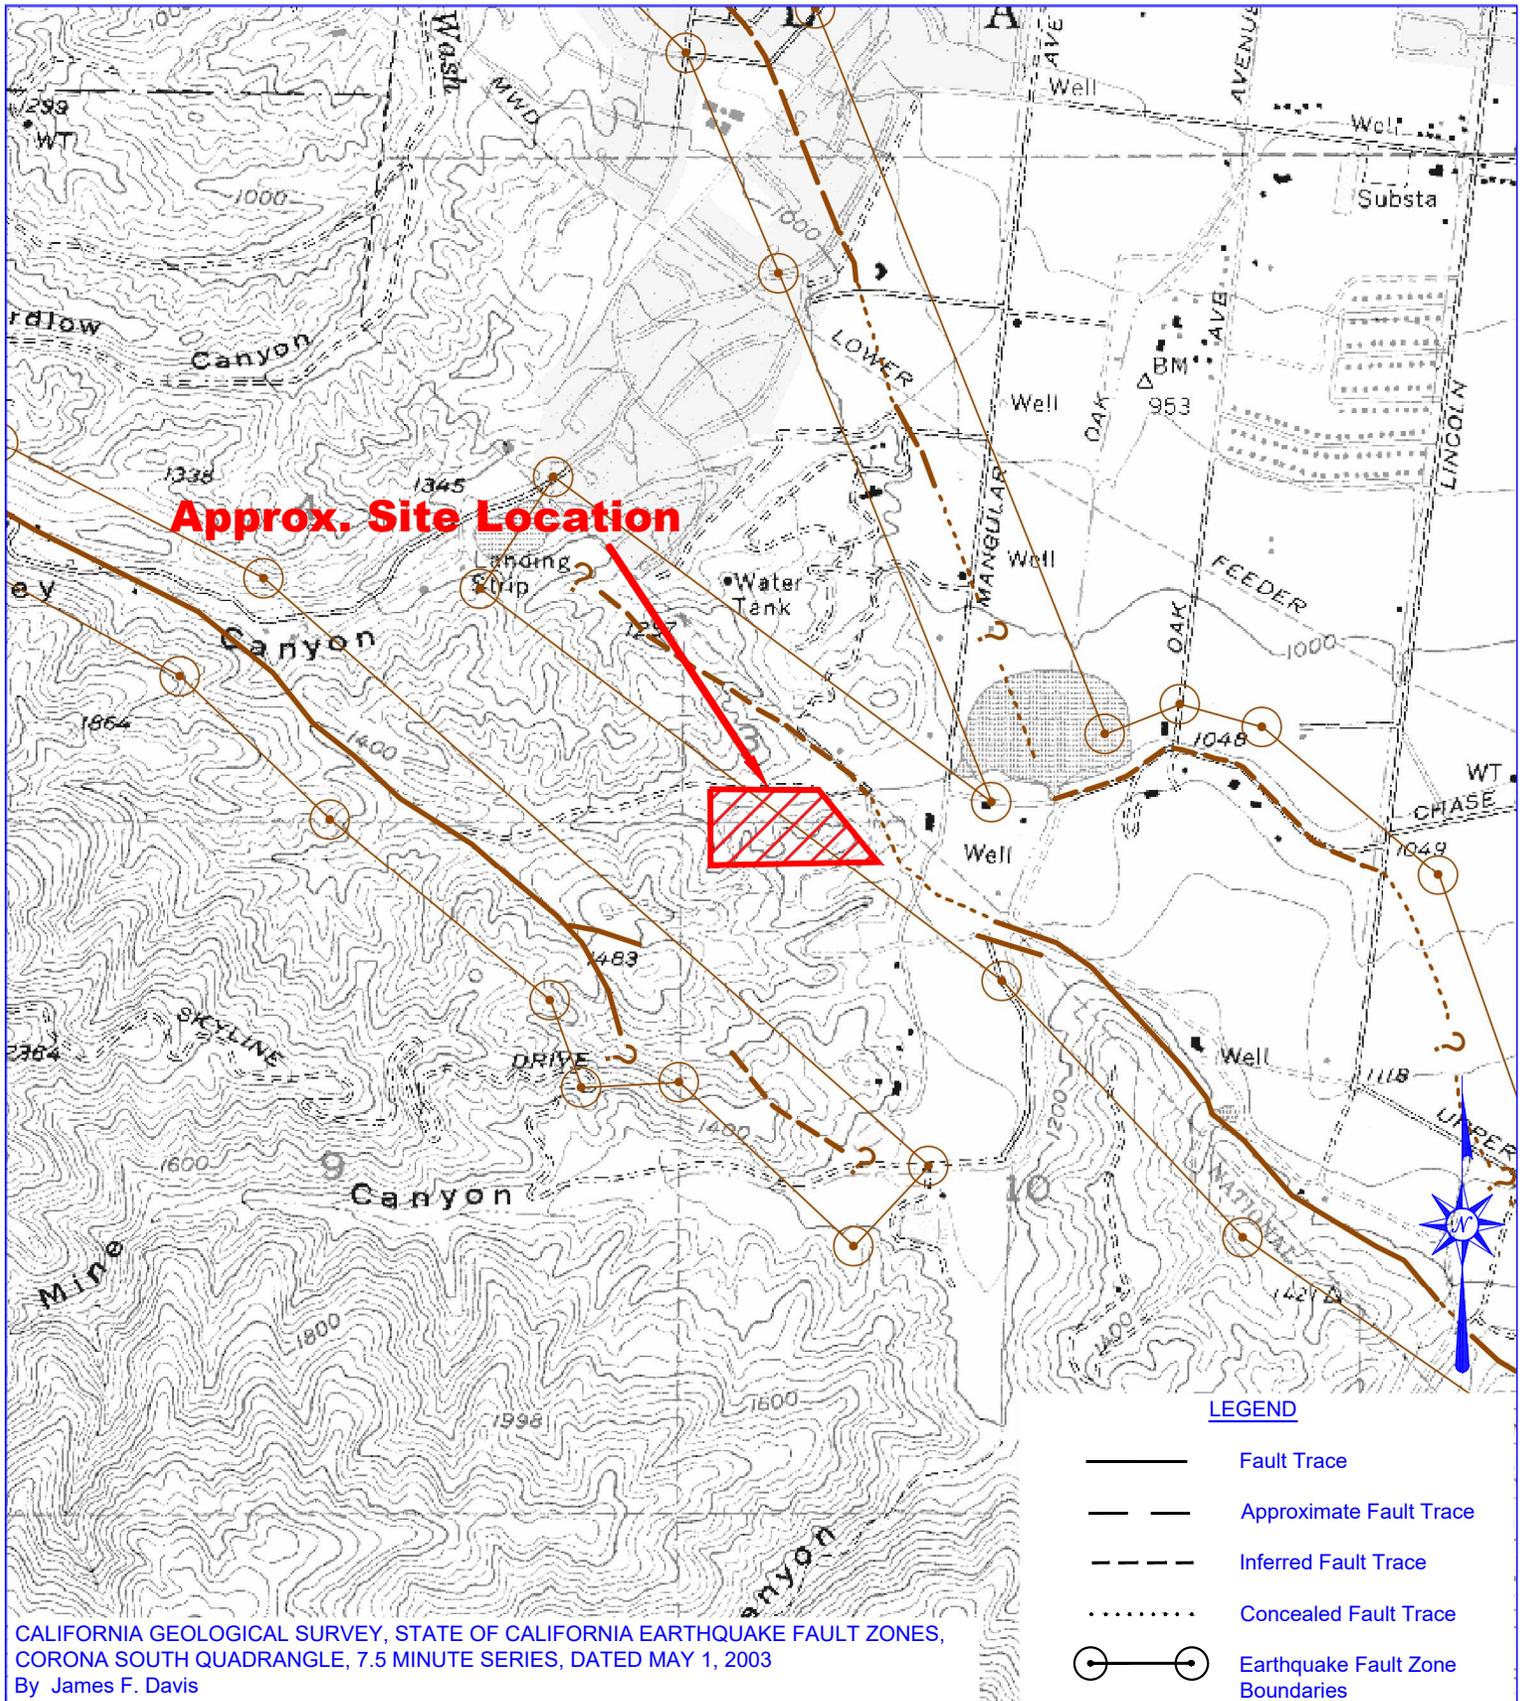
FIGURE 3
ALQUIST-PRIOLO EARTHQUAKE
FAULT ZONE MAP

Faults *are* known to project through the site. A portion of the subject site is located within a State of California Alquist-Priolo Earthquake Fault Zone and a Riverside County Earthquake Fault Zone for the Elsinore fault (Figure 3). During our evaluation, faulting associated with the Tin Mine fault was located trending generally east-west through the site in FT-1 (See Plate 2). Additionally, the fault contact between the Silverado Formation and Ladd Formation was encountered in trenches TR-1 and TR-8 excavated for the current geotechnical investigation of this site. The Riverside County Fault Map (Figure 4) indicates that the Tin Mine fault is the fault contact between the Silverado and Ladd Formations onsite and no earthquake fault zones have been established for this fault.
