**UPDATED PRELIMINARY GEOTECHNICAL INVESTIGATION
AND UPDATED FAULT RUPTURE HAZARD EVALUATION
TENTATIVE TRACT 34760, CORONA
RIVERSIDE COUNTY, CALIFORNIA 92882**

W.O. 5166-A-SC OCTOBER 9, 2006

Subject: Updated Preliminary Geotechnical Investigation and Fault Rupture Hazard Evaluation, Tentative Tract 34760, Corona, Riverside County, California

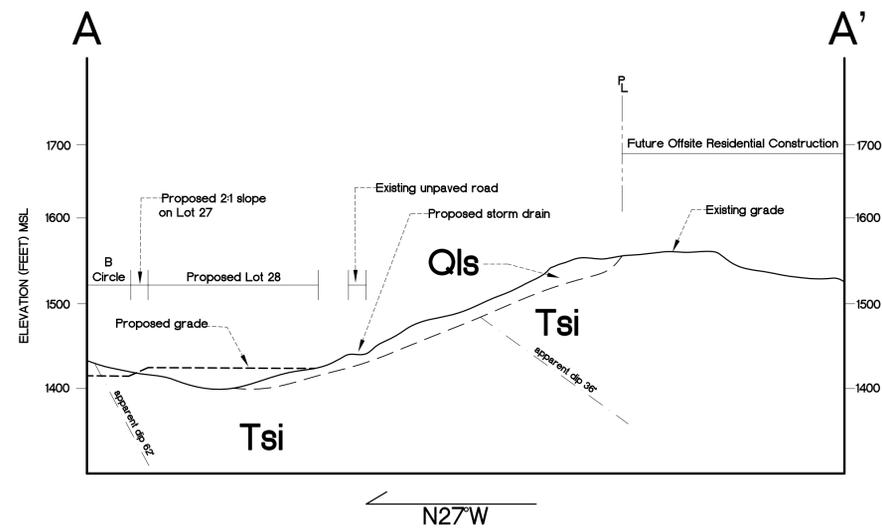
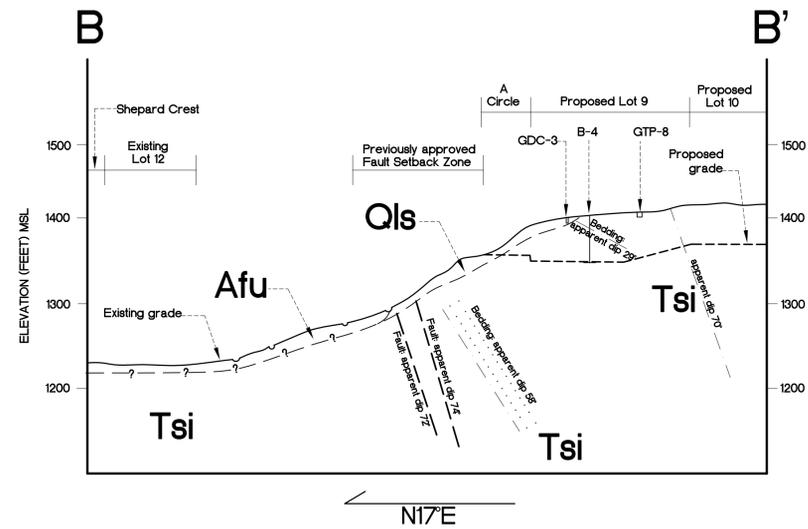
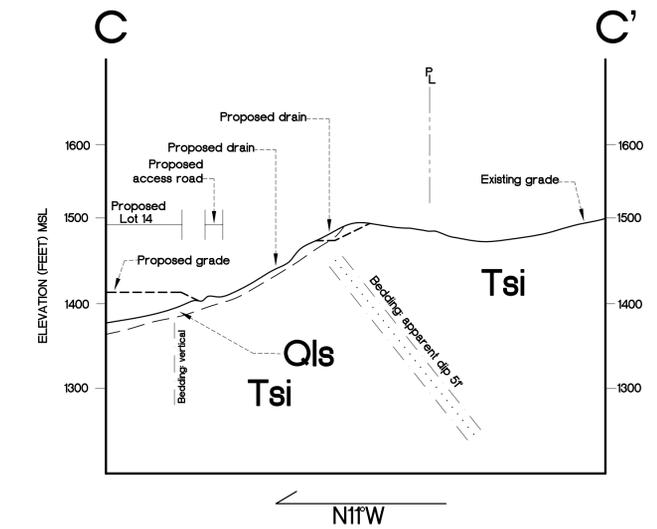
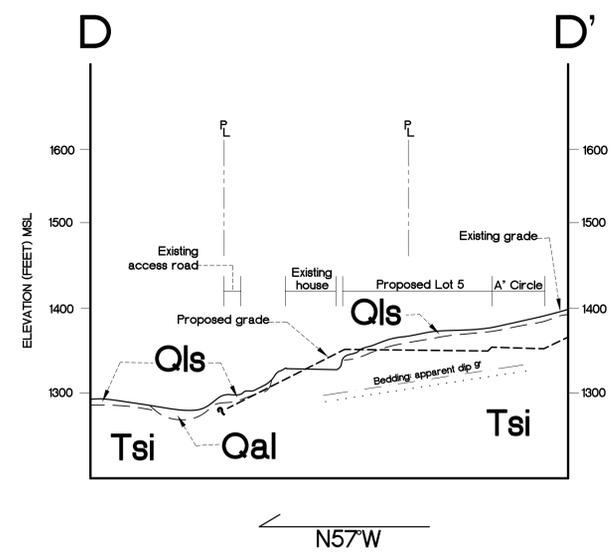
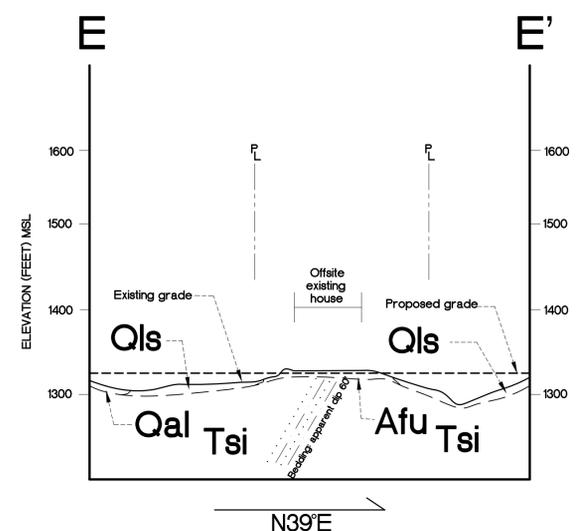
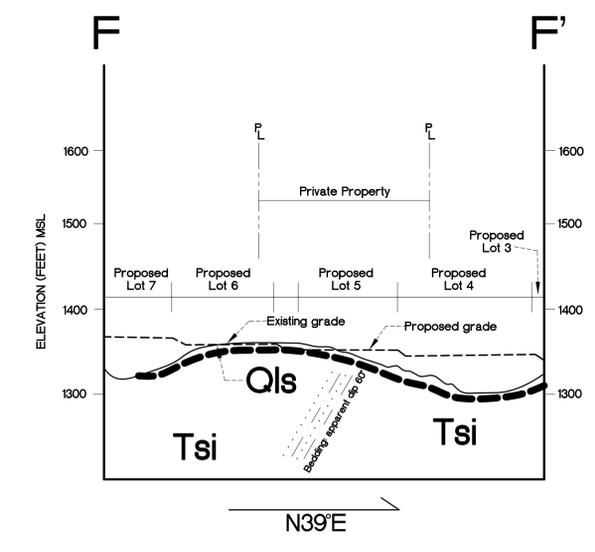
Plate 5 of 6

The fault-locating trenches and dozer cut were logged by geologists from our firm. These trenches and dozer cut were excavated by a trackhoe, and in total, were about 1,100 feet in length. Although the County geologist was invited to view the trenches, the invitation was declined. The trenches have now been backfilled with native materials, and track walked. The location of previous and current explorations are shown on the Geologic Map, Plate 1. The logs of the GSI trenches are included as Plate 2 (Trench Logs FT-1 and FT-2), Plate 3 (Trench Log FT-3), Plate 4 (Trench Logs FT-4 and FT-5), and Plate 5 (FT-6 and Dozer Cut Log DC-1).
